JK-GEN 384-12

ERRATA SHEET

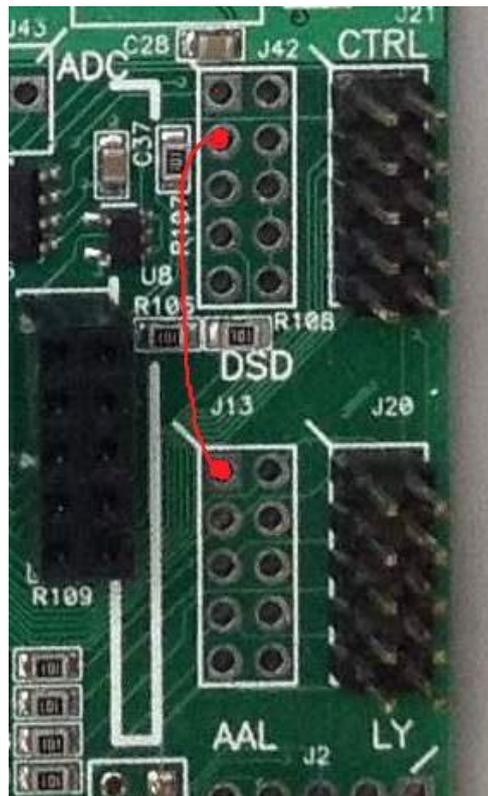
PCB Version before 1.3a does not have DSD possibility.
Starting from PCB Ver. 1.3A DSD signals are present at I2S connector pins:
WCLK -> DSD_Left
SDATA -> DSD_Right
BCLK -> DSD_Clock

- a) Check that resistors R107, R109 are exists, if not – put 100R 0805.
- b) Connect with wire J42 pin 3 to J13 pin 1.

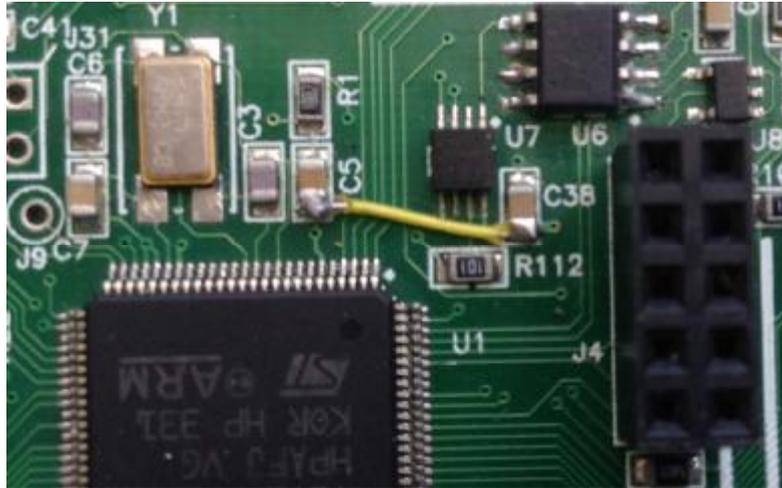
Sometimes, the internal main clock is not stable at 48x sample rate scale.
Actually for PCB Rev. 1.3 and 1.3a.

- a) Open the case and check if the wire jumper exists:

If it exists – you do not need to do anything. If it does not exist – continue.

- d) Put short wire on the top side, as it shown above.:
