Service Bulletin

KENWOOD ELECTRONICS, INC.

Bulletin SB 2023

SUBJECT: REPLACEMENT OF OUTPUT TRANSISTORS IN THE KR9400

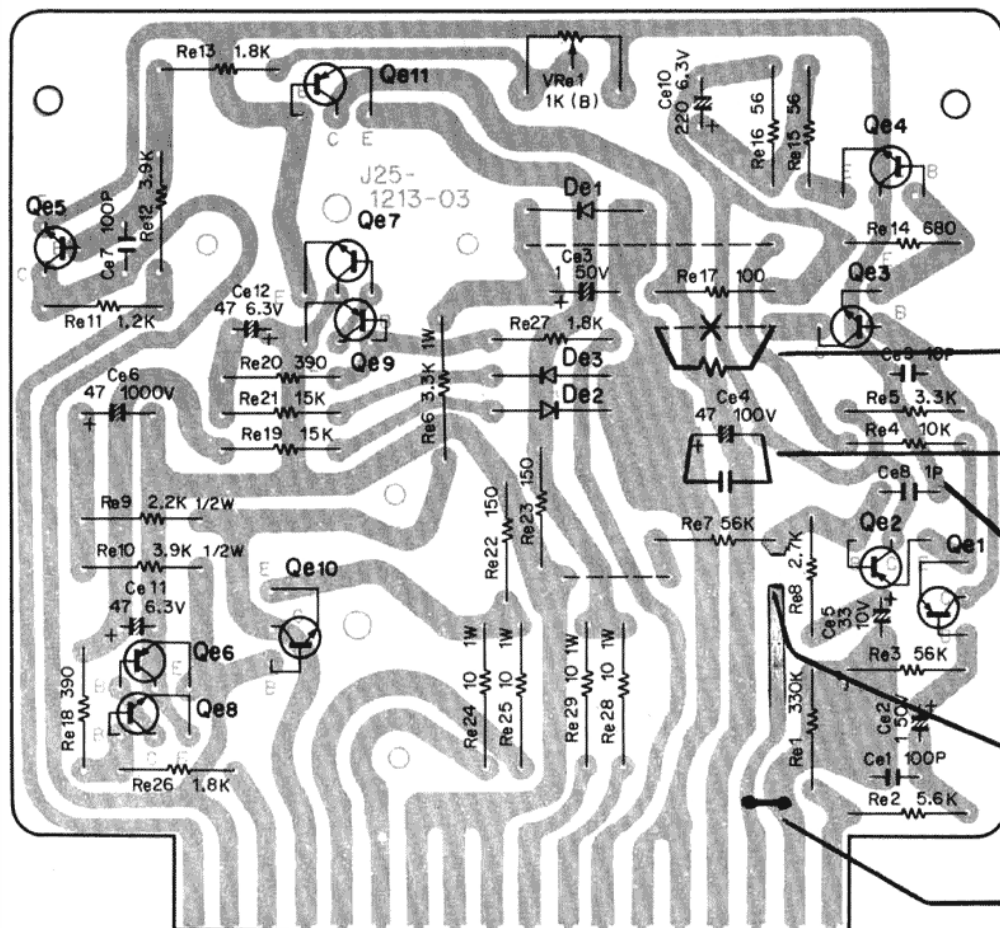
The following procedure should be observed when servicing a KR9400 with blown output transistors:

- 1) Replace the power transistors 2SB539 and 2SD287.
- 2) On the main amp board X07-1390-10, remove the jumper wire J2 which connects the collector of Qe3 to ground pins 5 and 6. In its place install a 15K ohm, $\frac{1}{4}$ W resistor.
- 3) Install a 0.47uf, 100V Mylar capacitor in parallel with capacitor Ce4 (47uf, 100V).
- 4) Replace the 1pf capacitor Ce8 with a 3pf capacitor. Alternatively, a 2pf capacitor can be added in parallel to the 1pf Ce8.
- 5) Sever the connection between pin 3 and Re7 on the main amp board by cutting the printed foil pattern between pin 3 and Re7. Make the cut as close to Re7 as possible.
- 6) Short pin 3 to pin 2 via a jumper wire.

The above service should be performed on both KR9400 main amp boards. Refer to figure 1 for further details.
