A3i transformer Hum Modification

16/1/97

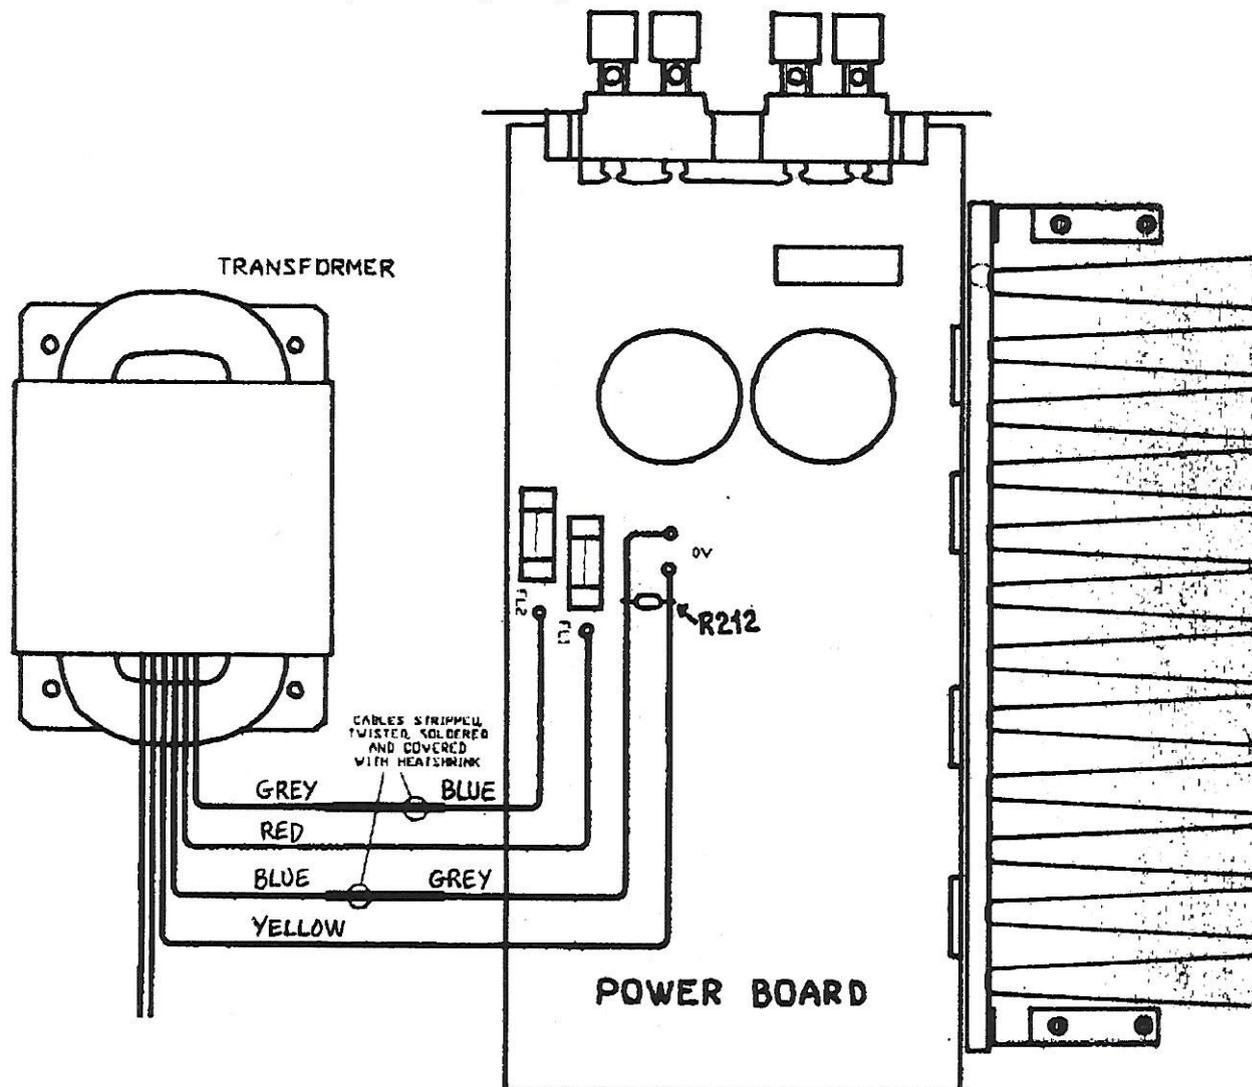
PROBLEM : R-Core transformer has excessive hum levels, even when the unit is idling. The hum is airborne and not transmitted through the casework.

1. Ensuring the unit is unplugged, remove the lid and locate the blue and grey cables connecting the R-Core transformer to the power amp board. (See Fig. 1).

SOLUTION : The phase of one of the secondary windings of the transformer needs to be reversed by following this procedure :-

2. Cut the blue and grey cables somewhere in the centre.

3. Strip back the insulation of both ends of the blue and grey cables by 10mm.

4. Place two 30mm tubes of heatshrink (Around 4mm diameter unshrunk will be suitable) on to the cables.

5. Twist the exposed conductors of the blue cable from the transformer with those of the grey cable from the board and solder.

6. Repeat with the grey cable from the transformer and the blue cable from the board.

7. Insulate soldered joints with heatshrink.

8. Redress cables neatly and test unit.
