EMI Stories Compendium

EMI Stories

A collection of 890 real-life short stories about the dangers of electromagnetic interference (EMI)

Compiled by Keith Armstrong
keith.armstrong@cherryclough.com

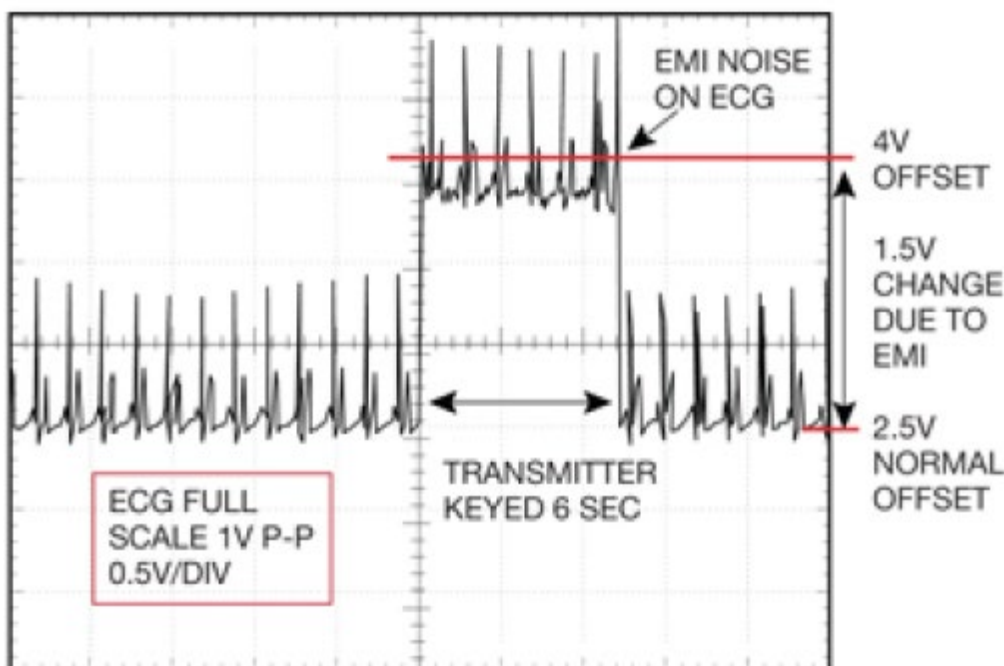
Figure 1 EMI from a cell phone can cause a 1.5V change from normal on an ECG. The ECG diagnostic tool senses a heart while a 0.5W, 470MHz transmitter turns on and off just one and a half feet away.

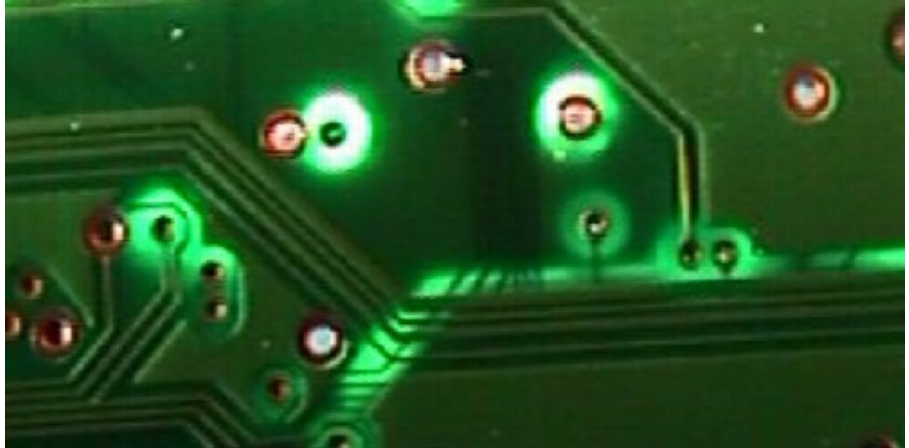
Figure 1. Circuit board with common design flaw

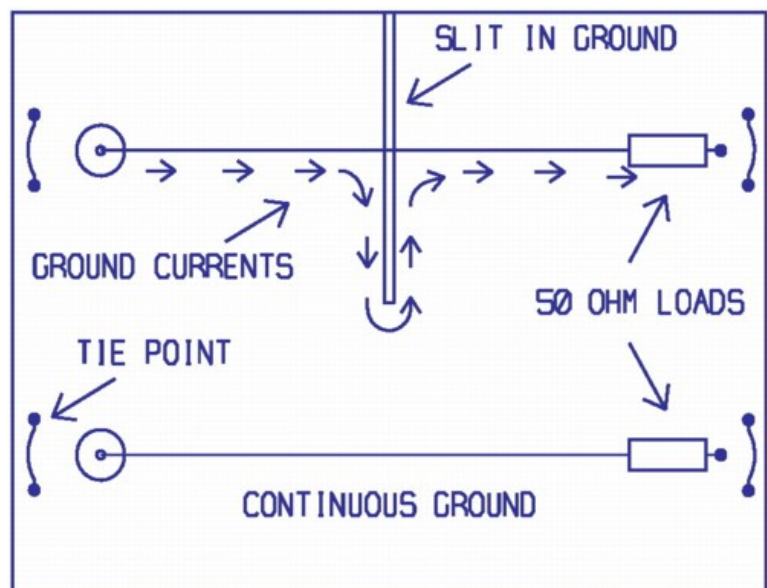
Figure 2. Drawing of Test Board With Slotted Ground

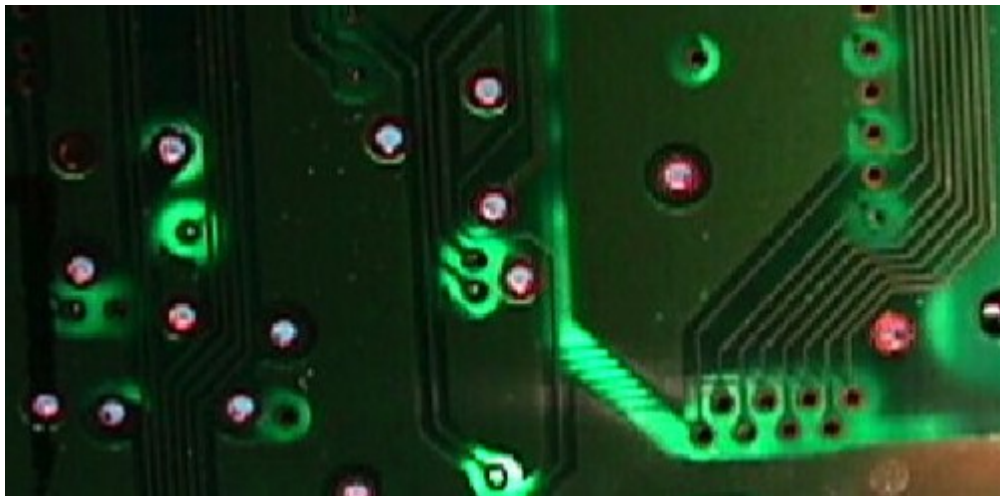
Figure 3. Another Circuit Board Example of Signals Crossing Plane Breaks

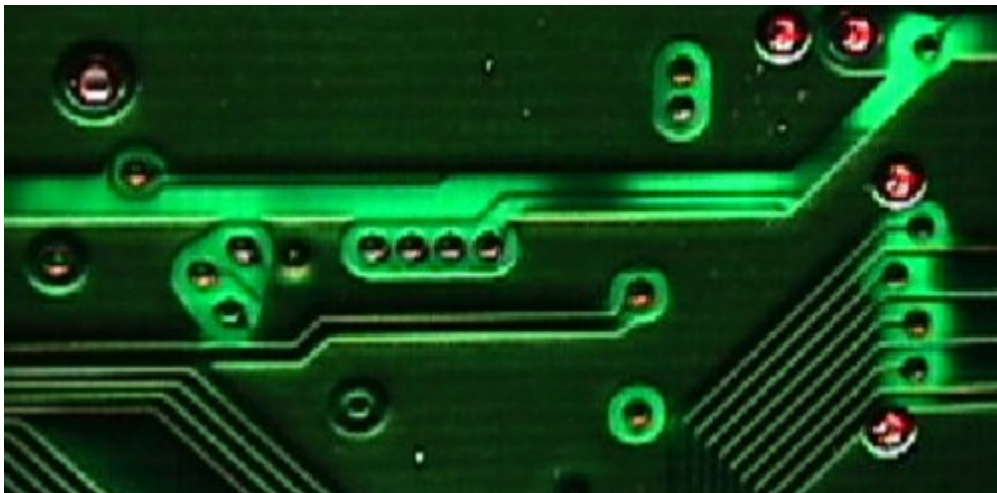
Figure 4. Third Circuit Board Example of Signals Crossing Plane Breaks

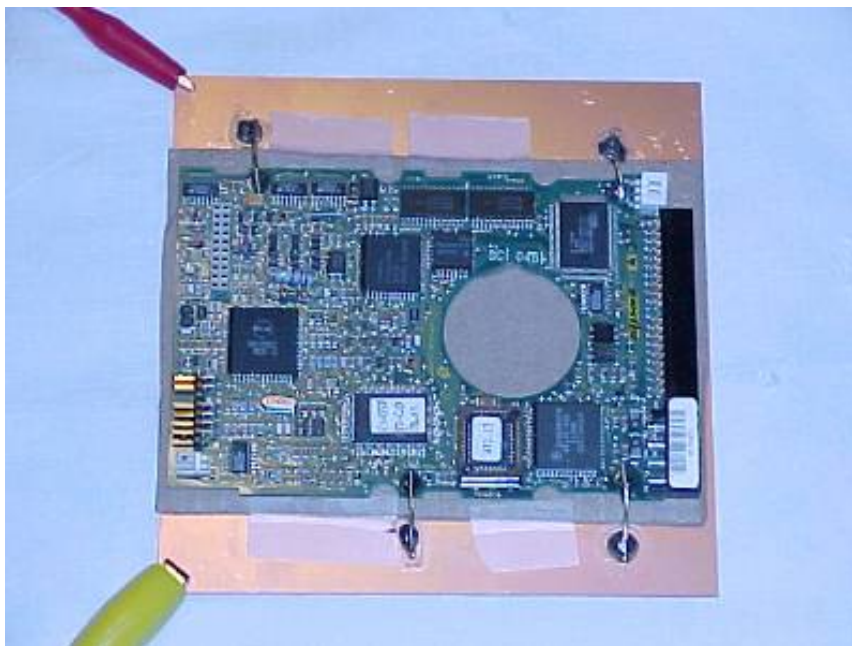
Figure 5. A Disk Drive Board Mounted Over a Copper Plane

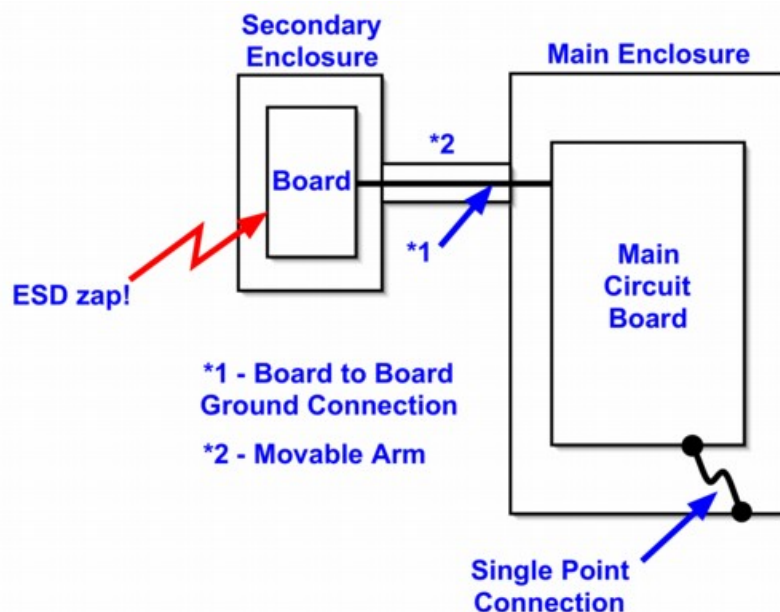
Figure 6. Circuit Boards Isolated From Chassis Ground Except at a Single Point

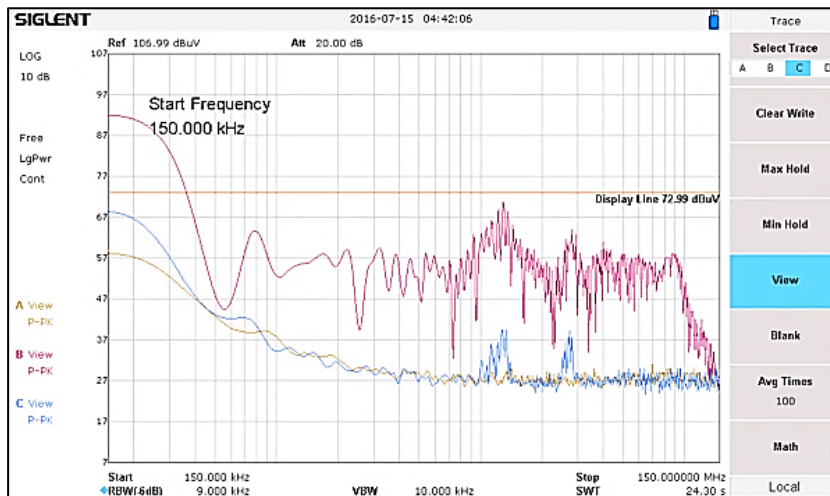
Figure 4 – The results with the 100 uH inductor installed (blue trace) over 150 kHz to 150 MHz.

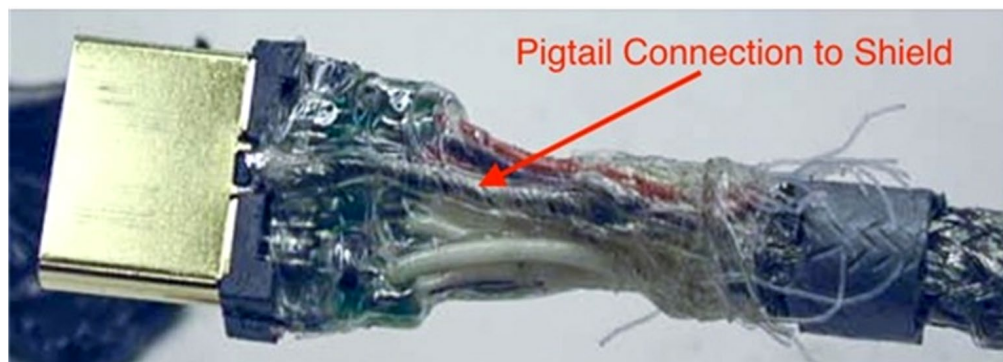
Figure 1 – A poorly terminated HDMI cable shield using a long pigtail connection.
Image, courtesy Dana Bergey and Nathan Altland.

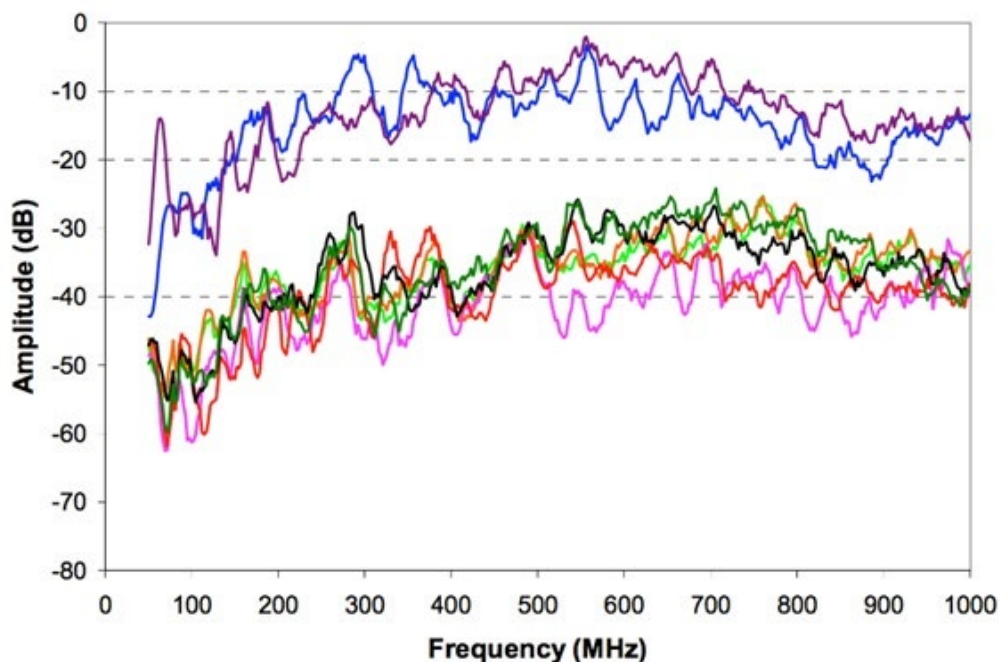
Figure 2 – The resulting radiated emissions from a sample of eight HDMI cables. Two of the samples exhibited EMI 20 dB higher than the average. Image, courtesy Dana Bergey and Nathan Altland.

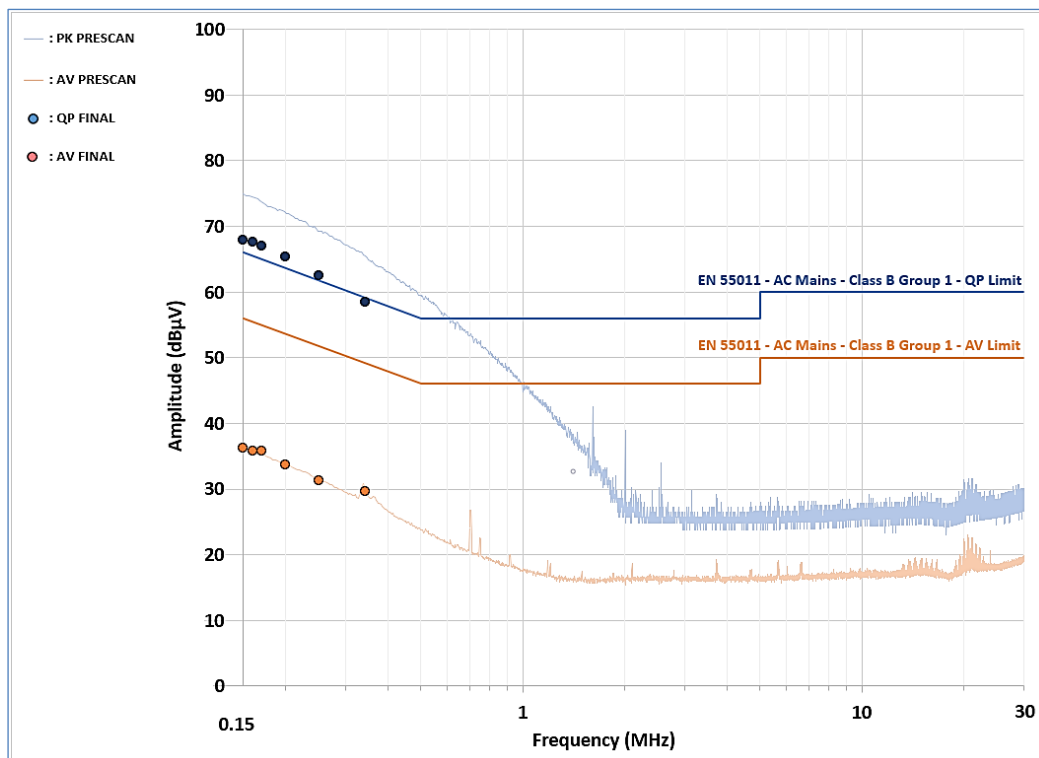
Figure 2 Conducted emissions plots, blue = QP, brown = AV
