<div>marantz®</div> <div>SERVICE BULLETIN</div>		Date: 17-Jul.-2002	Model: PM4200
		Page: 1/2	REF.NBR: MZ02-009revision
		Subject: Problem with incorrect operation of MUTE.	
Circulation:	Application:	Int.ref:	
x for information customer complaint in case of service mandatory	See below

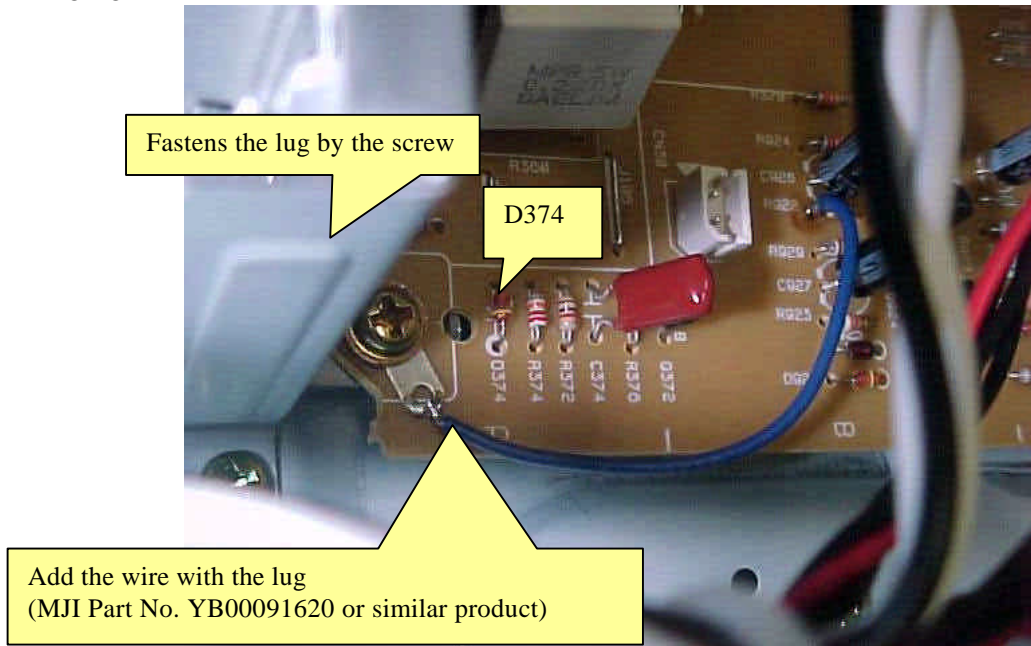
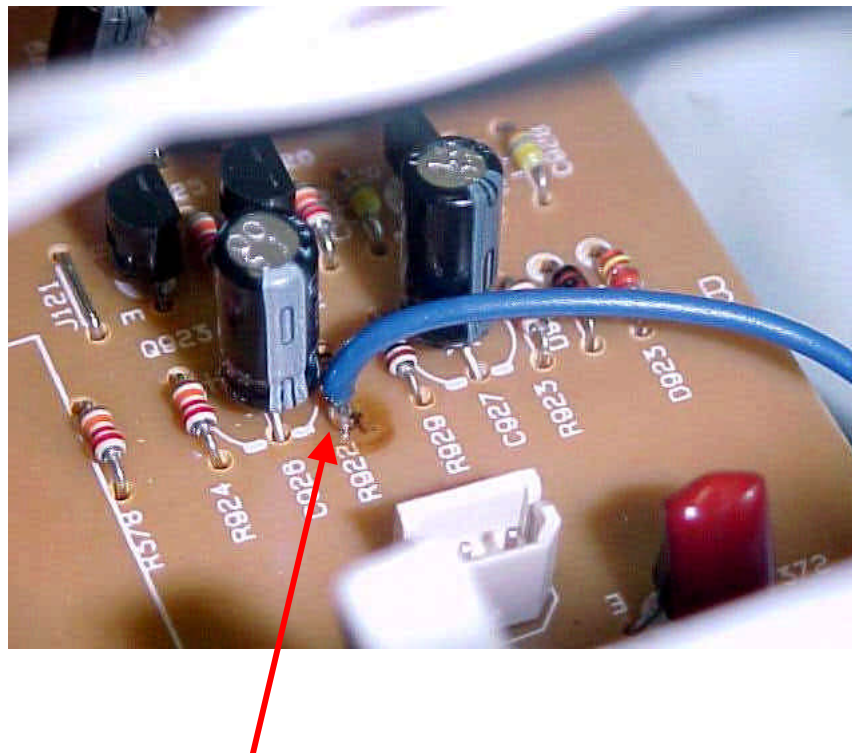
Processing figure (Part side view)

Contact error between the bracket (Pos. No. 30) and the ground of INPUT/AMPLIFIER PCB (Pos. No. 29).

Contact to the ground certainly by the wire with the lug.

Please refer to the processing figure of the next page and correct.

Solder the wire to the ground side lead of the R922 or R929
