Hi-Fi Products Service Bulletin

Model: GEN-HFP

No. 428

Subject: A Whistling noise is heard when playing certain Discs.

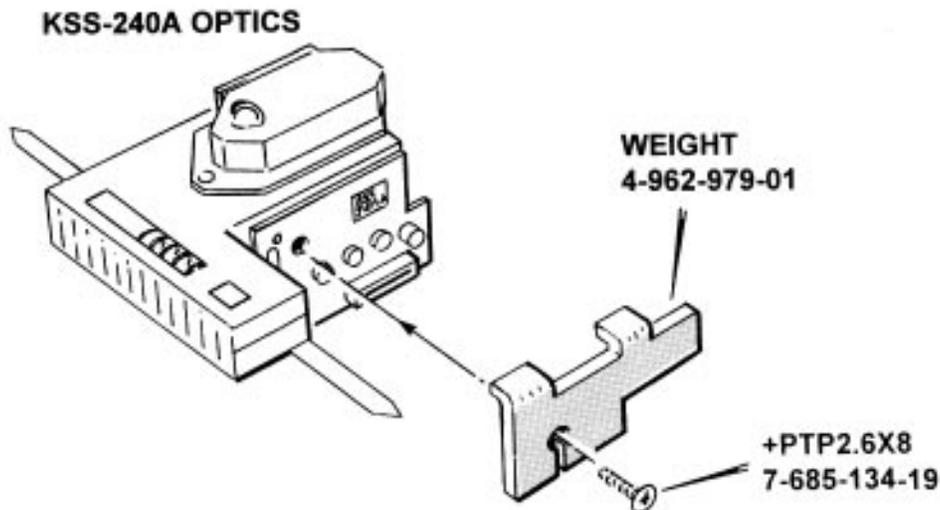
A whistling noise can be heard from the mechanical assembly. The whistling noise is a result of vibration of the disc, optical lens, and BU base which results in an audible resonant frequency. The following modification is applicable to all units that use the KSS-240A optics and exhibit the audible noise.

To reduce the vibration of the BU base add the weight (P/N 4-962-979-01) to the optical block using a +PTP2.6X8 screw (P/N 7-685-134-19) in place of the original screw.
