MODIFICATION

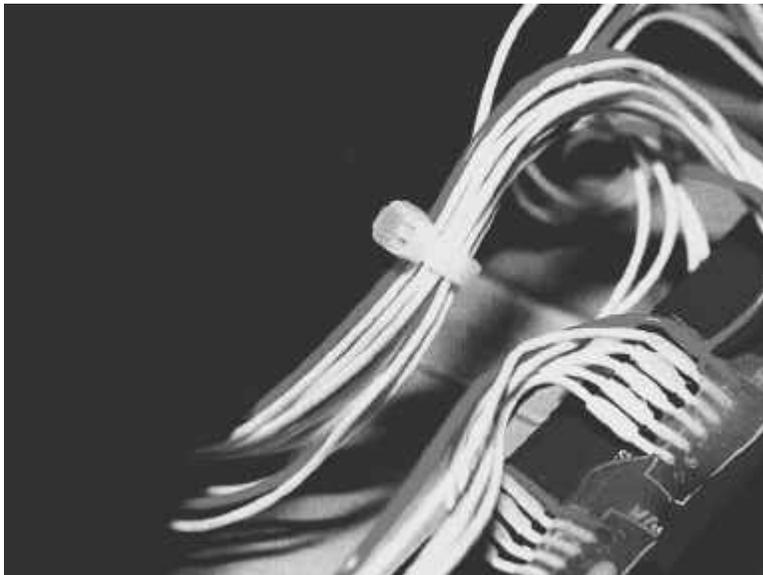
CD Player does not read disc, skips, produces scratching noise.

The cable tie that ties the two cables to the laser together scrapes over the bottom of the unit.

Relocate the cable tie as shown in the below picture, it's advisable to relocate the other cables as well to avoid any contact with the other cables.

It's advisable to perform this modification whenever a unit comes in for service.
