# PASS

OLD COLONY ATTN: EDITORIAL

I have encountered a design flaw in the A75 amplifier which can result in damage to the front end transistors. Under conditions of hard clipping, the gate to source voltages of Q9 and Q10 can experience transients which exceed the manufacturer's recommendations.

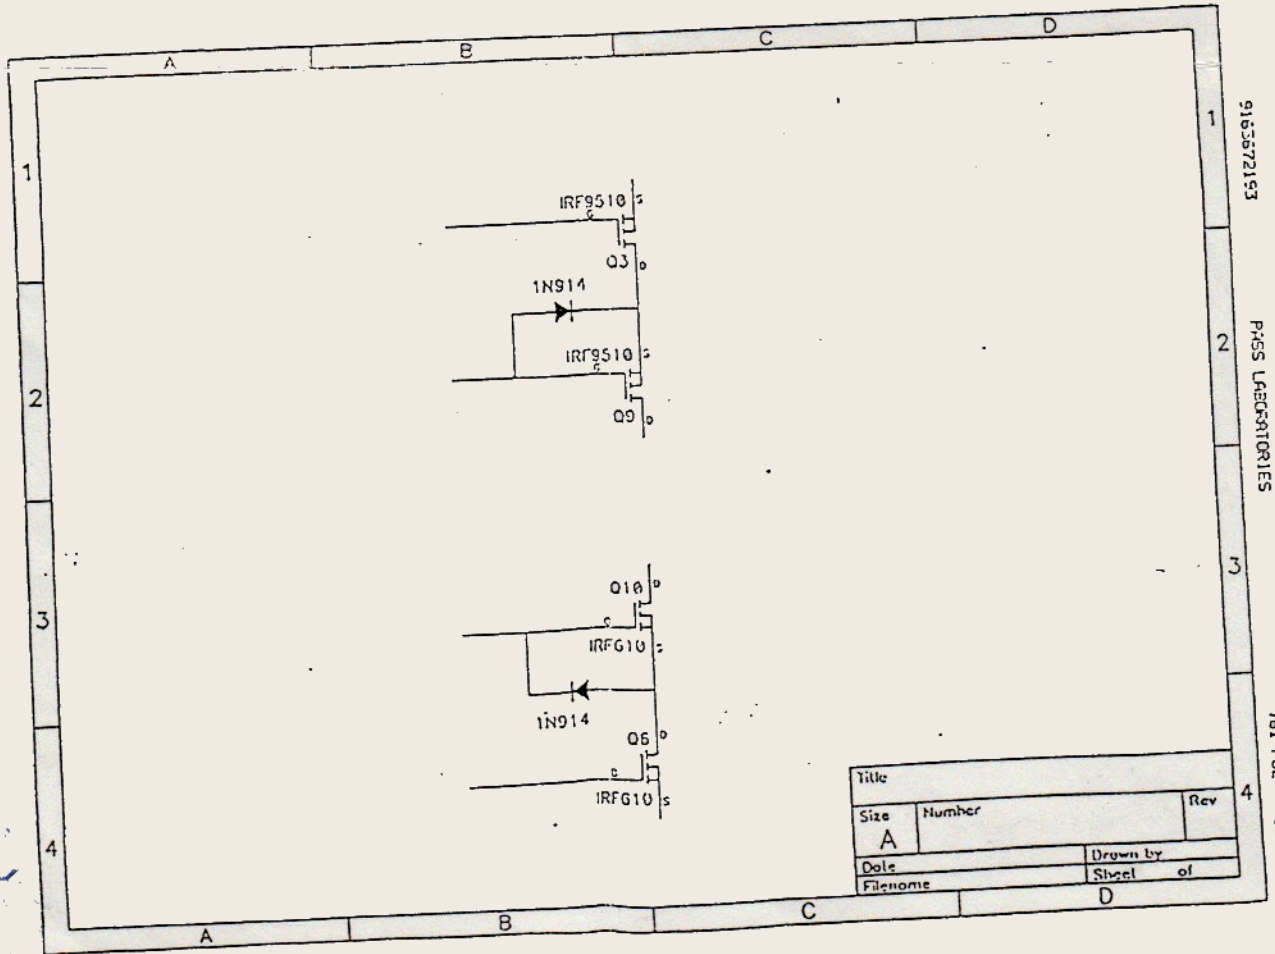
During clipping, Q3 and Q6 can be seen to shut off briefly, and this leaves the source connections of Q9 and Q10 open, allowing the leakage current through Q9 and Q10 to briefly pull the source voltage toward the drain's potential.

In a small percentage of the amplifiers this transient will punch through the gate oxide of the transistors and result in failure.

To prevent this, signal diodes such as 1N914 or 1N4148 must be installed between the gate to source connection on Q9 and Q10 as shown in the accompanying diagram. Normally these diodes will be reverse biased, but they will become forward biased during the transient, protecting the gate.
