I have encountered a design flaw in the A75 amplifier which can result in damage to the front end transistors. Under conditions of hard clipping, the gate to source voltages of Q9 and Q10 can experience transients which exceed the manufacturer's recommendations.

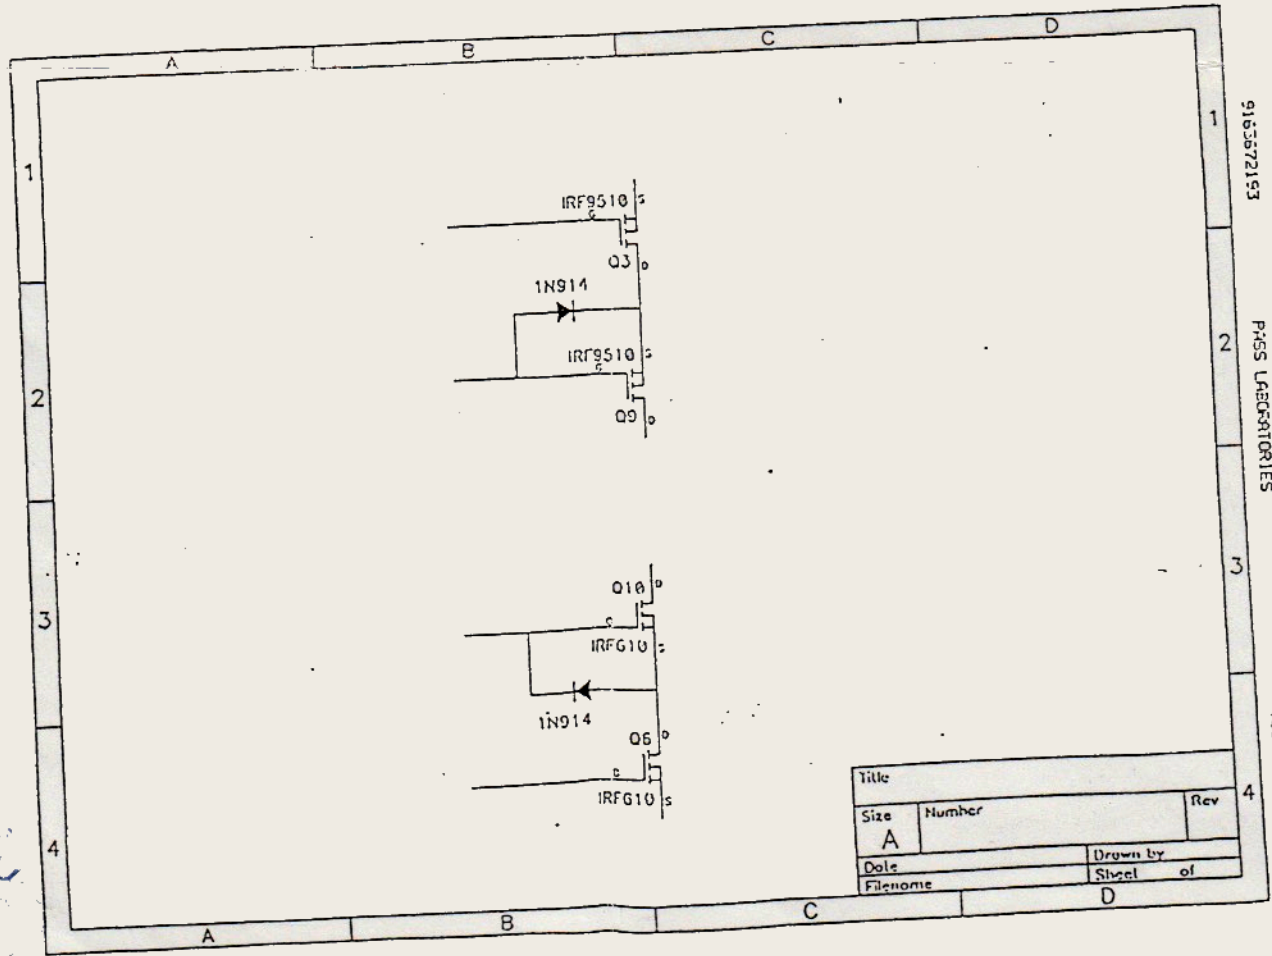
During clipping, Q3 and Q6 can be seen to shut off briefly, and this leaves the source connections of Q9 and Q10 open, allowing the leakage current through Q9 and Q10 to briefly pull the source voltage toward the drain's potential.

In a small percentage of the amplifiers this transient will punch through the gate oxide of the transistors and result in failure.

To prevent this, signal diodes such as 1N914 or 1N4148 must be installed between the gate to source connection on Q9 and Q10 as shown in the accompanying diagram. Normally these diodes will be reverse biased, but they will become forward biased during the transient, protecting the gate.
