MODEL

THALIA (801)

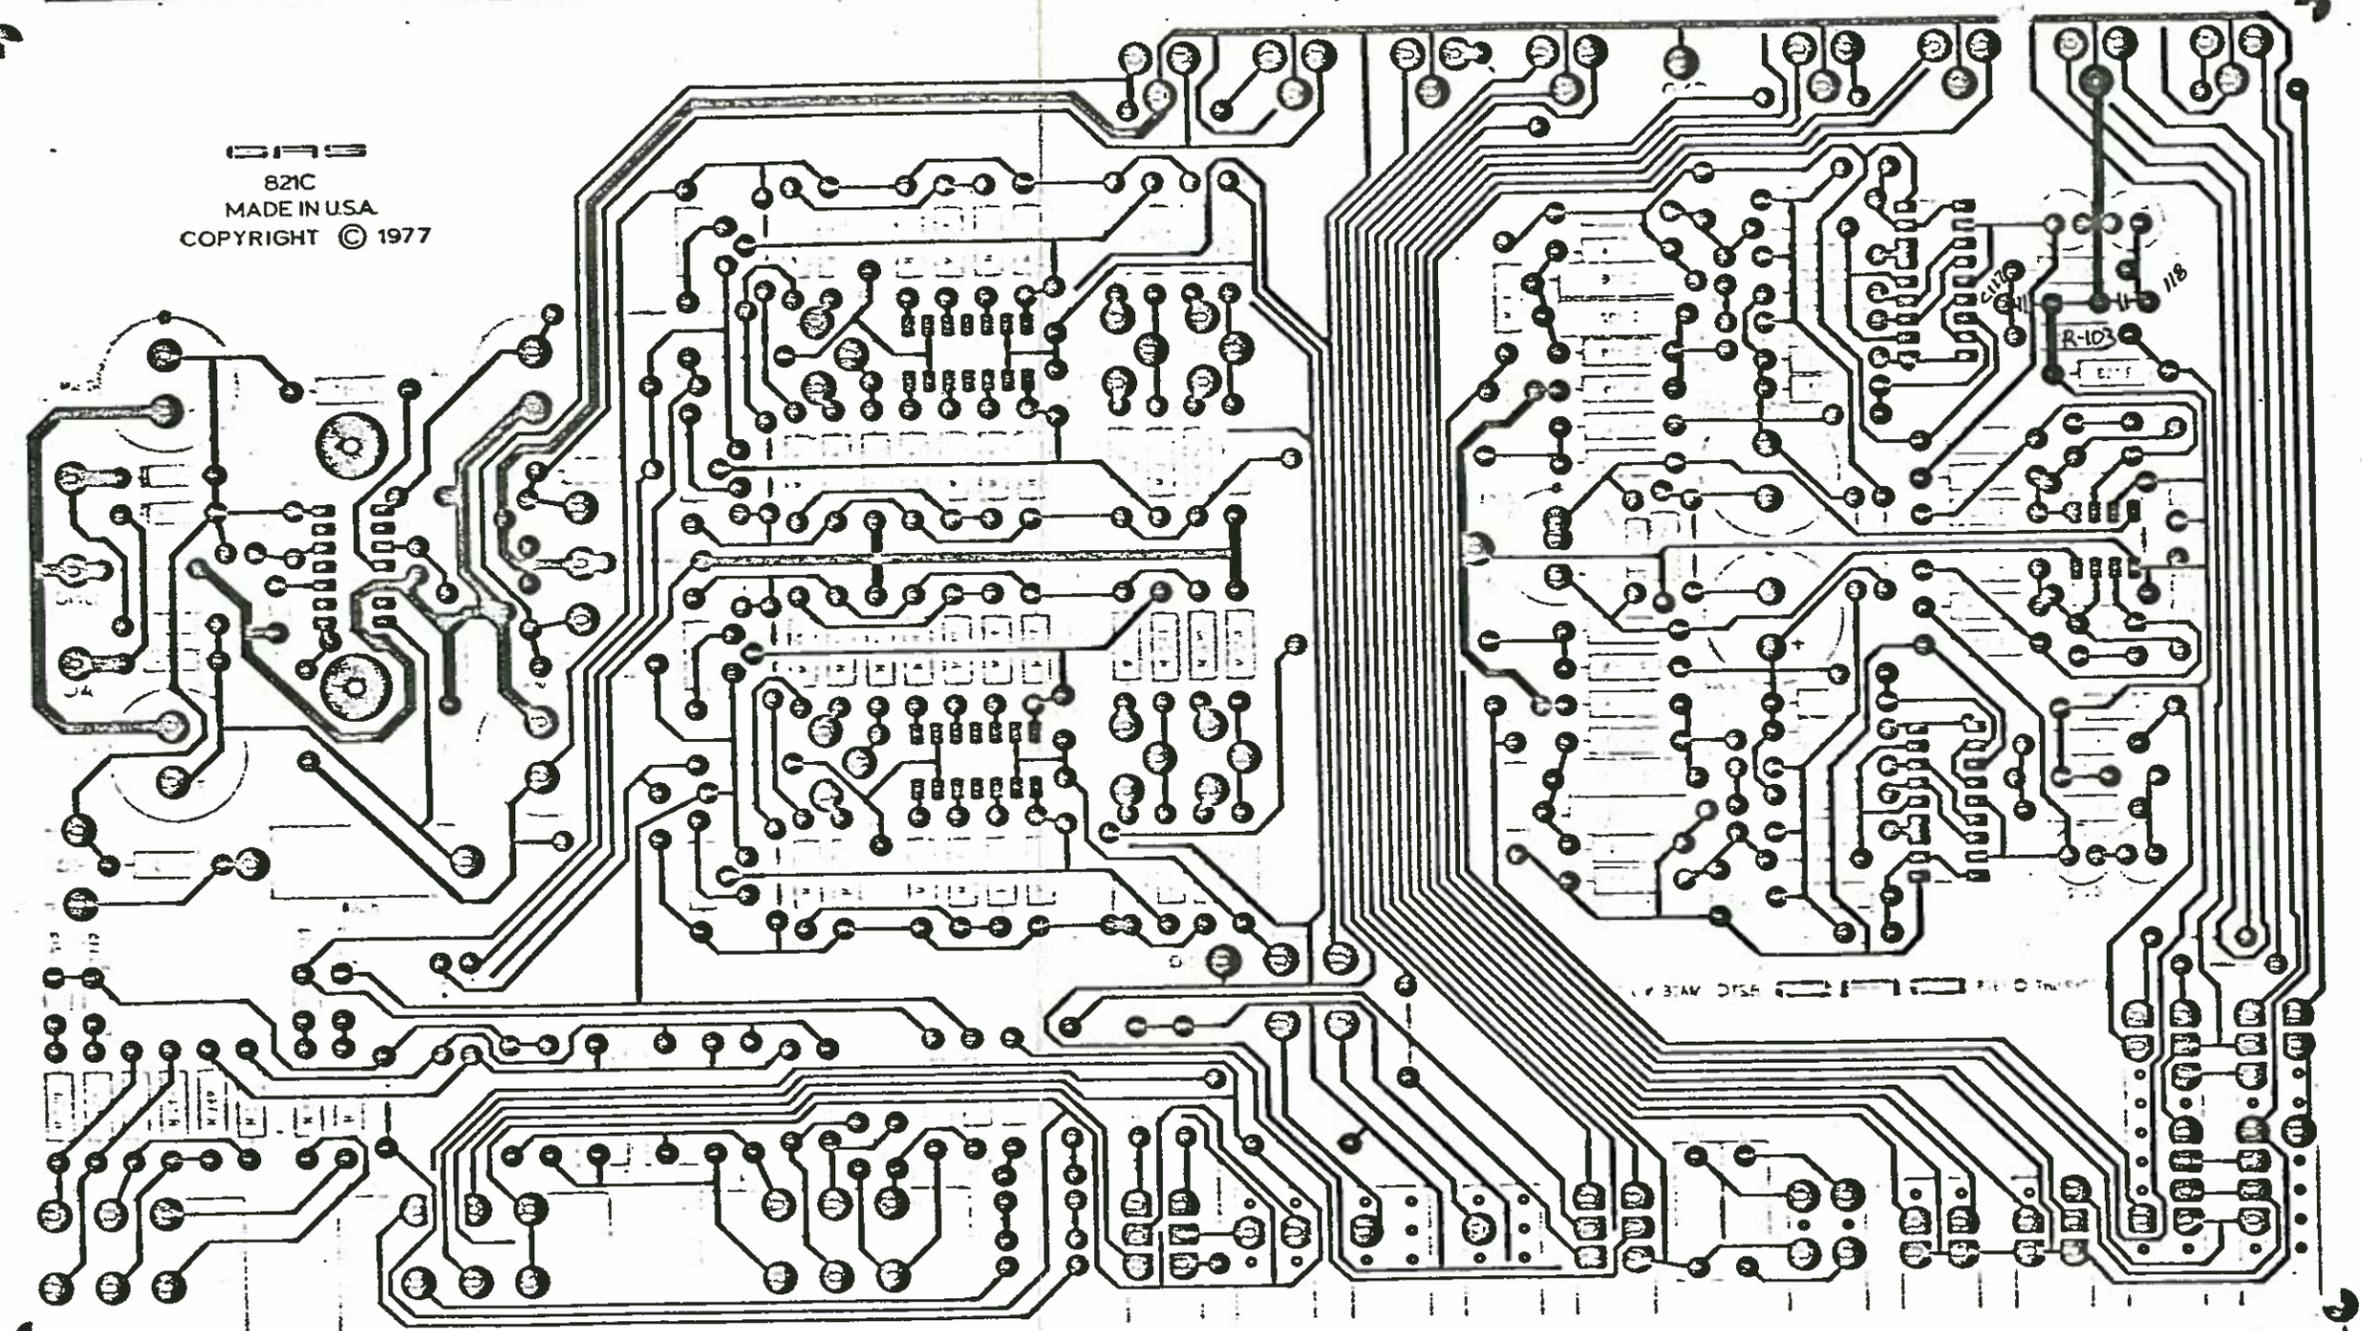
Excessive hum in phono when Thalia is placed on top of a power amplifier.

Ground loop in phono circuitry.

CUT
FOIL
HERE →

Modify ground traces on phono section.

- (1) 1.125" Jumper with sleeving. Part #815004
- (1) 0.5" Jumper with sleeving. Part #815001

1. Remove bottom cover.
2. Refer to the pictorial for location of repair area.
3. Cut ground foil, between phono II and tuner at (Point No. #1).
4. Add jumper 1.125" between the ground of phono II at (Point No. #2), and the ground of C117 and C118 at (Point No. #3).
5. Add 0.5" jumper between (Point No. #4) and ground R103 at (Point No. #5).
6. Replace the bottom cover.
7. Turn on unit, check for proper operation.
