THE GREAT AMERICAN SOUND COMPANY

SERVICE TECHNICAL BULLETIN

NO. 36

MODEL TEALIA (801)

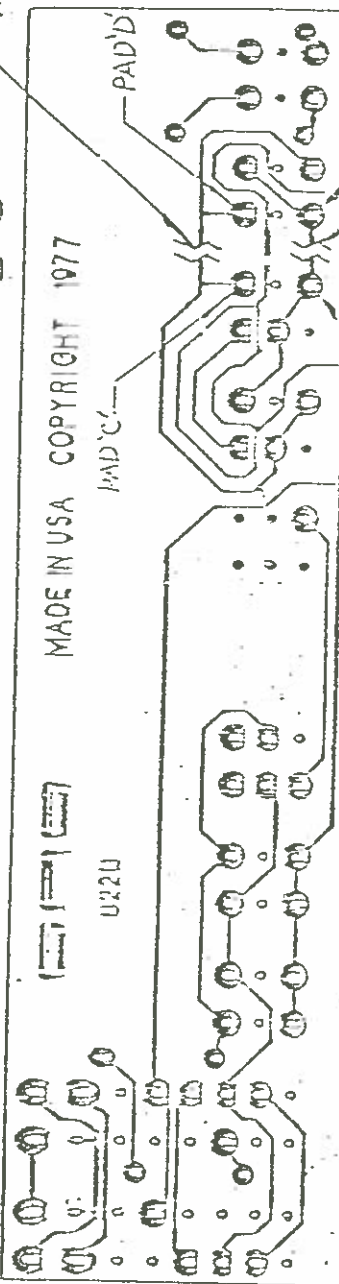
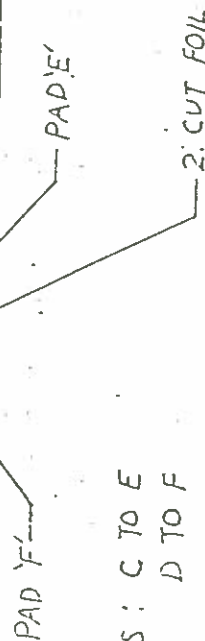
When pushing Channel A bottom Mode Switch, Channel B is heard; when pushing Channel B bottom Mode Switch, Channel A is heard.

Reversed connections to Mode Switches.

CORRECT WIRE COLOR SHOWN

JUMPERS : C TO E
D TO F

Interchange connections on Switch PC Board.

1. Remove top cover and place at side of unit.
2. Refer to pictorial supplied for location of switching PC Board #322 circuitry.
 - A. Cut foil at points 1 and 2.
 - B. Add jumpers between points C and E, and points D and F.
 - C. Interchange the wires between points A and B.
3. Replace top cover.
4. Turn on unit and check for proper operation.
