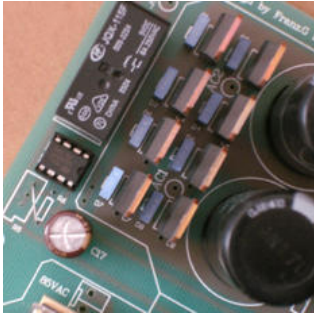
In this picture, posted by Zang, you can see that the diodes and suppressor capacitors are indeed swapped place because of the pin spacing. Not a big problem here, just a case of the silk screen being mixed up.

The bigger problem in this picture is the faulty orientation of the diodes.

Going back to Zang's picture, you can see the correct orientation of the NE555 timer IC. This is also 180° rotated opposite from the silk screen.

In order to make a correct diode bride they all need to be rotated 180°

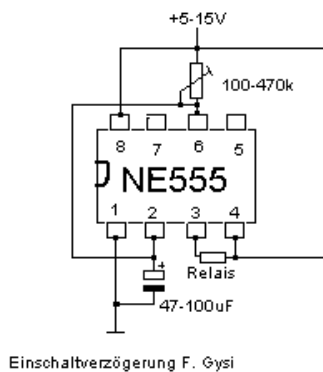
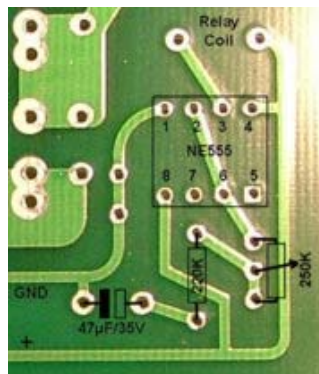
I populated the board with all the necessary components and when I fired up the Power Supply board it came to my attention that the relay didn't activate after the approximate proposed 20 seconds. First I thought it was a faulty relay but when I applied power to the coil it worked. Next in line was the timer IC that might be the culprit, Franz assured me that these things are quite sturdy and therefore hard to believe that this was the cause of the malfunctioning of the circuit. I replaced it anyhow with another one but without any luck. Only when I started comparing the PCB traces with the wiring diagram it dawned on me that the layout on the circuit board is wrong.

As you can see in the above images there are some differences. On the left is Franz's circuit, on the right the actual PCB layout. The left image shows you that the 47µF capacitor is connected between ground and pin 2 (6) of the timer IC and that the resistor (or trimmer) is connected between +VCD and pin 6 (2) of the timer relay. On the PCB the capacitor goes from ground in series with the resistor to pin 6 of the timer relay. Get the picture!
