## LINE 2 - REPAIR MANUAL

Please read these instructions before attempting any service work. They are intended to aid the electronics technician in making the proper diagnosis in repairing the Line 2 preamplifier.

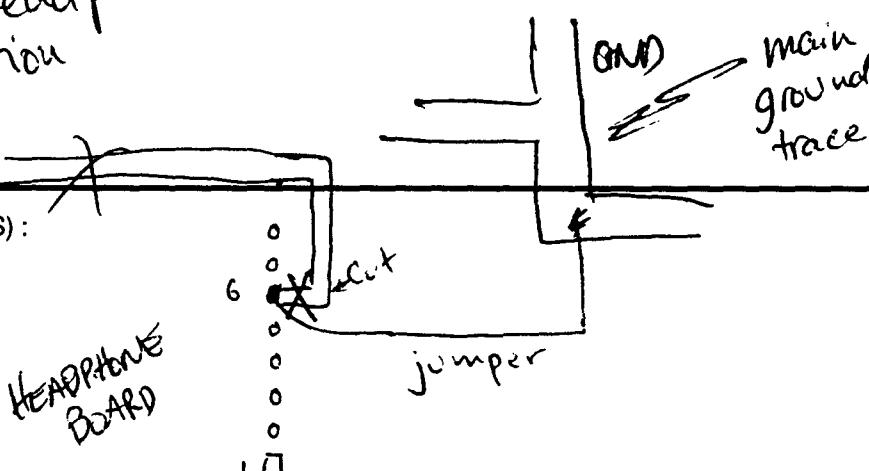
<b>PRODUCT(S) AFFECTED</b> <u>Change or modification</u> Temporary ( )      Permanent ( )		<b>DATE OF ISSUE:</b>  <b>ISSUED BY :</b>  <b>APPROVED BY :</b>
<b>PURPOSE OF CHANGE(S):</b> <i>Line 2 Headphone Hum Reduction</i>

<b>DESCRIPTION OF CHANGE(S):</b>		
<b>PART(S) AFFECTED :</b>	<b>PART #</b>	<b>LOCATION:</b>
<b>ADD:</b>	<b>PART #</b>	<b>LOCATION:</b>
<b>MODIFICATION DIAGRAM:</b> See attached sheet		C.C I. Driver T. Nguyen A. Jez K. Wilk N. Platsis
		<b>CONFIRMED :</b>
