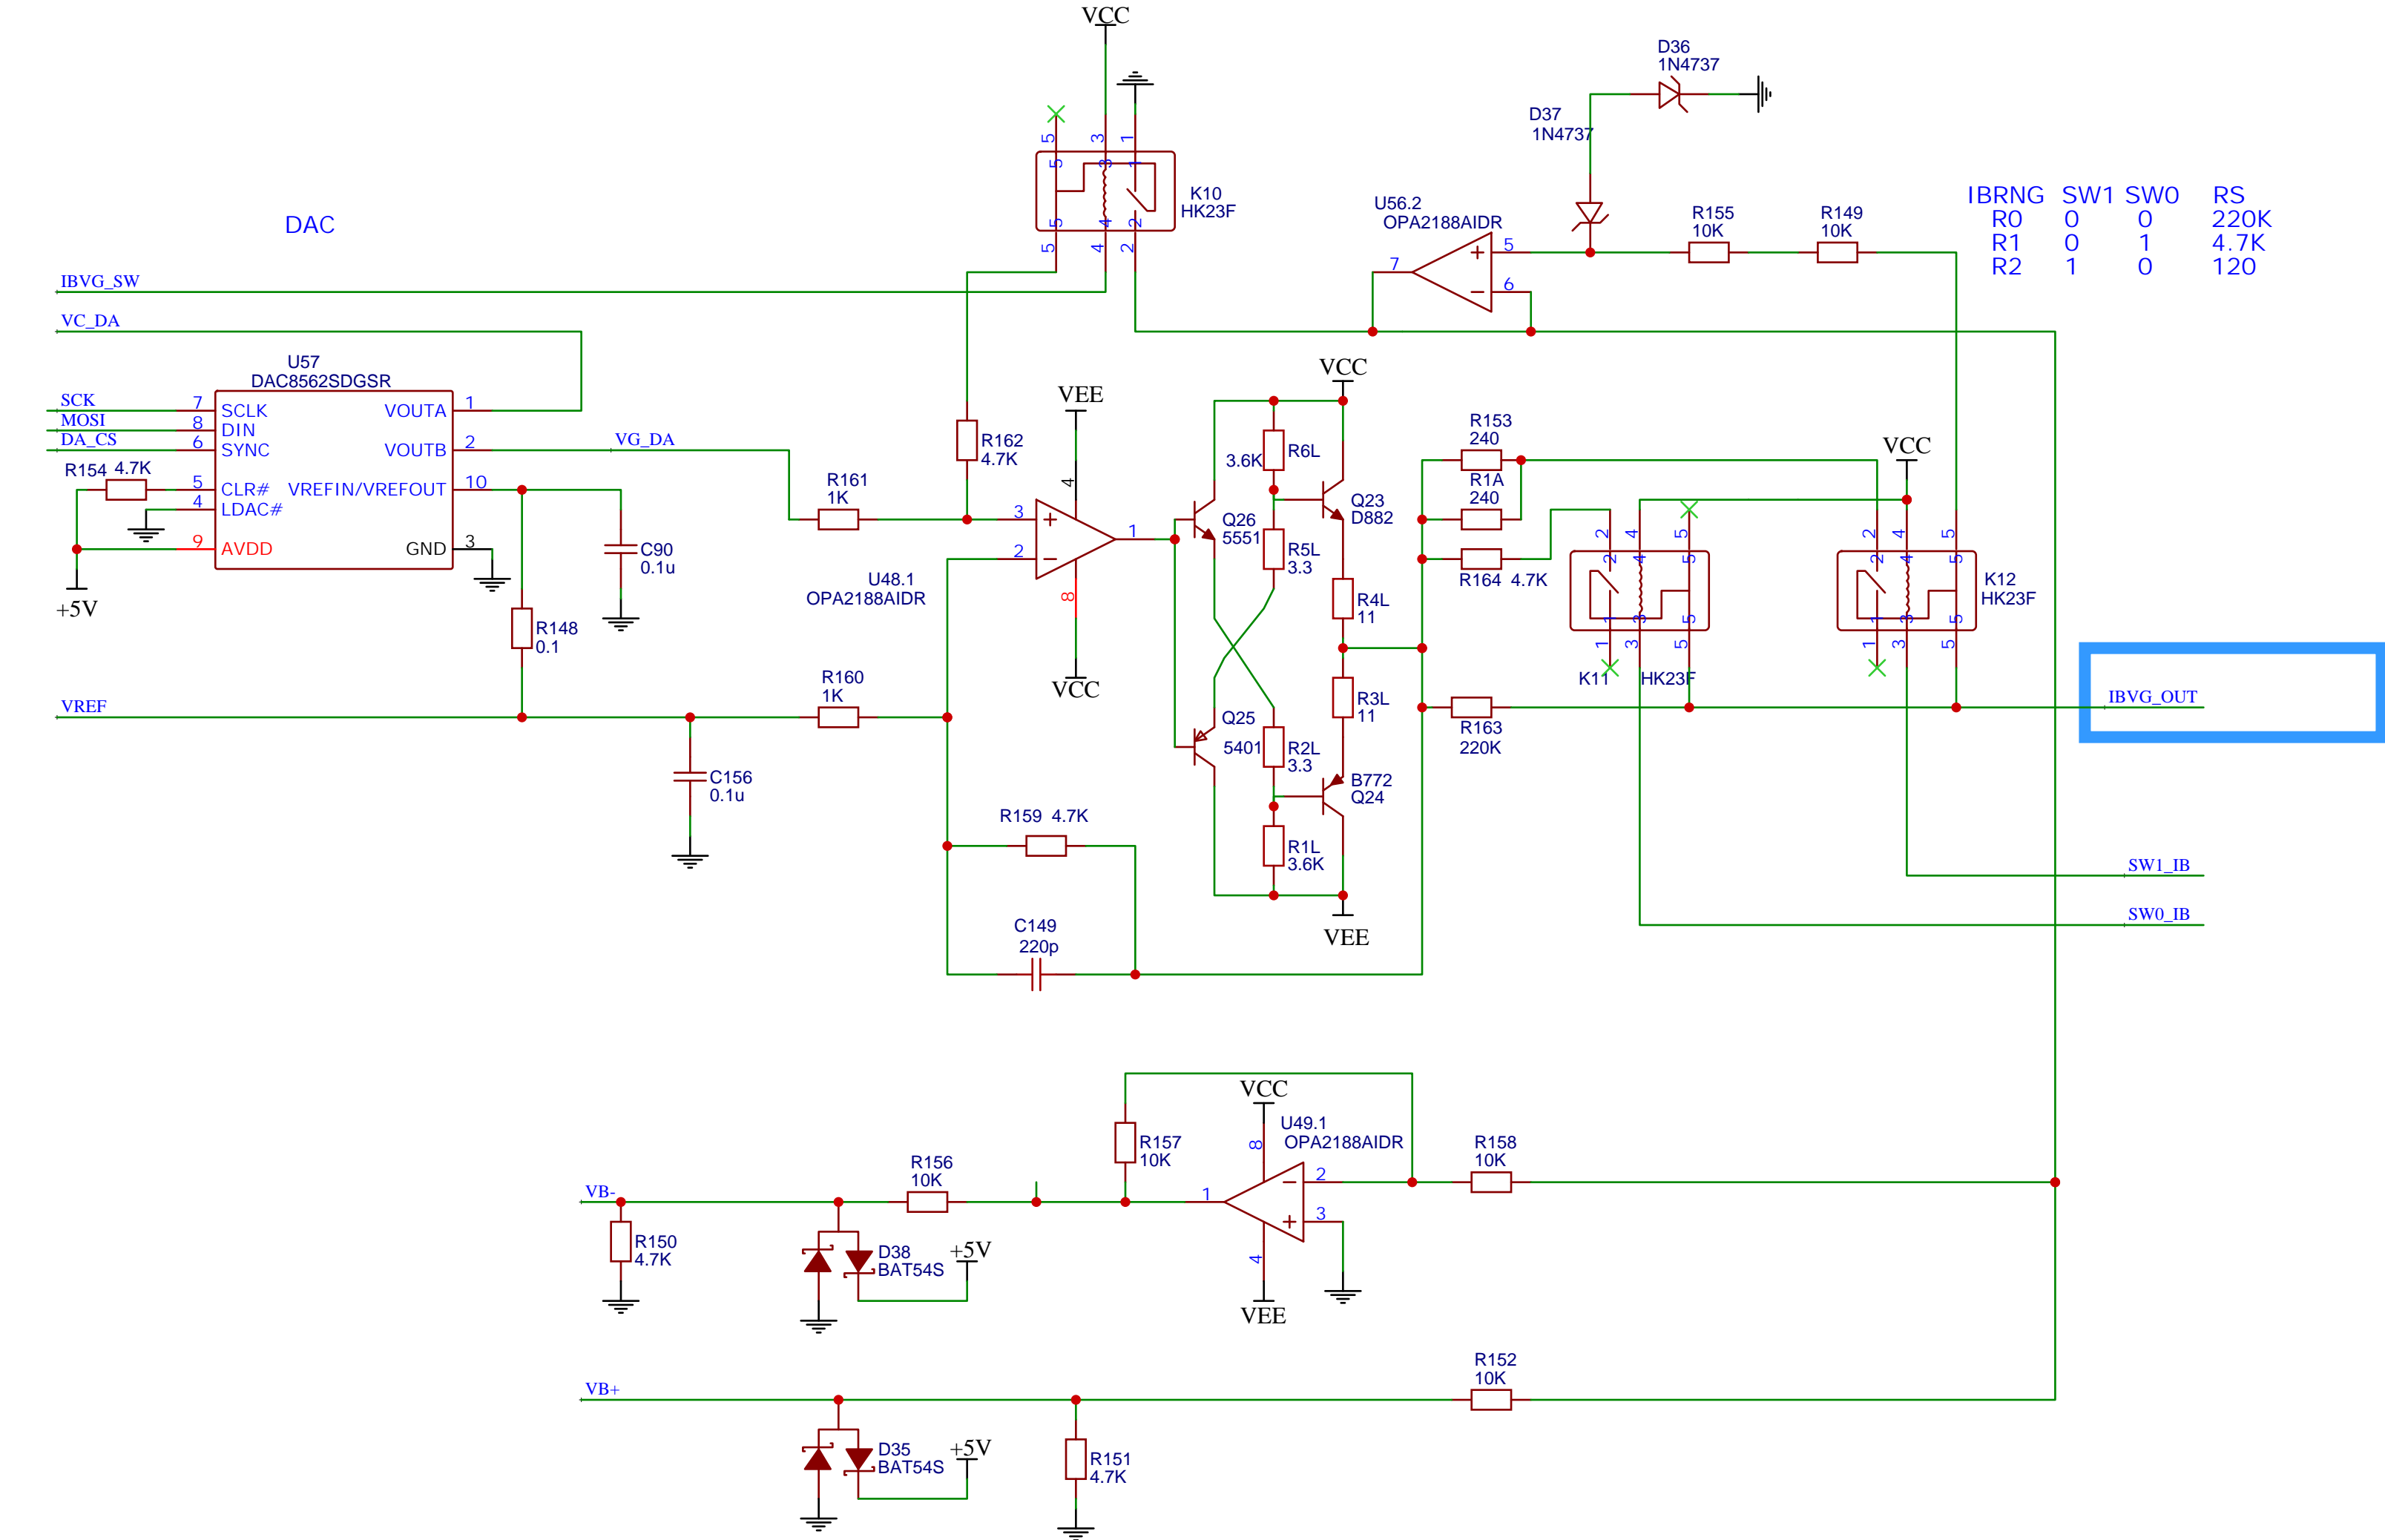
Due to interference of MOSI, adding one 22pF shunt capacitor to GND fixes problems writing to the DAC.
