TECHNICAL BULLETIN

No331 / 332 / 333 Replacing Surge Resistors

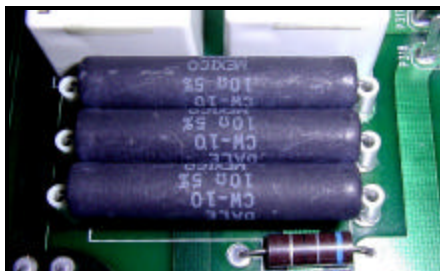
Original Surge Resistor

Units manufactured prior to January, 1 1997 use the original black epoxy resistors depicted below on left. The resistors are located on the VSMB board under the VSMB daughter card. The black epoxy resistors should be changed to the current version, part number 11087, depicted below on right.

The current surge resistors, implemented after January 1, 1997, will open with far less potential to damage other components in the amplifier. We highly recommend that when an older 300 series amplifier is repaired for any reason, the surge resistors are checked and updated if found to be the original design.

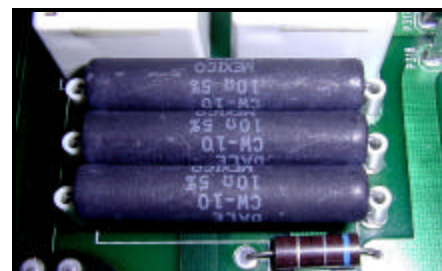
5. Locate R303, R304 and R305 Surge Resistors.
