The Two Towers

Testing “Improved IM radios” at a real world worst case location

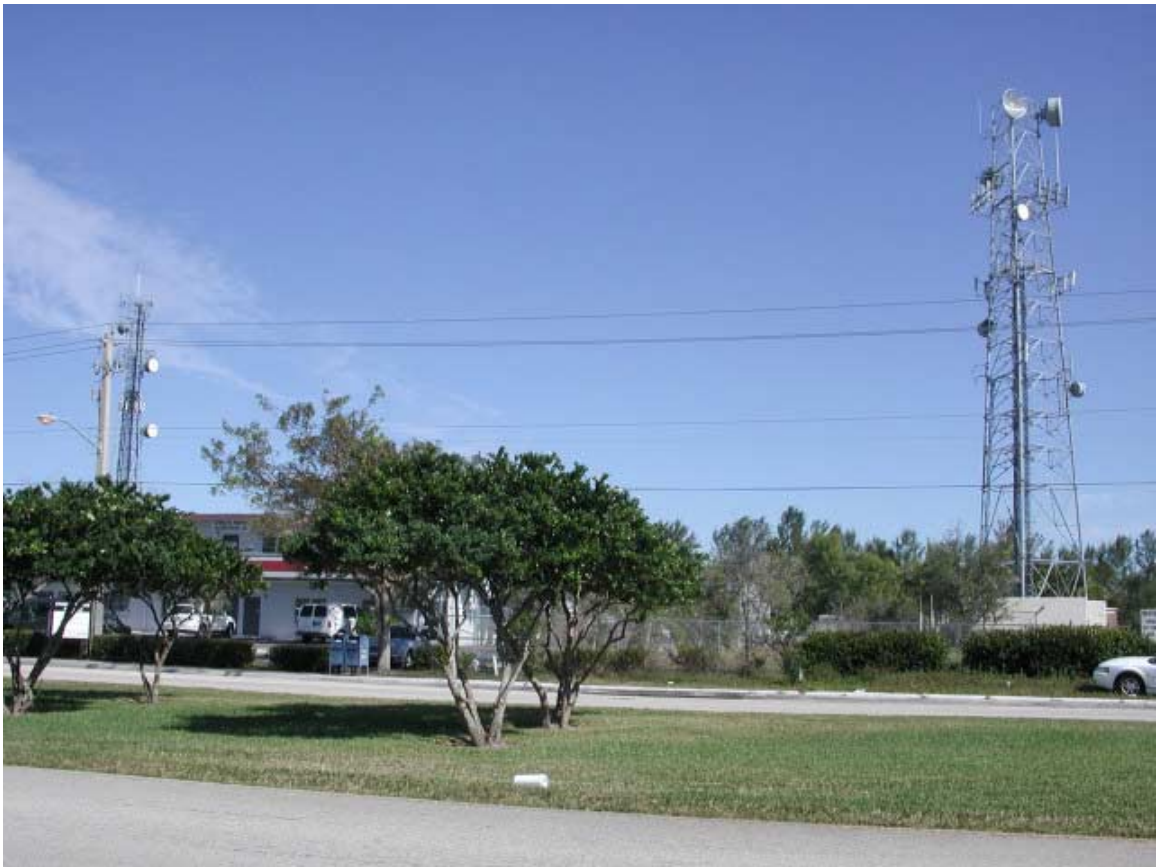
This site consists of two towers about 50 feet tall and about 500 feet apart. The south tower (the one on the right in the picture) was originally put up by Bellsouth (now Cingular) and AT&T installed the north tower. There are now six sets of cellular antennas (3 on each tower), several omni directional antennas, and several microwave dishes. This represents the six of the seven cellular carriers in this market. Nextel has their antennas on the south tower. The area, which used to be empty field, has become populated with warehouses making access to the areas adjacent to the towers difficult.
