# Checking out the Xiang Sheng 728A pre-amplifier.

## G4CNH – APRIL 11<sup>TH</sup> 2021

Findings on a recent 728A that came in for repair

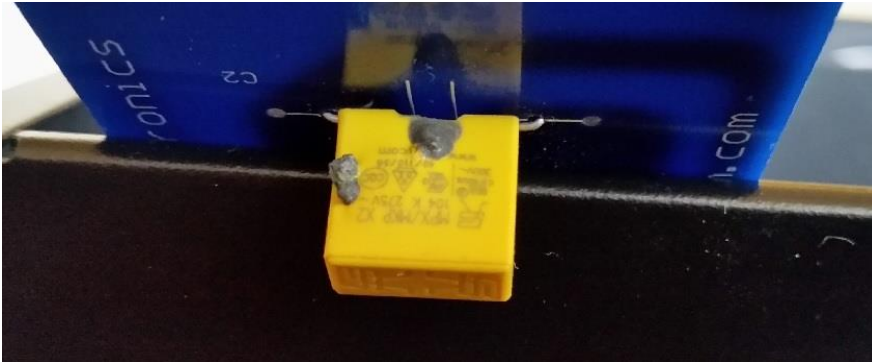
Capacitor C2 found blown, a 100nF 275V X2 capacitor. C1 and C2 replaced with RS Stock No. 220-7786 Mfr. Part No. F1772 410-2000 Brand Vishay. X2 class anti-interference capacitors, series F1772-2000 310 V ac. Metallised film capacitors for interference suppression installed between phases or between phase and neutral. Epoxy resin-sealed, flame-retardant case.

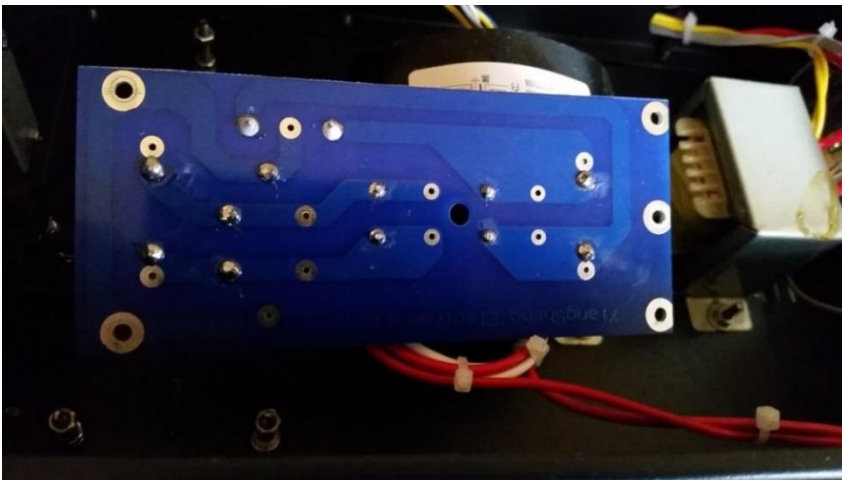
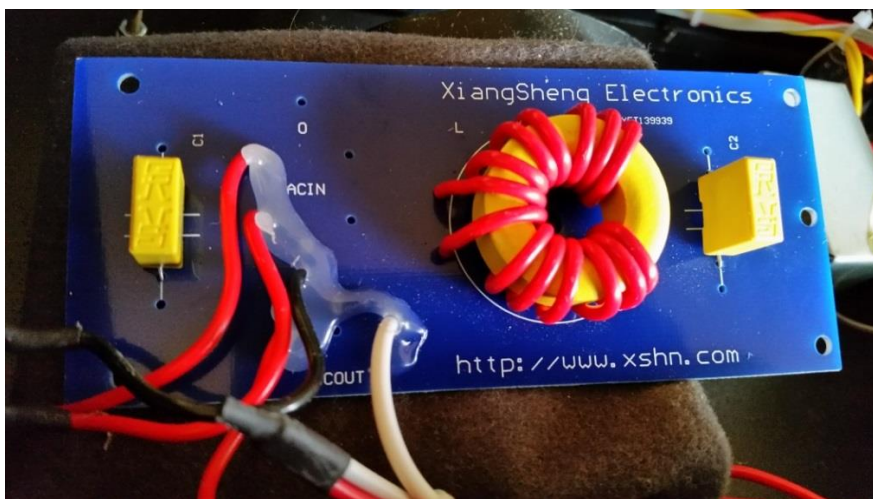
Top View

Supply Ground wire does not go directly to case earth, but via a compression between board and a fixing nut.

Top left hand fixing hole is the only safety Ground connection by way of pressure contact with a fixing nut!

This is not acceptable and a new additional Ground Wire was fitted to take the Input Ground connection directly to the metalwork.

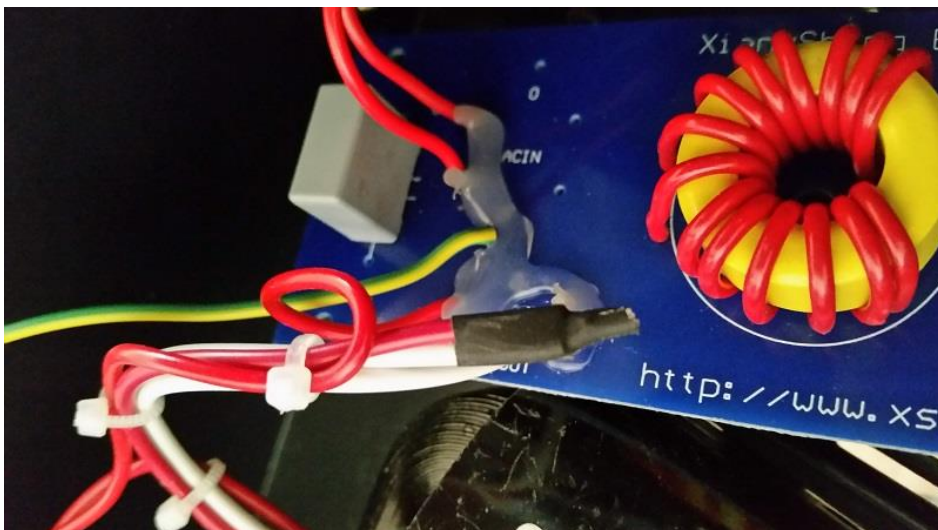
Proper Yellow/Green Ground wire fitted to PCB.

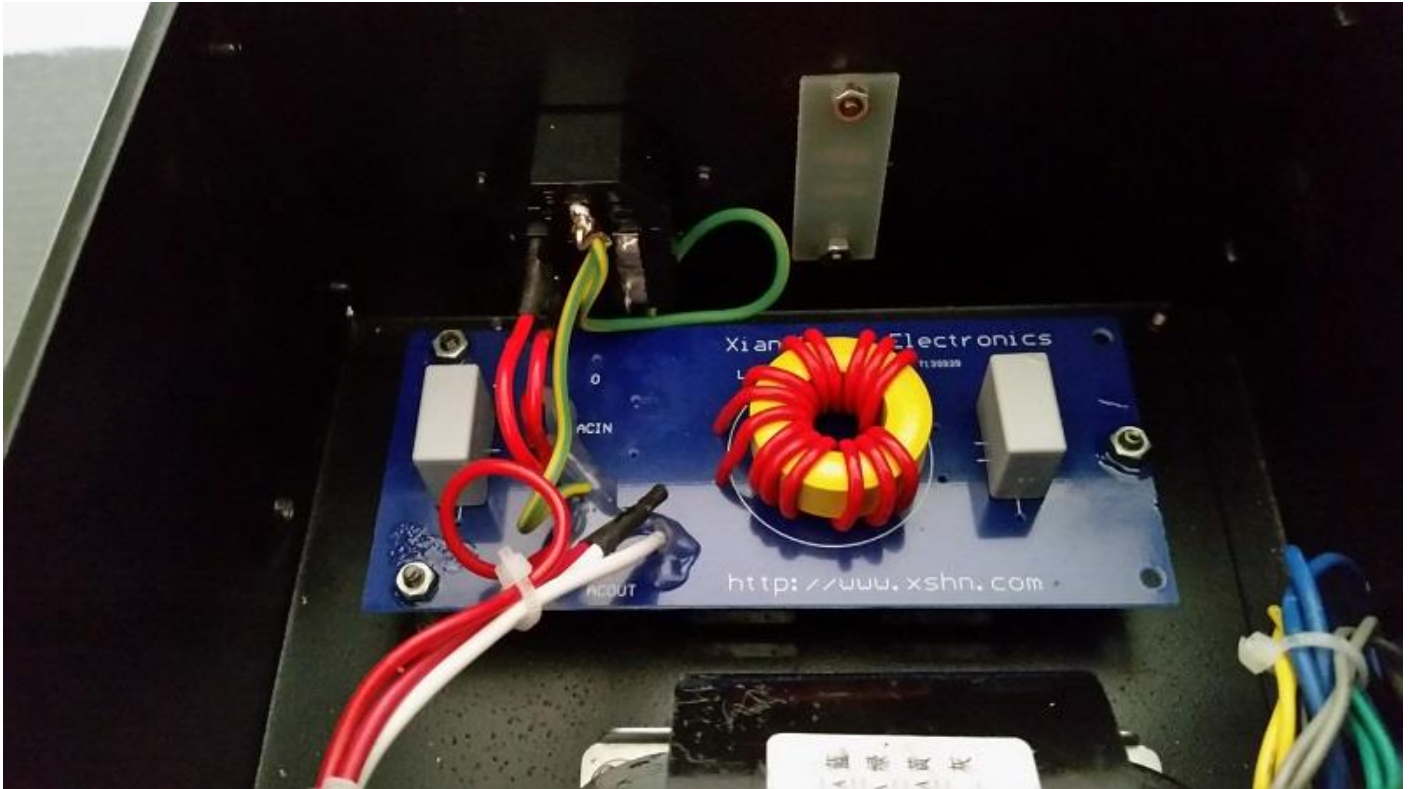
## Re-worked PCB with new capacitors.

The board is now bolted down onto three proper brass stand-off pillars, rather than be sandwiched between two nuts at each point. A small spot of Loctite thread lock was applied to each top fixing nut.

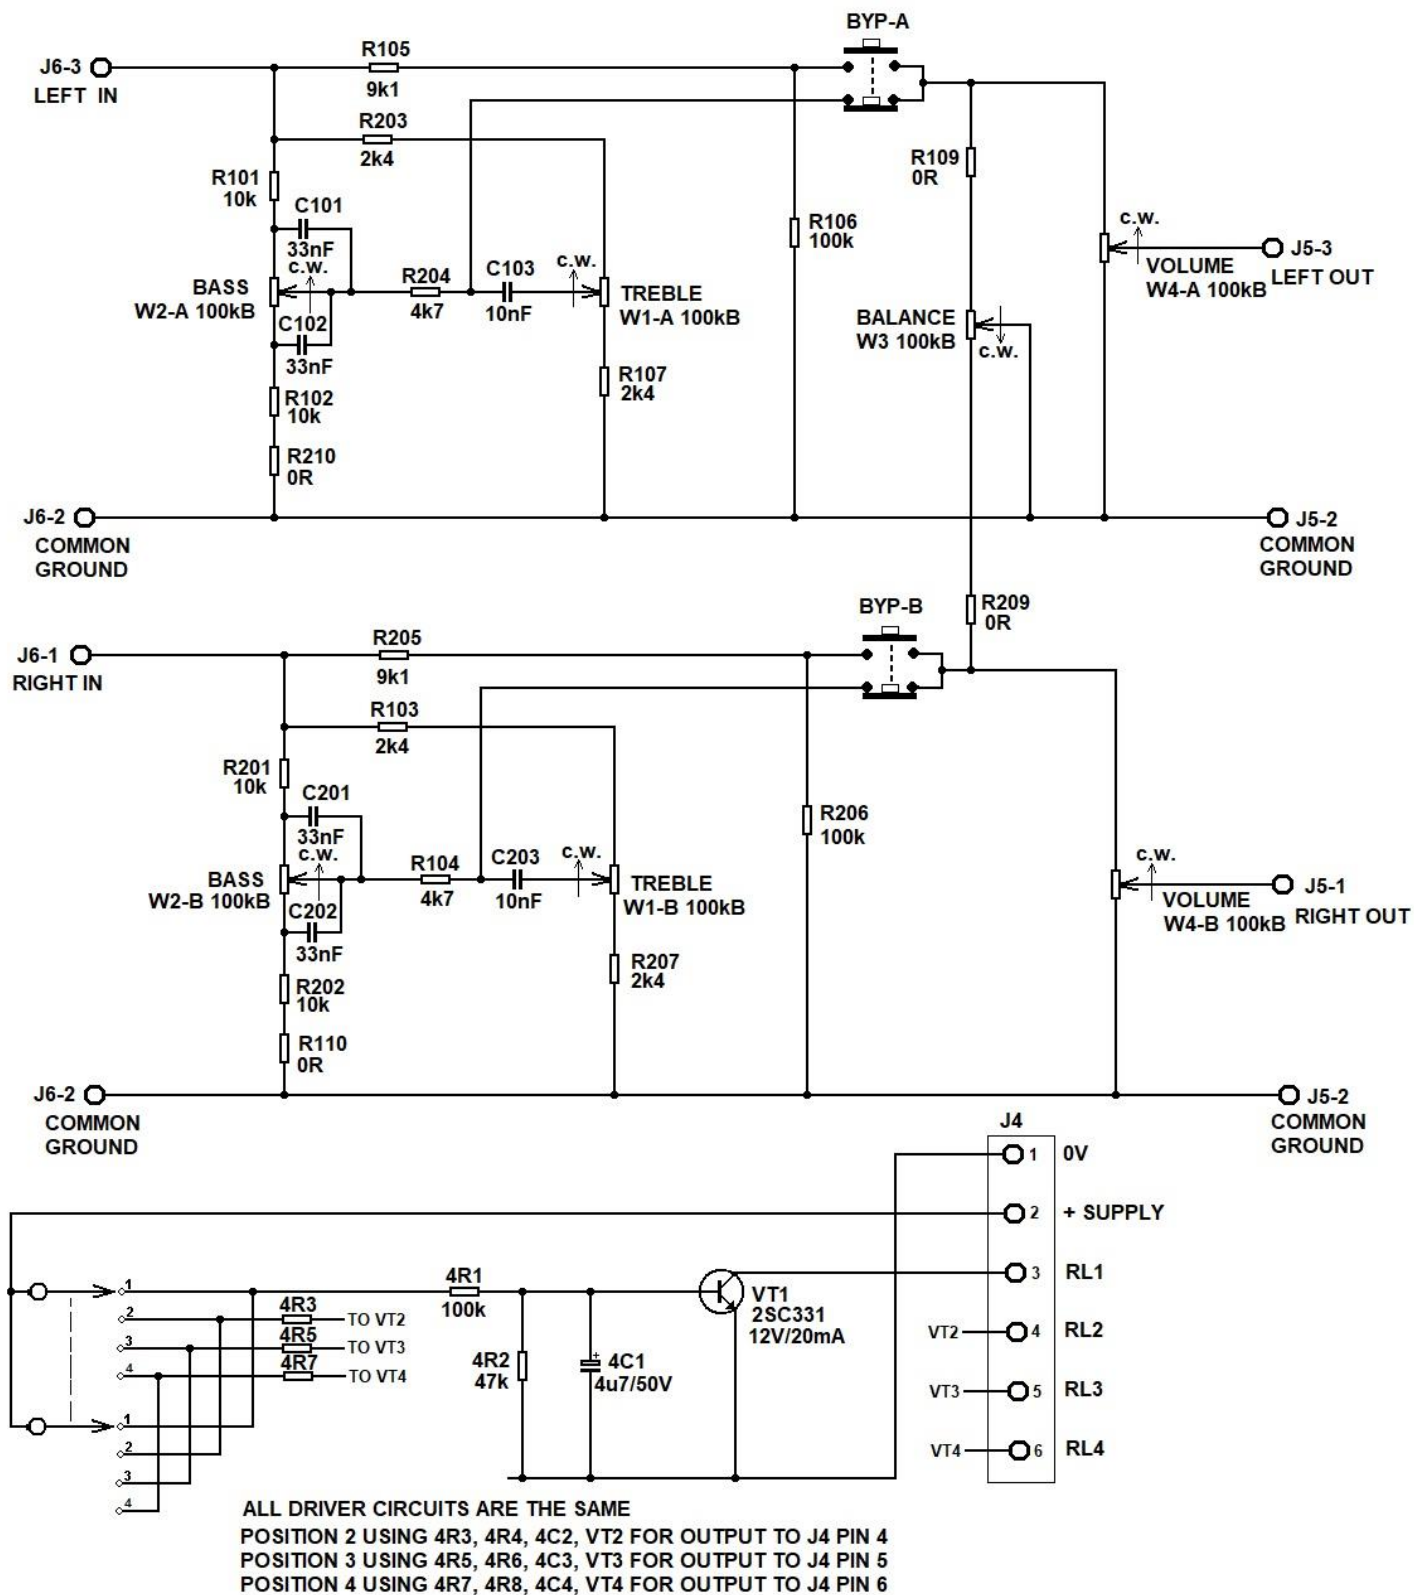
## EQ Circuit.

Next task was to reverse engineer and map out the Tone control, volume and balance circuits as no information is available. The task was made more difficult due to the manufacturer mixing up component designations. It is usual to number all parts for say the Left channel as R1xx and use R2xx for the Right channel. In this circuit, R103/R203 and R104/R204 were swapped over. They also used zero Ohm links for R110/R210/R109/R209 and note that R110 and R210 are also switched over.

The + Supply on pin 2 of J4 is 12V from a 7812 regulator which also feeds the 12V Relays on the main board.

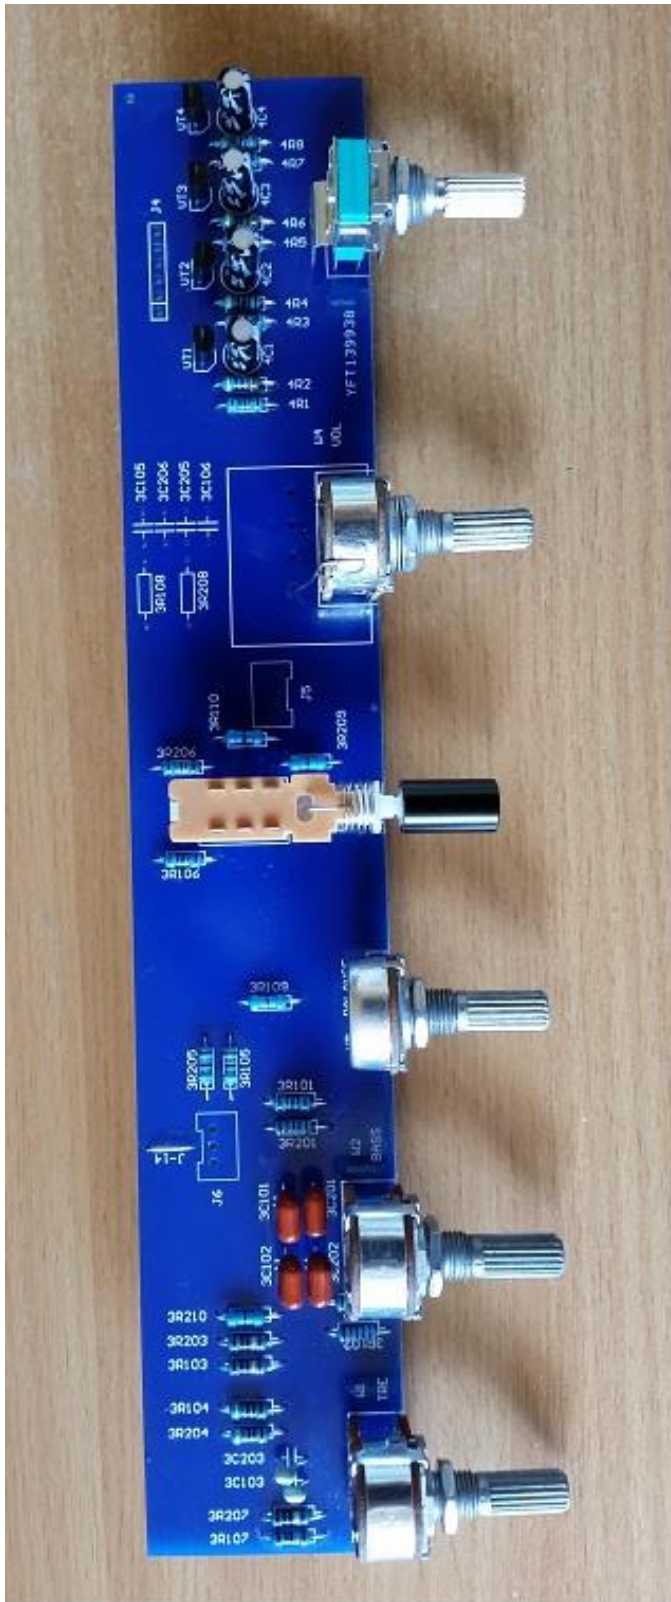
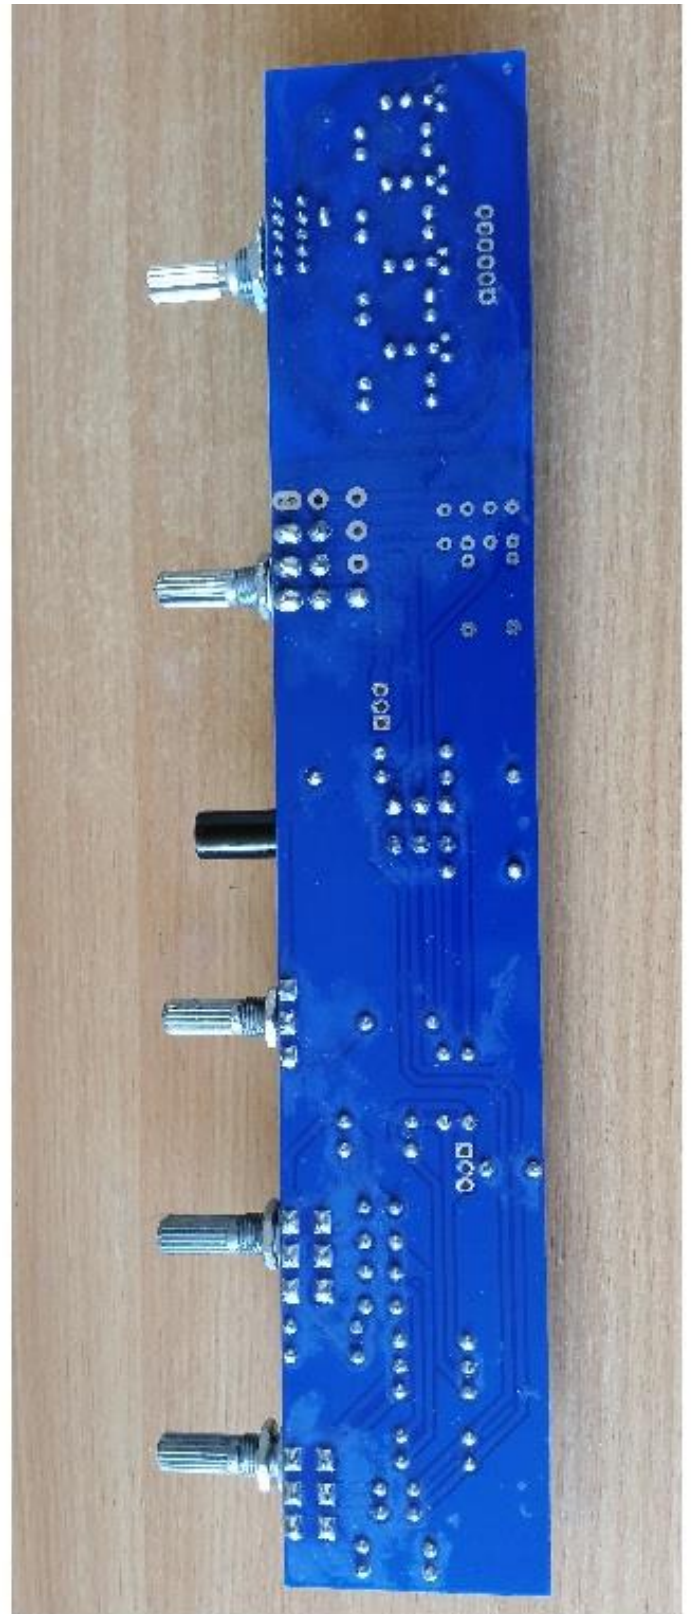
## EQ Circuit Board Lay-out.

I had to unsolder all flexible cable connectors as I could not determine any way of actually disconnecting them. Was I missing something here 😊?

This board was a mess with lots of flux everywhere; the manufacturers should invest in a de-fluxing bath.

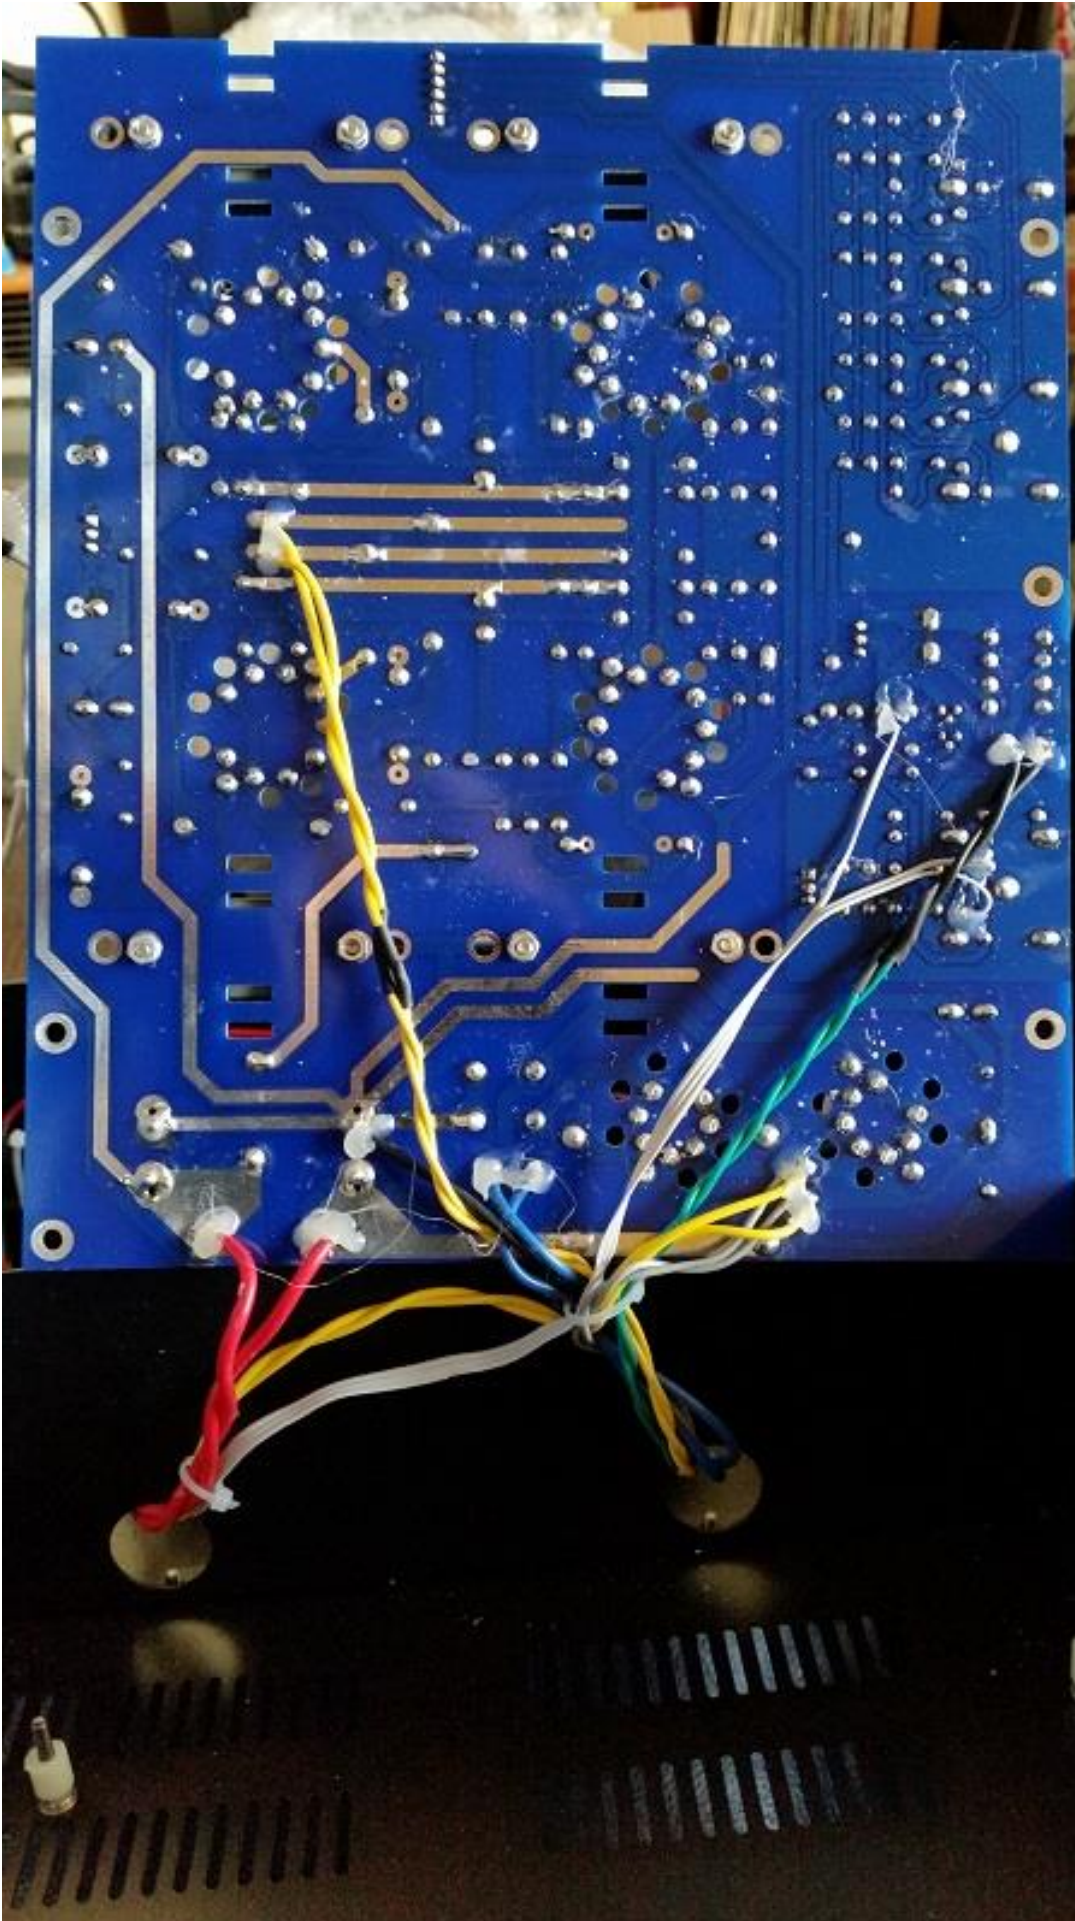
The Mess underneath, may prove very difficult to reverse engineer.

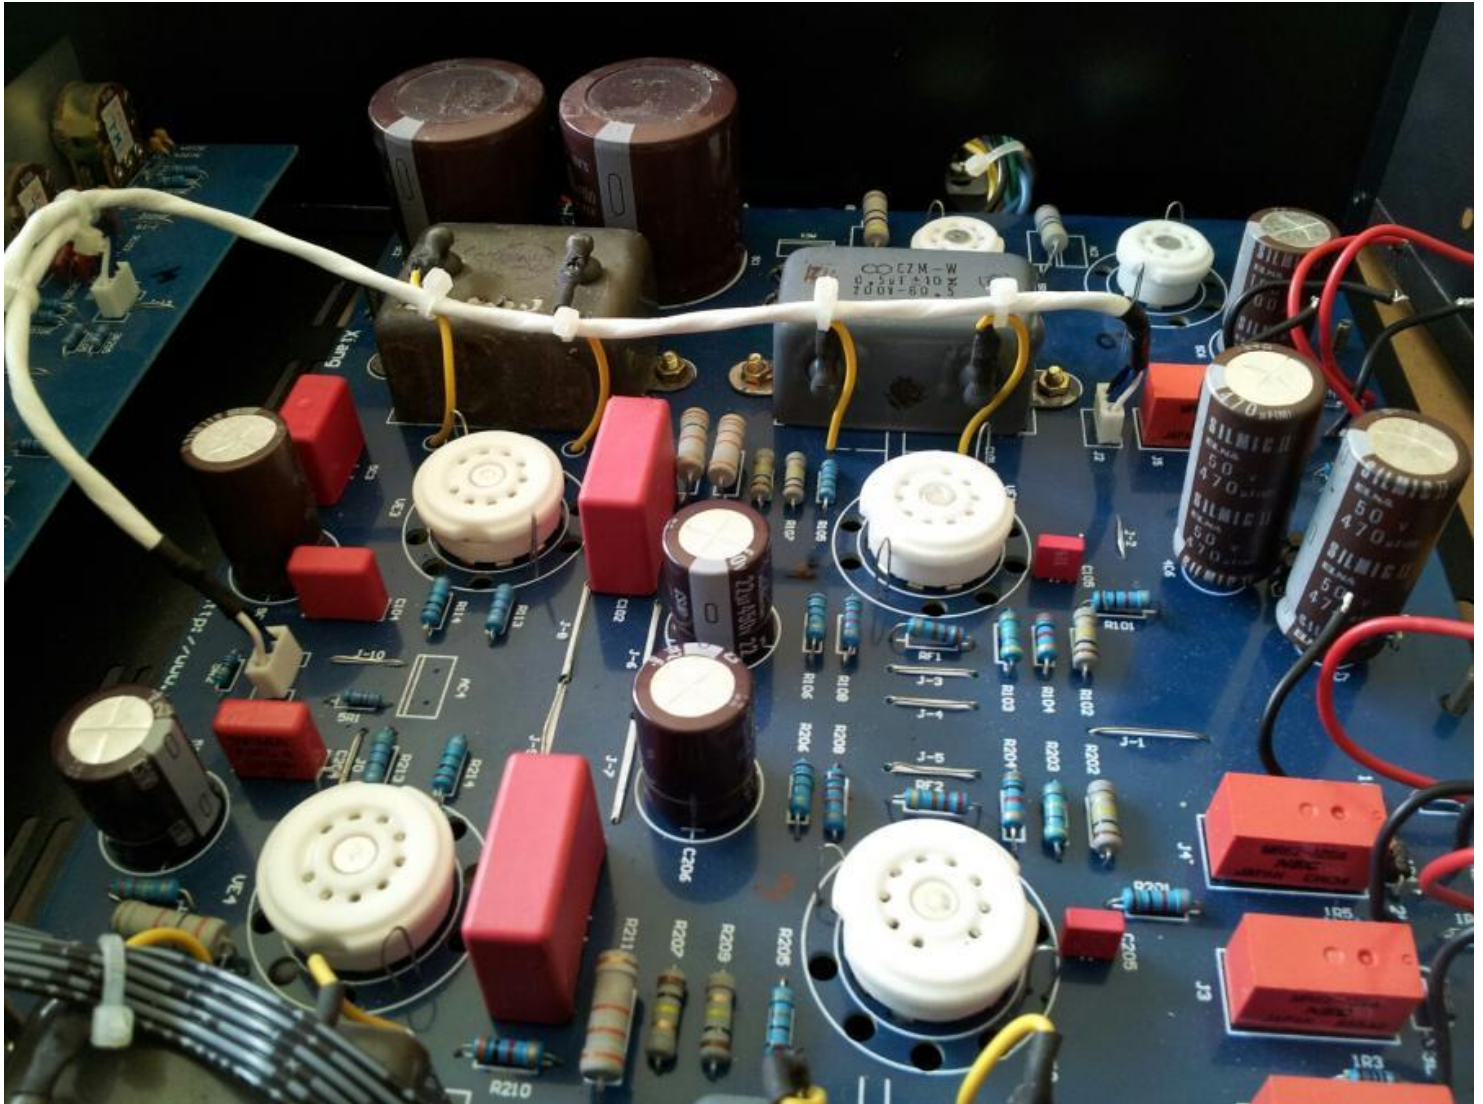
## The task ahead.

The full circuit is on the following page, I cannot guarantee it is 100% correct but I have not found an error yet and it is better than nothing I suppose.

Please note that the filter board is not included to save drawing space.

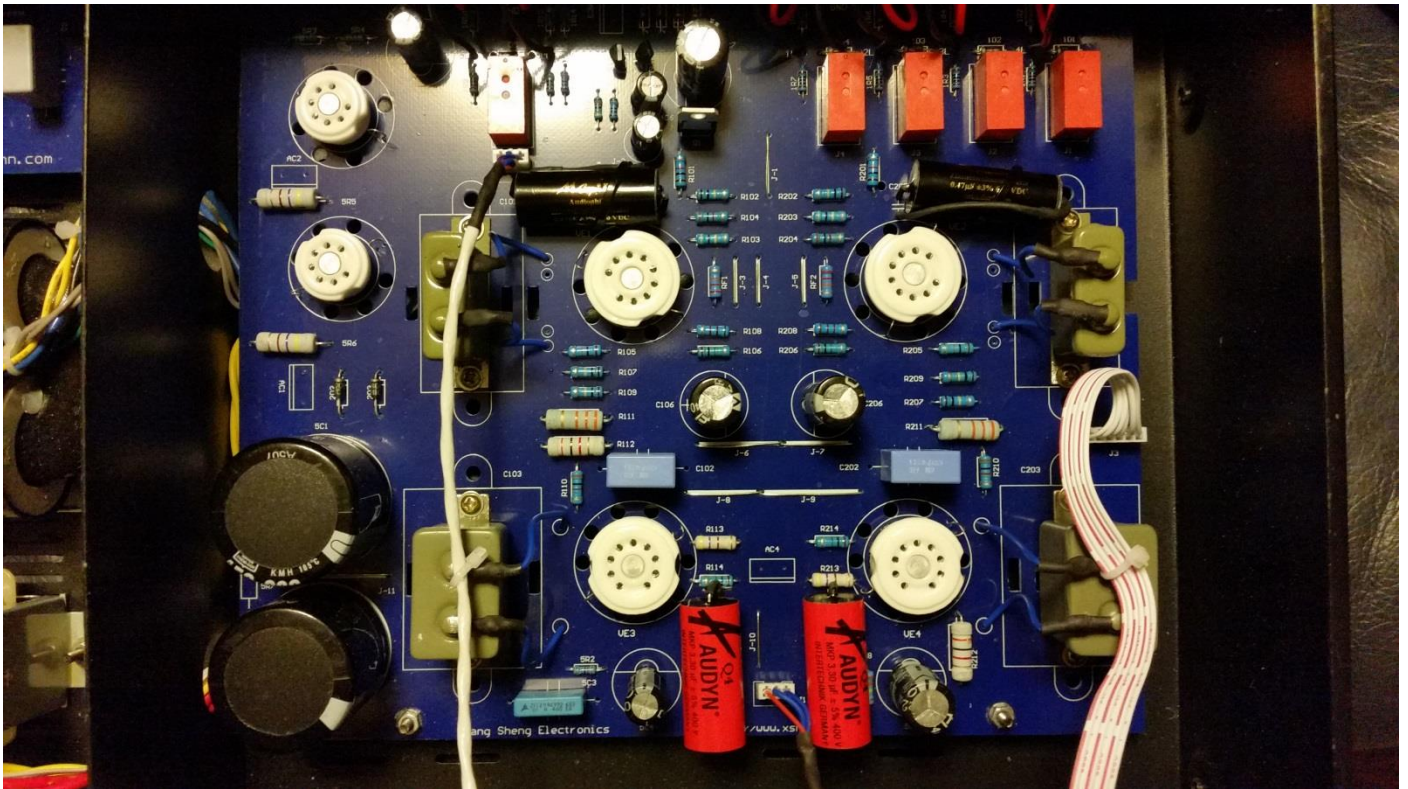
## View of Main board, new capacitors and prior to fitting valves and Tone Control panel.

I insulation tested the square Paper In Oil capacitors and they tested OK for capacitance and leakage.

I replaced the small Wima capacitors (C106,C206) at the front end with some Audyn's.

C106 and C206 were hard to replace owing to the Audyn's amazing difference in size, but with the help of some 20 a.w.g. copper wiring, sleeving and tie-wraps, this was achieved. The tie-wraps were essential in keeping these two bulky capacitors anchored to the board, I did not want to use hot glue like the Chinese did, but care was needed to find a suitable mounting position and holes for the tie-wraps.

The same applied to the output capacitors (C104,C204) but these were not tie-wrapped as their leads were more than adequate for support.

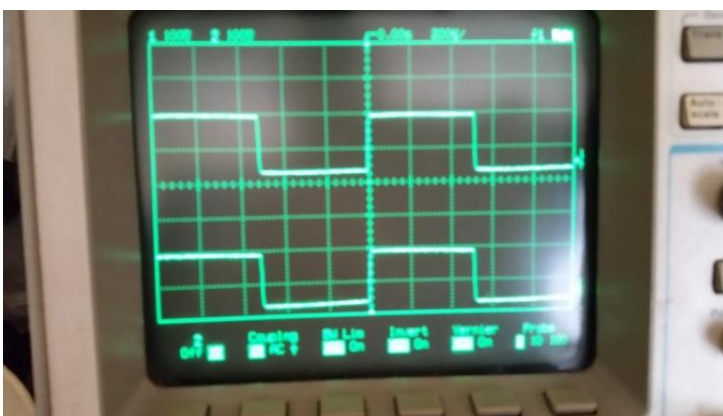
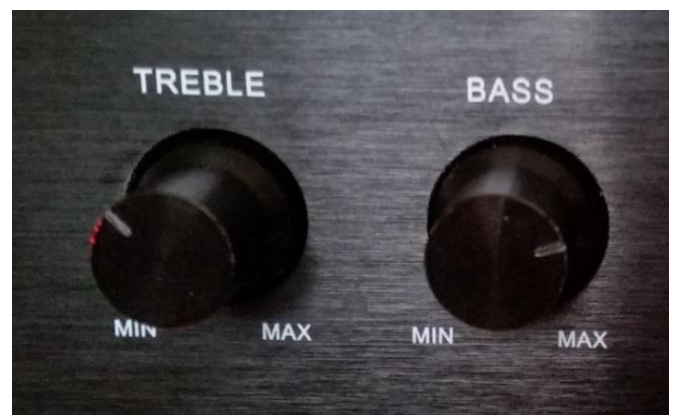
## Flat Response at 1kHz square wave and the Control settings required to achieve it.

Here are some photos of the EQ section in operation. Notice that you do not get a flat response with Bass and Treble set to mid-position! This phenomenon is well documented on the internet; I have included first of all, a photo showing the control positions that actually give the best 1 kHz square wave i.e. flat response.

Both channels are virtually identical as you can see in the photographs.

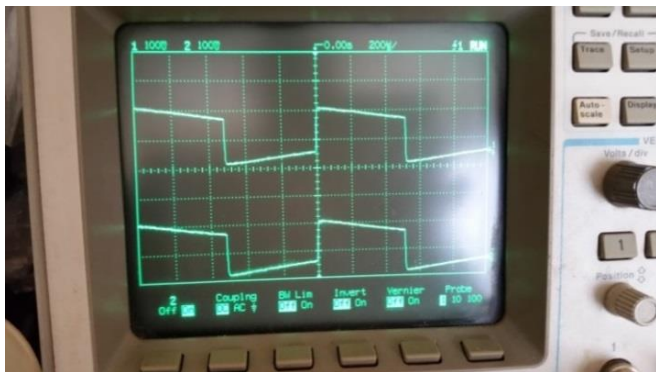
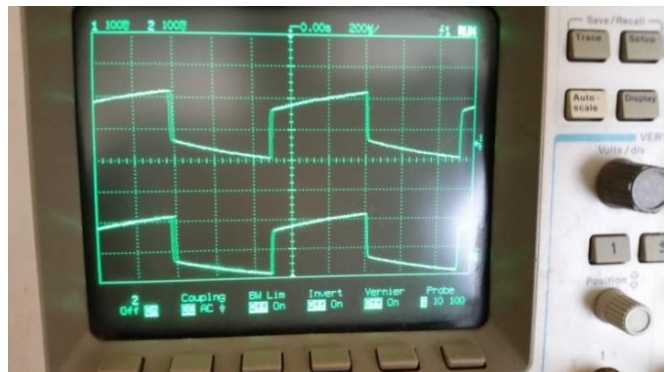
## Bass at minimum and at maximum.

It is true that the levels are not the same when you bypass the tone controls, there is an approximate 7dB increase!

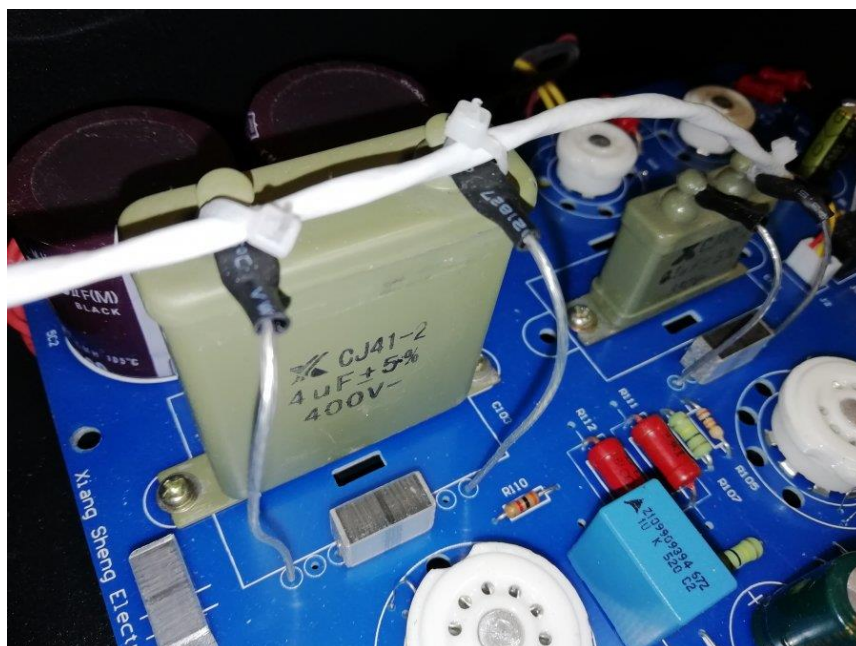
C103 & C203 were 2.5uF. They are now 4uF with a parallel connected 150nF across each one.

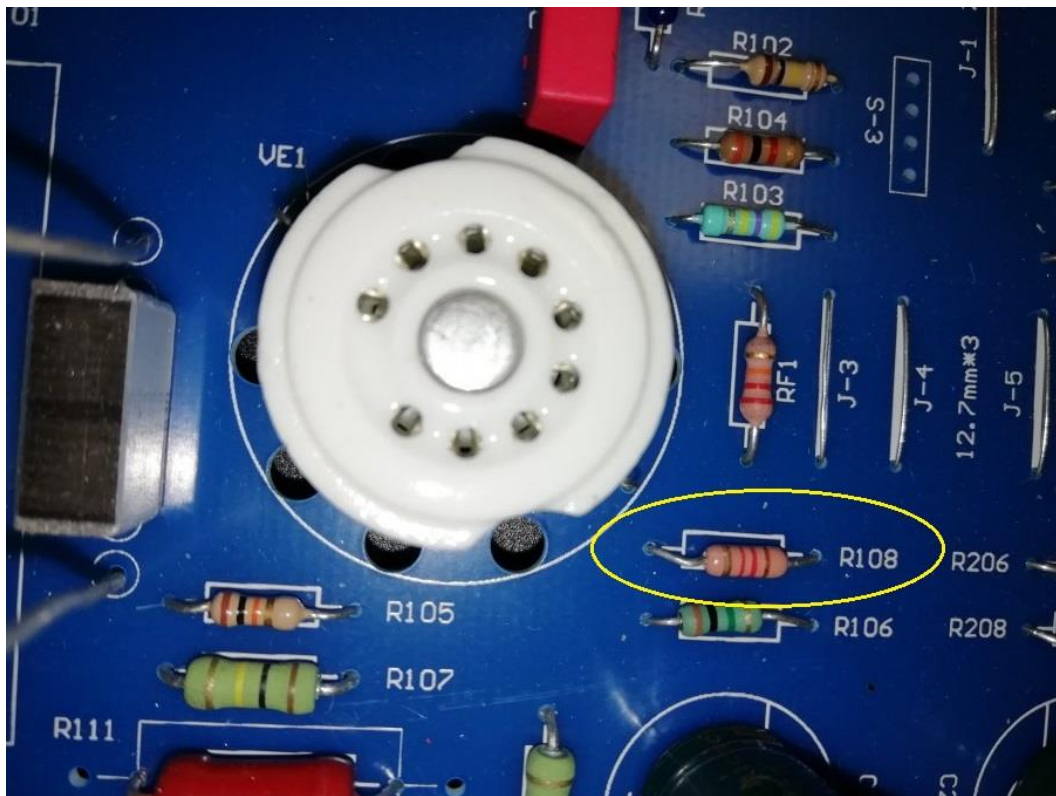
R108 & R208, they are now 1k2 instead of 8k2.

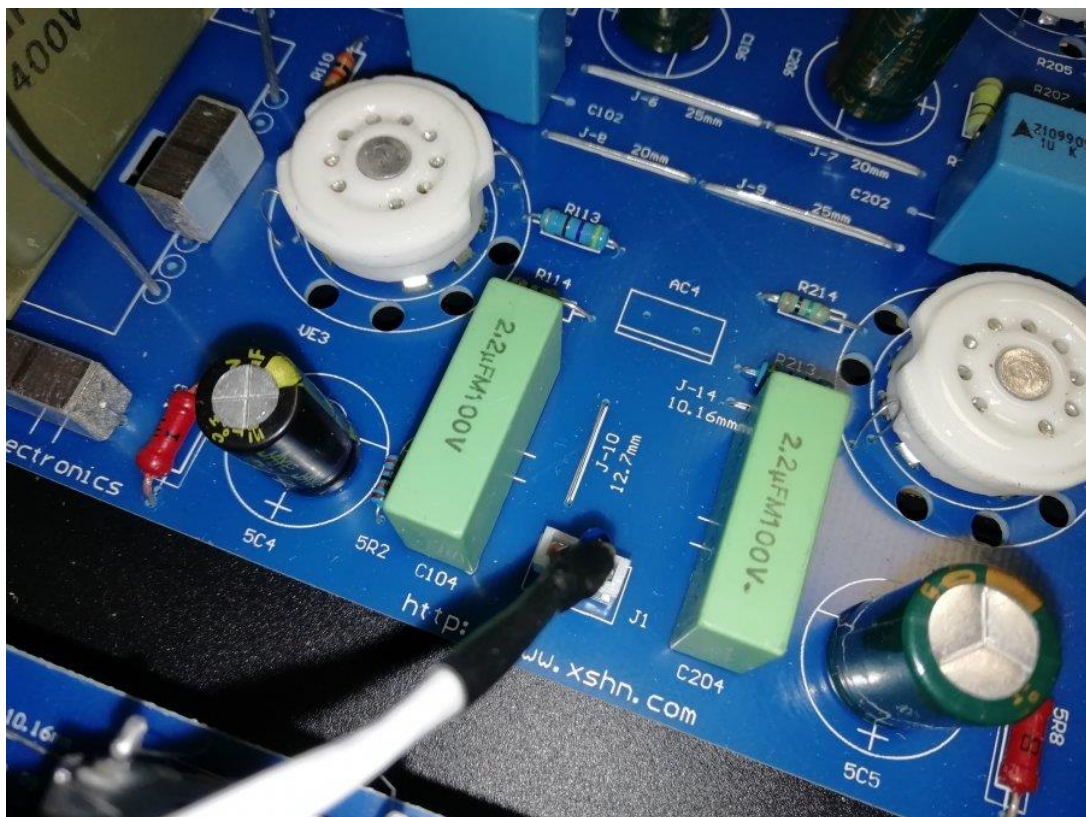
C104 & C204 1uF have been increased to 2.2uF.

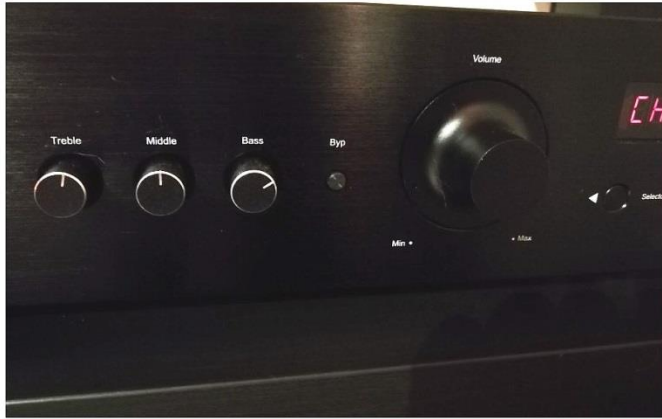
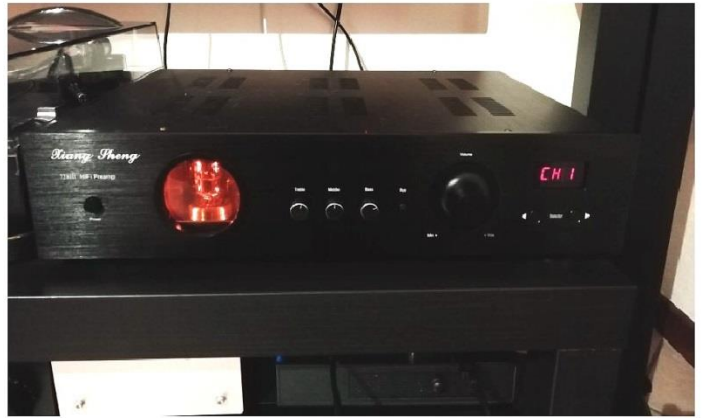
He also advised that the front panel has changed and sent in the following photos to show an extra 'Middle' control'. The main circuit board is probably different and the front panel circuit board is obviously very different. I shall have to wait until someone provides me with this newer version so that I can reverse engineer the whole unit. I wonder if Xiang Sheng have designed-out the 7dB change in volume when the Tone Controls are switched out?
