# Acoustat Magne-Kinetic Interface MK-121-2 – A Successful Restoration

## History

- These Acoustat Model 2 Slimline Series electrostatic loudspeakers with Magne-Kinetic Interface MK-121-2, serial numbers 104333 and 104336 I purchased new in 1980 from Straight Gain Electronics, Toronto ON.

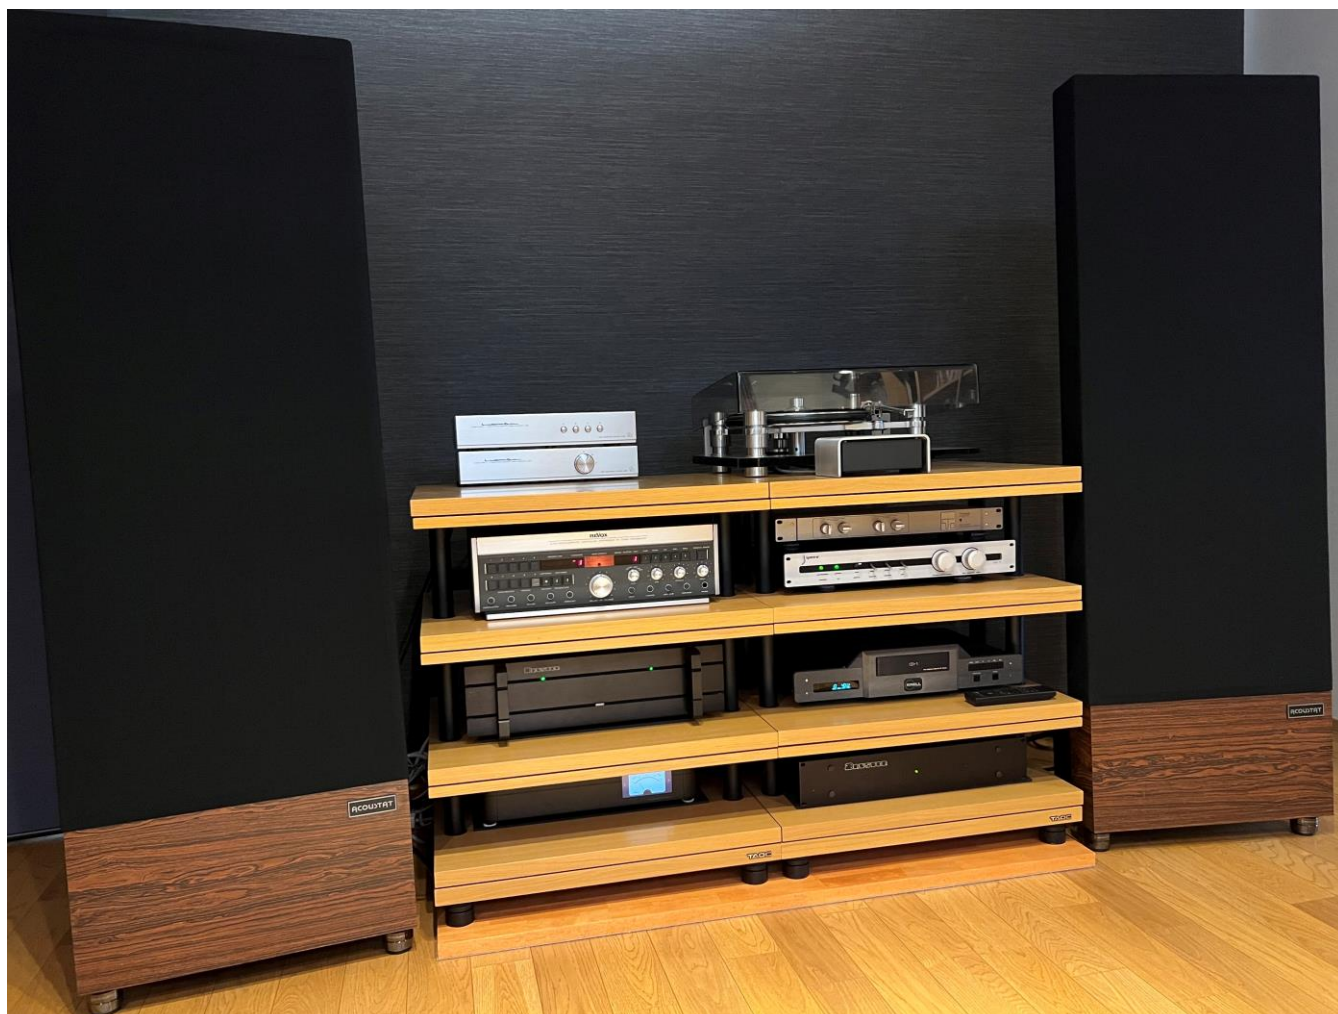
**Figure 1. Acoustat Model 2 home setup** – photo taken October 2023 after restoration.

- While there are many aftermarket brands to choose from, I replaced the original support legs with IsoAcoustics GAIA IIs, the GAIA II series being suitable for speaker weights up to 120 lbs. (54 kg). You can see a partial view of these in Figure 1.
- Whichever brand and model you choose, ensure they support the weight of your speakers and are supplied with the common thread size of ¼ inch - 20.

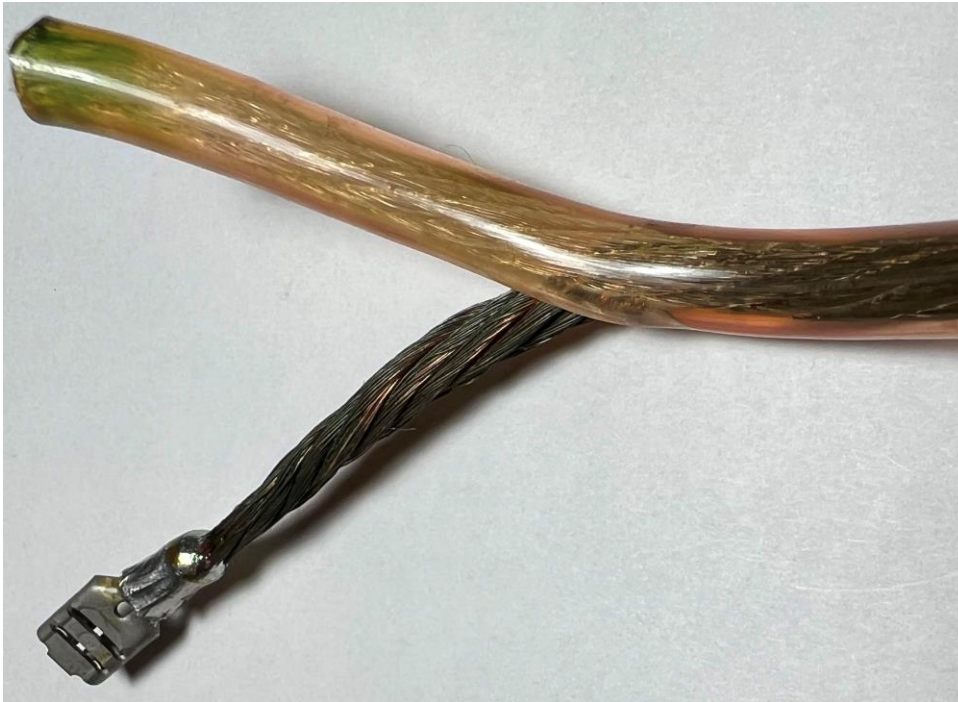
- Discolouration, corrosion in the low-frequency internal wiring (Fig. 3).

Figure 3. Discolouration in low-frequency wiring conductors – sheath pulled back for clarity.

- The corroded low-frequency wiring was replaced with new Oxygen Free Copper (OFC) speaker cable that I had spare from another project (Fig. 18).

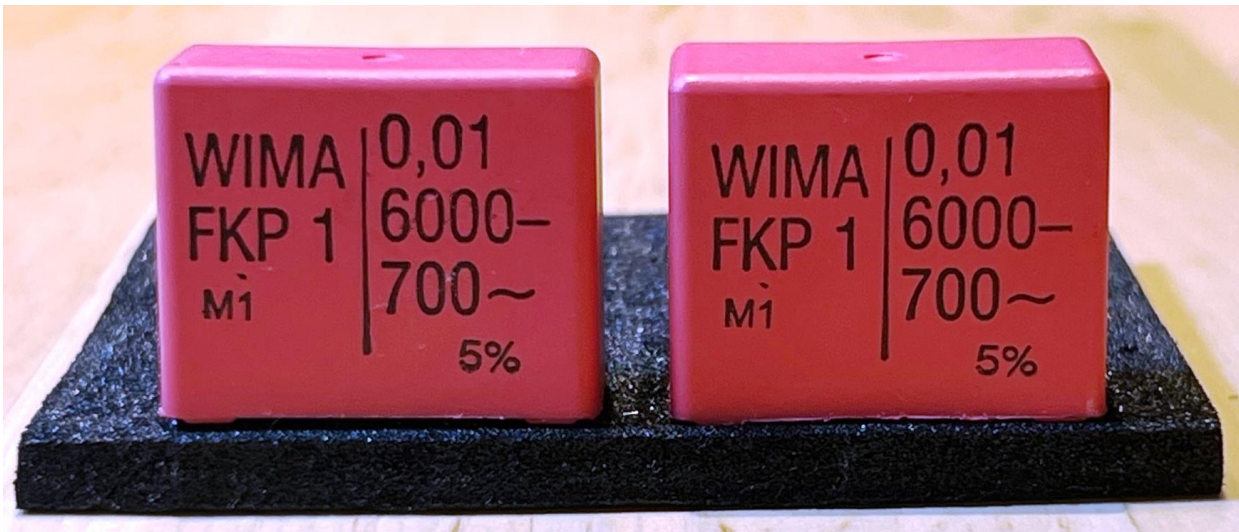
Figure 14. WIMA high-voltage capacitors, type FKP1Y021006F00JSSD

- The original high-voltage audio capacitors that leaked oil I replaced with 0.01 uF, 6 kV polypropylene capacitors (FKP1Y021006F00JSSD, WIMA). While the DC voltage rating of these capacitors is 6 kV, I was concerned about the lower AC voltage rating of 700 VAC RMS (Fig. 14).

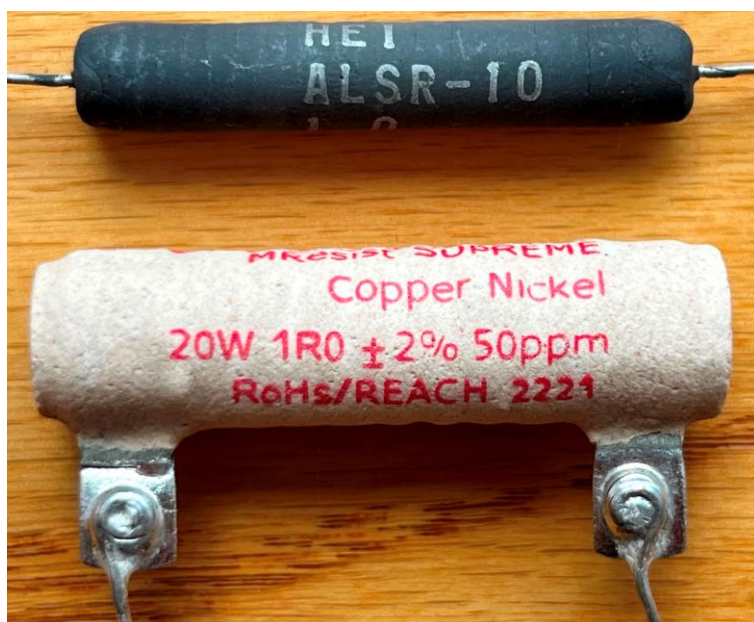
Figure 17. Original Huntington Electric 1-ohm 10W resistor (*top*), Mundorf MResist Supreme 1-ohm 20W resistor (*bottom*).

- Although both original 1-ohm 10W power resistors tested fine, as precaution I replaced them with new 1-ohm 20W bifilar type (Fig. 17).

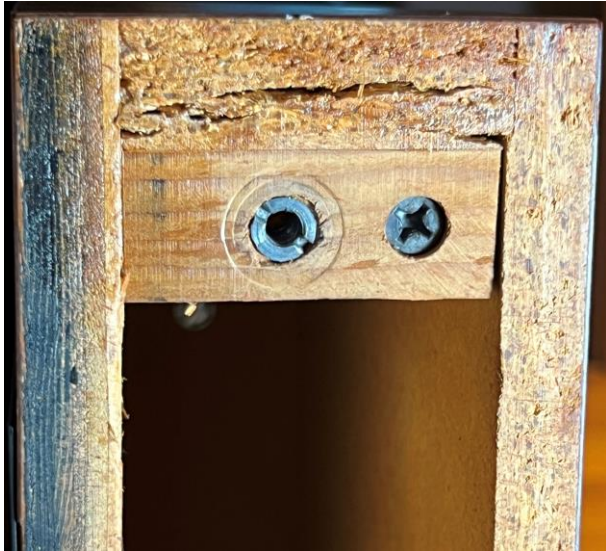
- Both speakers suffered from a slight sideways tilt with uneven levelling, caused by splits in the particle board wooden frame (Fig. 21). Although not directly related to this interface restoration, with the interface detached from the speaker's frame it's an opportunity to carefully inspect each wooden frame's condition.

**Figure 21. Underside of wooden frame base showing split in the particle board.**

- Using wood glue and C-clamps the repair is not difficult (Fig. 22), for my first attempt I used a general-purpose wood glue but after a few months a split reappeared. For my second attempt at repair, I used a stronger brand of glue “Gorilla”, and as of this writing the repair has remained intact. Both speakers now align level when viewed from the front.

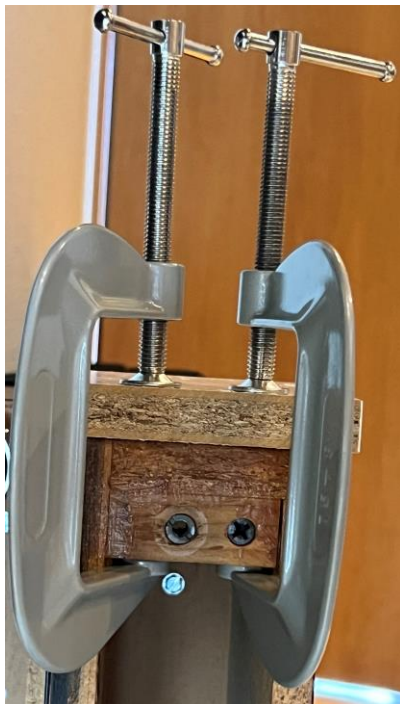
**Figure 22. Clamping of wooden frame base – a spacer board helps even the c-clamp force.**

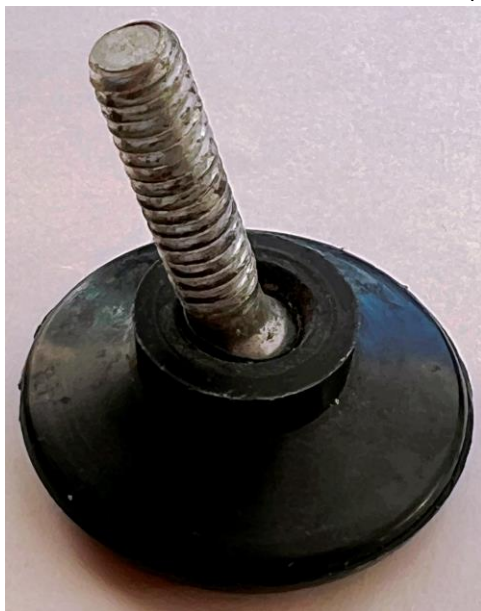
- There are 4 support legs for each speaker, thread type ¼ inch diameter with pitch 20 threads per inch, with 2 support legs on the front that screw into the base of the speaker frame (Fig. 21), and 2 on the back that screw into the chassis of the Magne-Kinetic Interface.
- Perhaps from uneven levelling caused by the broken wooden frames, the support legs had become twisted and stuck within the base feet (Fig. 23).

**Fig. 23. Original threaded support leg (4 pieces per speaker)**

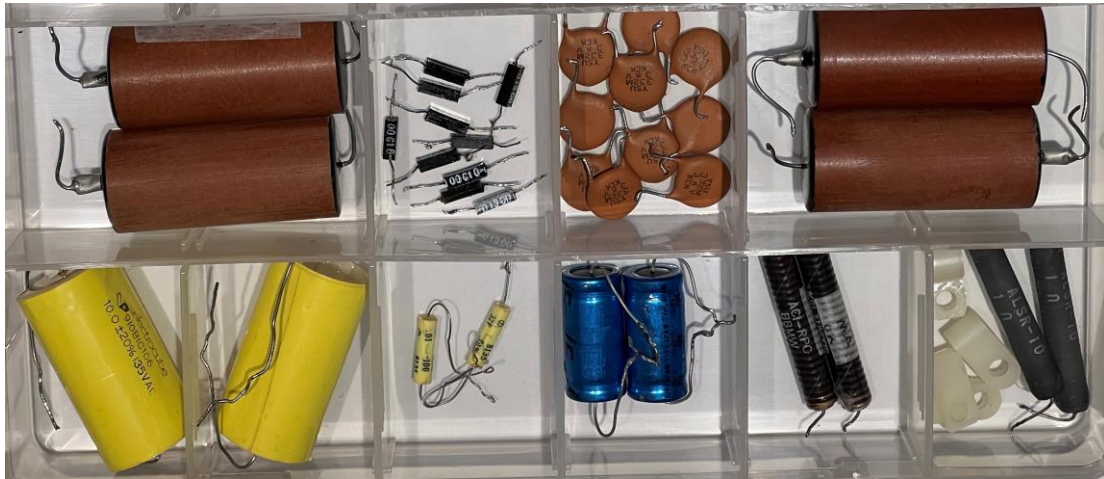
Figure 31. Original components replaced.

- Top bin: HV audio capacitors, HV diodes, HV ceramic disc capacitors, HV audio capacitors.
- Lower bin: 10 uF and 0.01 uF capacitors, 220 uF bipolar capacitors, 500 M-ohm resistors, cable clamps and 1 ohm power resistors.
- Not shown: 5-A slo-blo fuses, speaker support legs, low-frequency cabling.
