Audio Restoration Project: Repair Source Selector Switch and Upgrade Arcam Alpha 9 Integrated Power Amplifier.

The objective here was to upgrade all components which would contribute firstly to increased reliability and longevity, and secondly to improved sound quality, and then to replace the troublesome motorized Source Input Selector Switch.

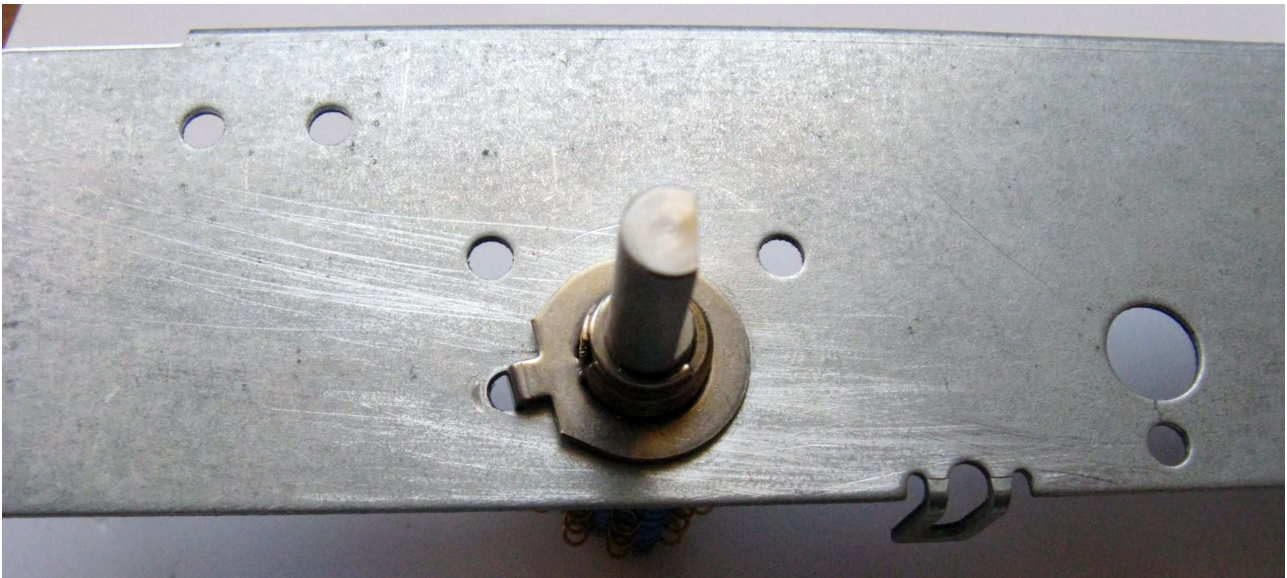
5a. Prepare the Panel

The original hole must be widened to accommodate the 3/8" bushing - I used a 9.5mm ream.

A 3mm hole for the lock-nut must be drilled 15° below horizontal on the left, at a radius of 9.6mm, so that when fully CCW, the flat edge of the D-shaft is aligned vertically at the 0° position.

A 2.5mm thick washer with I.D. of 10mm is inserted on the bushing BEHIND the panel.
