# Optimum Corrosion Protection of Nd-Fe-B Magnets

S. R. Trout  
Spontaneous Materials

**For a long time, the successful application of Nd-Fe-B magnets was jeopardized by their poor corrosion resistance. At first, coatings alone were thought to provide adequate protection. We now know that correctly applying the best-suited coating and optimizing the microstructure of the magnet are both necessary for outstanding performance. This article reviews the present state-of the art, with guidance on best practices.**

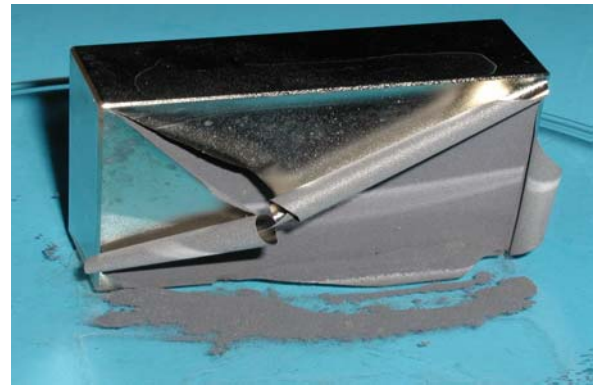
Figure 2. A sample with Ni-plating after 20 hours of a HAST at 130°C, 260 kPa and 95% humidity. Note that the plating has peeled away from the magnet.

In other words, coating alone does not guarantee good corrosion resistance, as shown in Figures 2, 3 and 4. In extreme cases, the coating remains intact and undisturbed, while the magnet underneath completely disintegrates.

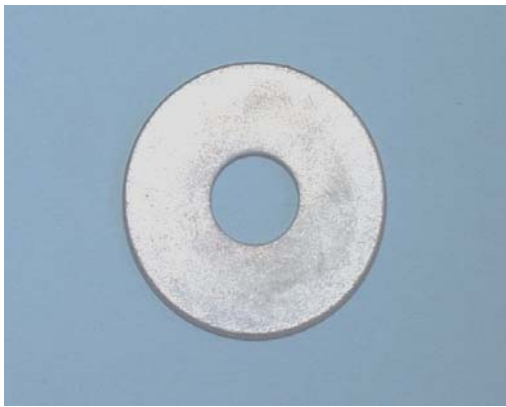
Figure 3. A sample with an electrolytic zinc plating, as received from the manufacturer. It appears to be a good magnet.

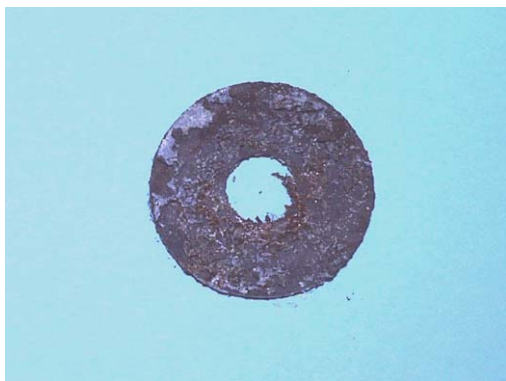
Figure 4. The same sample after 24 hours of a HAST at 130°C, 270 kPa and 100% humidity. The test demonstrates the plating was poorly applied.

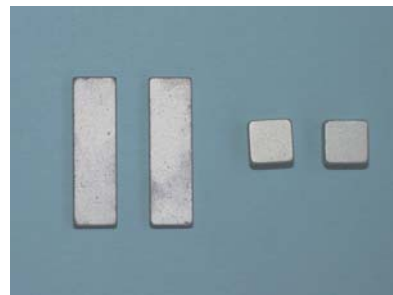
Figure 5. Samples with a spray coating after 12 days of a HAST at 130°C, 270 kPa and 100% humidity.

The manufacturer must control the microstructure of each magnet appropriately to control corrosion. Novices tend to make magnets with excess Nd, a serious mistake, inviting corrosion. Well-established manufacturers usually have better control of their process. Again, it is always best to confirm corrosion resistance by testing it thoroughly. Ideally, the magnets should fare as well as the ones shown in Figure 5.
