Update for uTracer6 to reduce MOSFET failure and improve accuracy at low voltage and high currents

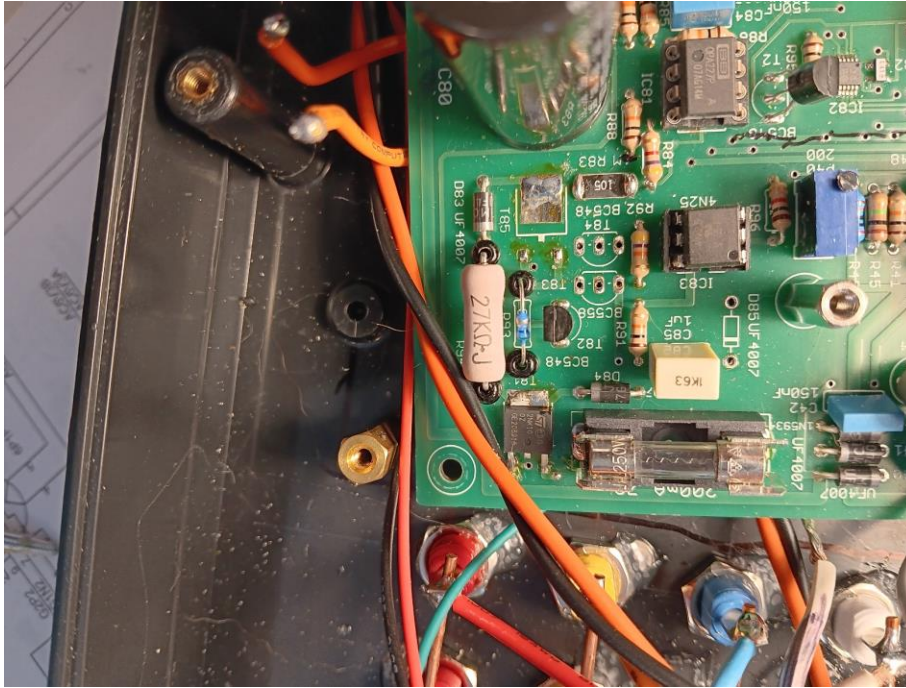
Step 1)

Remove the following in the anode and screen circuits.

T65, T85, T63, T64, T83, T84, D65, D85

T65 and T85 the SMT parts can be tricky to remove without damaging the pads on the PCB.

The mod only uses the large fat pad of T65 and T85 so if the smaller pads become damaged it is not a big issue.

Clean out solder from all the other holes.

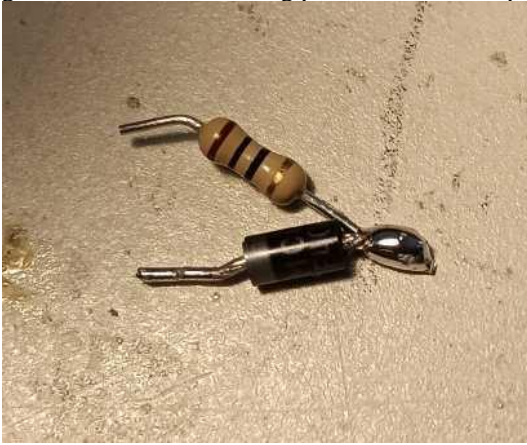
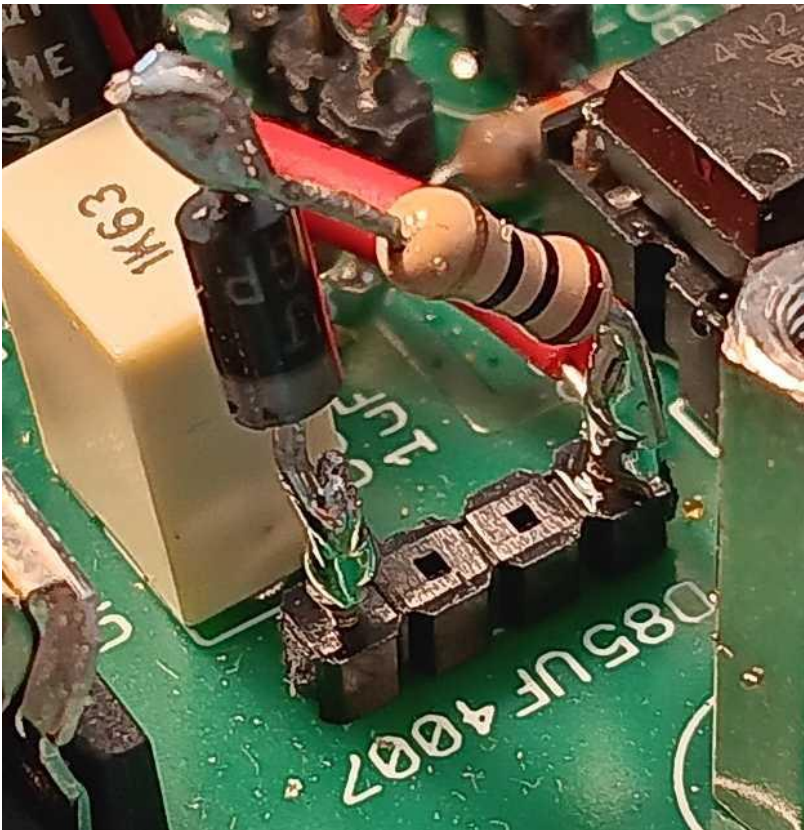
Step 3) Solder the diode resistor assembly to the berg pins installed in step #2 at D65 and D85
The diode cathode (band) goes to the berg pin at D65's cathode on the PCB and the new 10 ohm resistor goes to the D65 anode berg pin on the PCB. Repeat for D85.

Step 2) Take two berg 0.1 pitch pin strips and cut 4 pin sections. Pull out the two center pins leaving only the two out side pins. Solder this in place of D65 and D85.

Take the diodes removed and solder one 10 ohm 1/4 resistor to the anode (NO stripe) of each diode

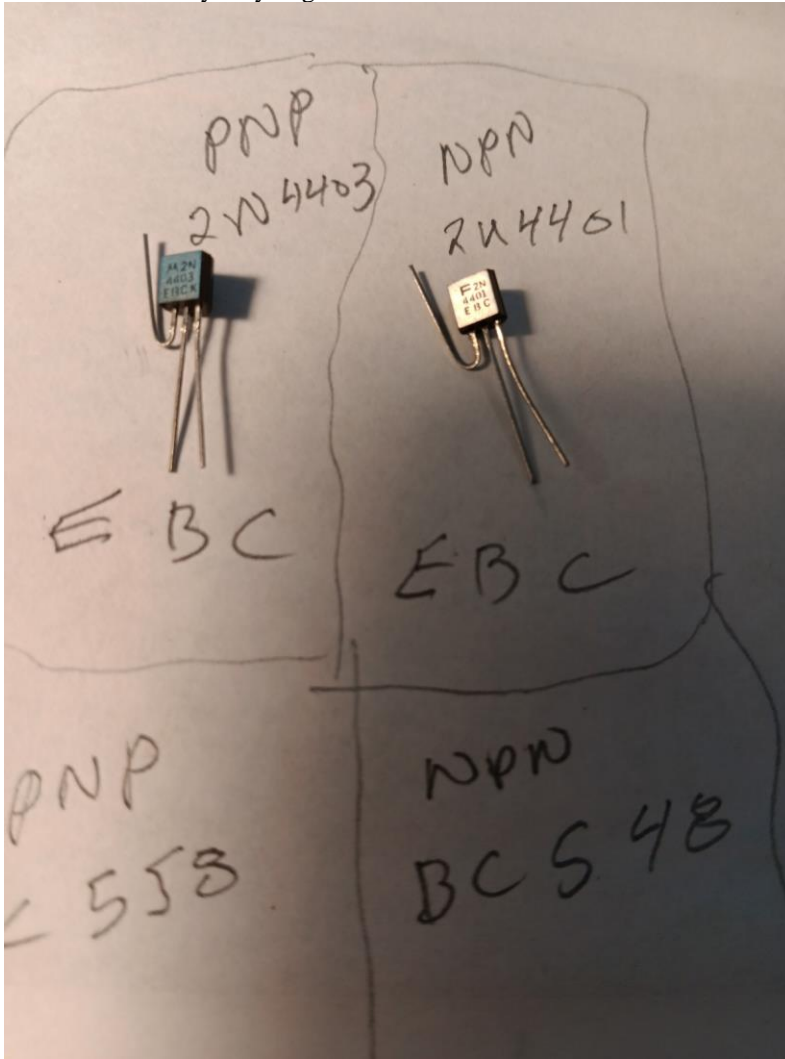
Step 5) Bend upward the emitter lead of both the 2N4401 and 2N4403 transistors as show in the picture.
SEE PICTURE

NOTE The pin out for the 2N4401/2N4403 are the mirror image of the original BC548/BC558 transistors.
This means the new transistors must be installed reversed to how the transistors are shown on the PCB silk screen.

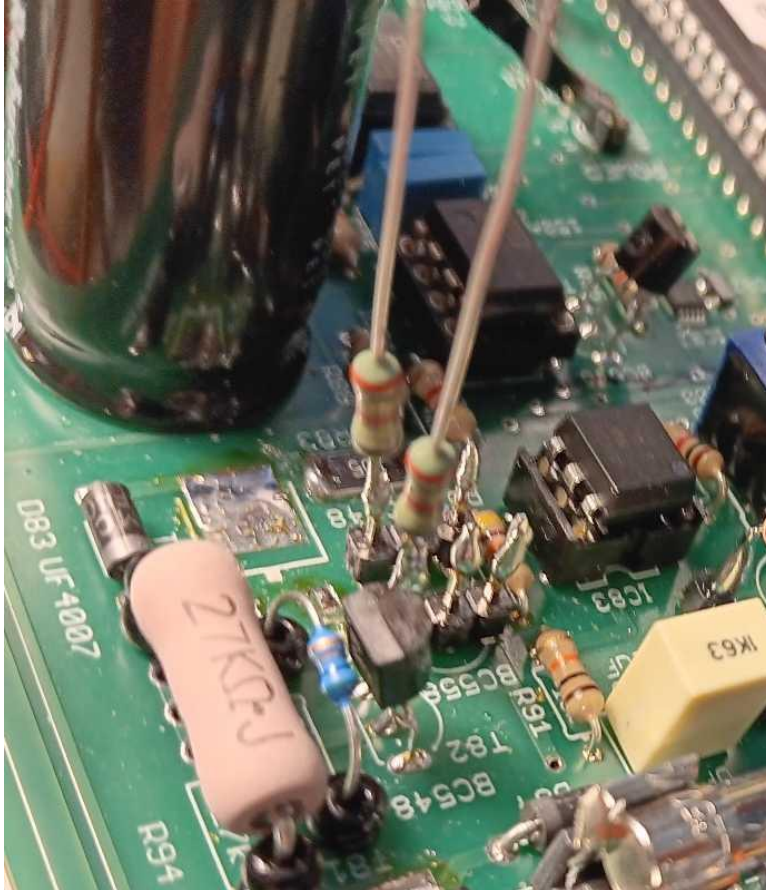
Step 6)

Clip one end of the 18.2 ohm resistors short and solder this end to each of the four resistors to the emitter pins of the machined pin strips soldered on the PCB in step #4.

NOTE The pin out for the 2N4401/2N4403 are the mirror image of the original BC548/BC558 transistors. This means the new transistors are install reversed to how the transistors are shown on the PCB silk screen. Be careful it is very easy to get confused as to where the emitter pin is.

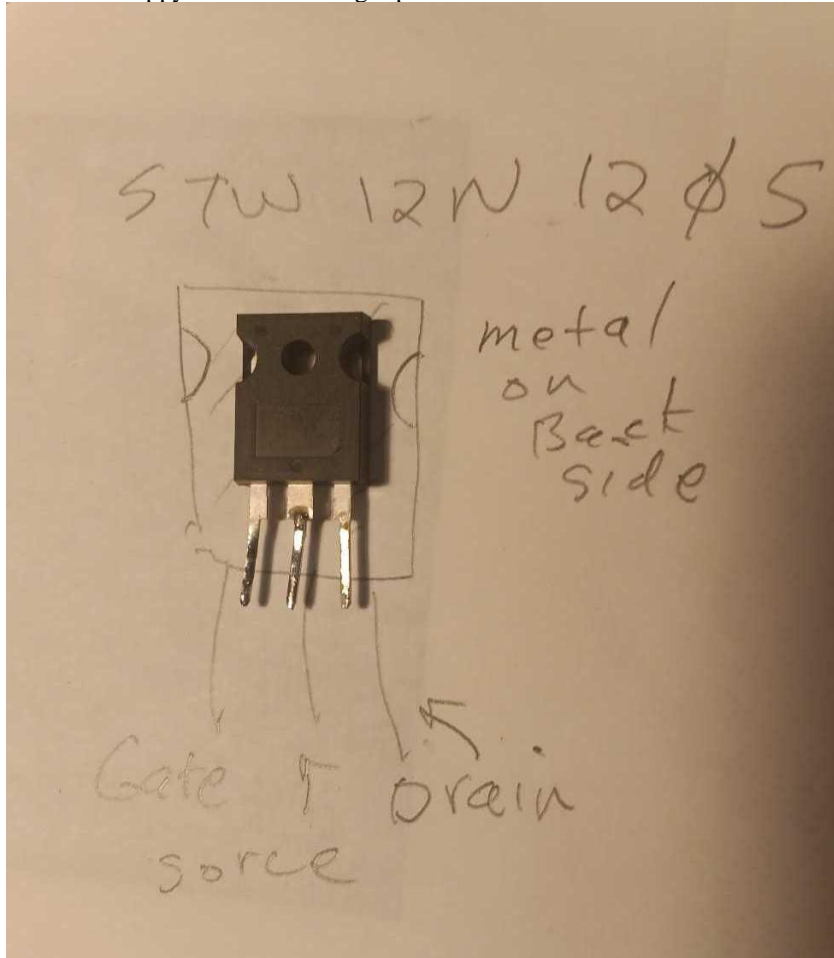
Step 9)

The new MOSFET is a large through hole part and can not be placed on the PCB.

It is mounted on three added wires above the PCB.

This has a happy effect of making replacement in the future of the MOSFET quick and easy.

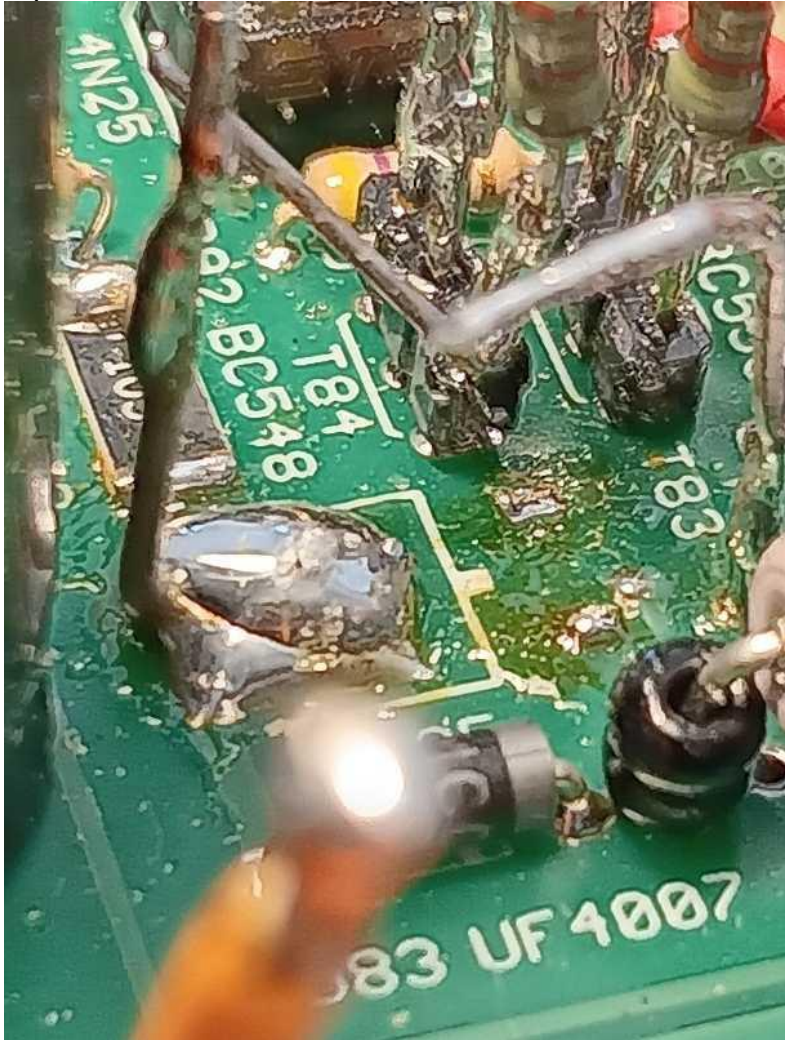
Take a #18 bare wire or thick resistor lead and make a small 90 degree bend on one end. Solder this bent end of the thick wire lead to the large pad of T65. The lead is to be soldered standing vertical a little out from the large storage capacitors. The thick wire will provide support for the weight of the new large MOSFET.

This thick wire lead will become the MOSFET source connection (center MOSFET pin)

Repeat for MOSFET T85

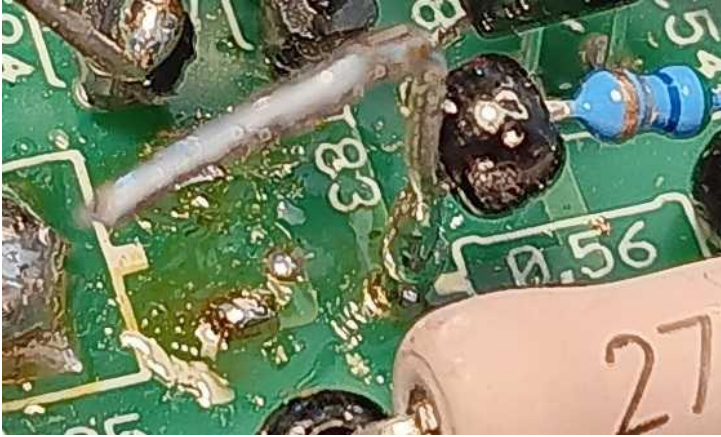
Next take a medium thickness wire lead and solder it to the lead of R73 closest to the MOSFET. The lead should be soldered standing vertical.

Do not use too thick a lead as R73 is a very small and thin leaded part (TOO SMALL??).

Repeat for R93

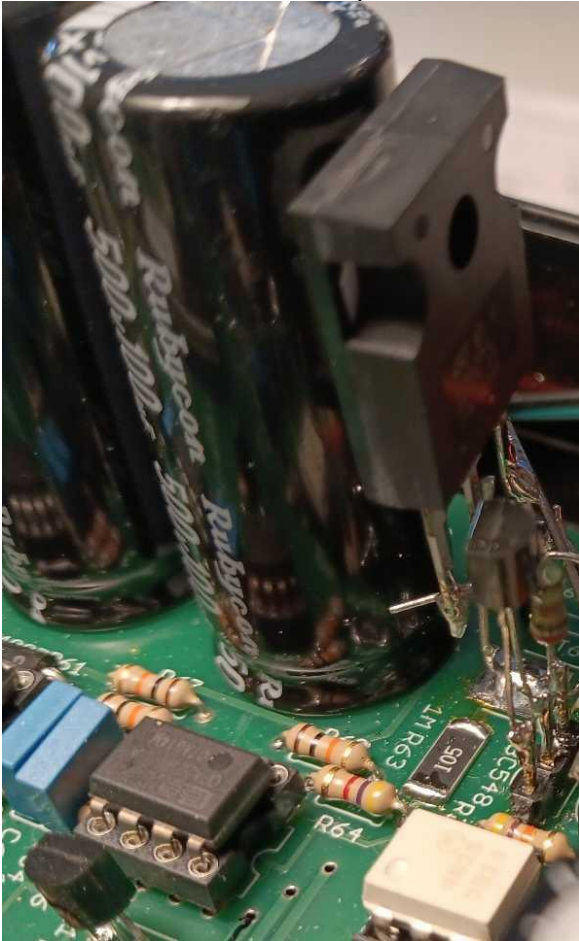
Step 10)

To make the MOSFET connections shorter and more direct the MOSFET at T65 is mounted on the right side (anode circuit) with the MOSFET metal backing facing the storage capacitors.

Solder the thick wire lead added to the large pad of T65 to the new MOSFET's center pin. Take care to mount the MOSFET a little below the top of C60,61. This will insure if the PCB is turned over the MOSFET will not be bent out of position and it's connections broken or shorted.

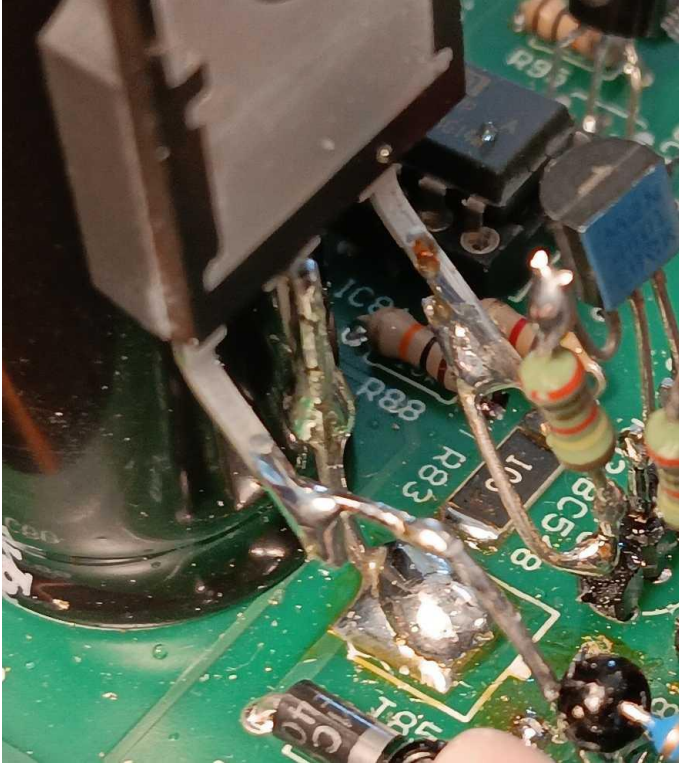
Step 11)

Repeat step #10 on the screen circuit for T85.

NOTE. On the screen side the MOSFET is to be mounted with the metal side facing AWAY from the storage capacitors.

Watch this point!!! The MOSFET metal side must be facing AWAY from the storage capacitors on the screen side.

If you miss this the connections will be reversed for the MOSFET drain and gate pins and circuits will be damaged.

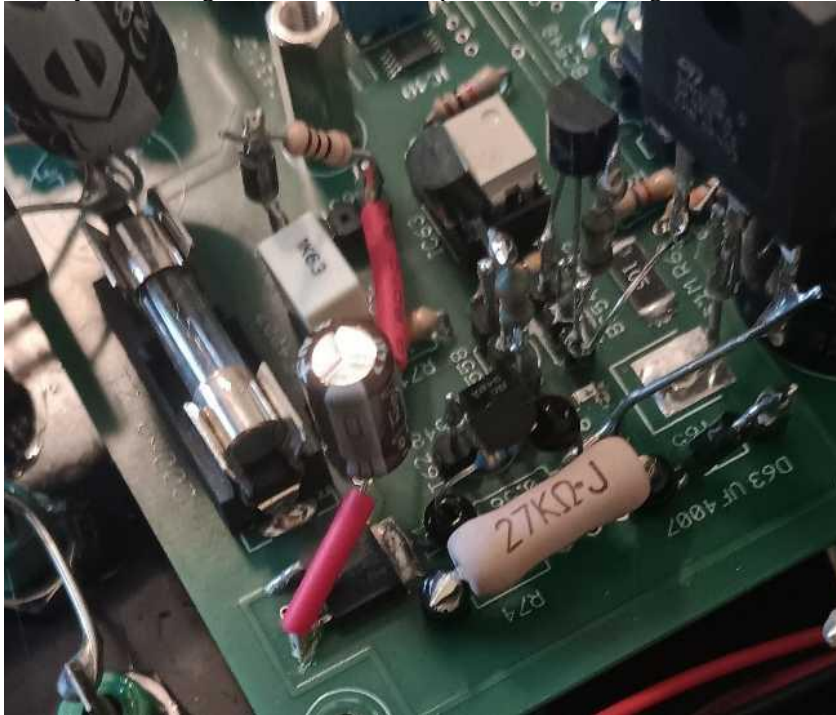
Step 16)

A 22uF capacitor is added between anode connection point at the header added at D65 and the ground connection for the drain of T61 the side right pin.

The positive lead of the added 22uF capacitor is soldered to the header pin at the PCB for D65 where the new 10 ohm resistor was soldered.

The negative lead of the added 22uF capacitor is soldered to the RIGHT lead of T61.

Be very careful to get the correct side of pin on T61 or damage will result.

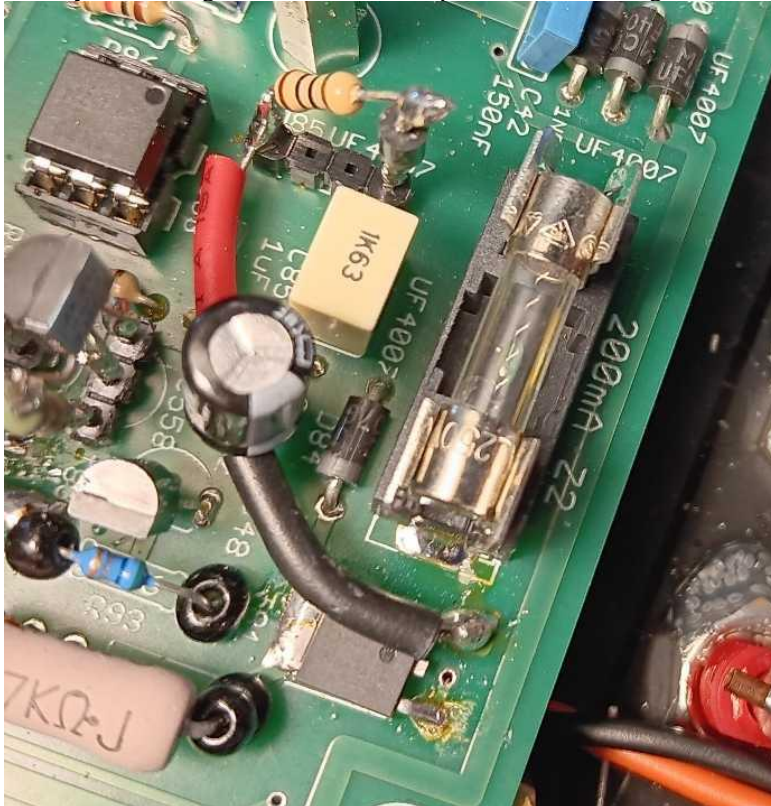
Step 17)

A 22uF capacitor is added between screen connection point at the header added at D85 and the ground connection for the drain of T81, the side right pin.

The positive lead of the added 22uF capacitor is soldered to the header pin at the PCB for D85 where the new 10 ohm resistor was soldered.

The negative lead of the added 22uF capacitor is soldered to the RIGHT lead of T81.

Be very careful to get the correct side of pin on T81 or damage will result.

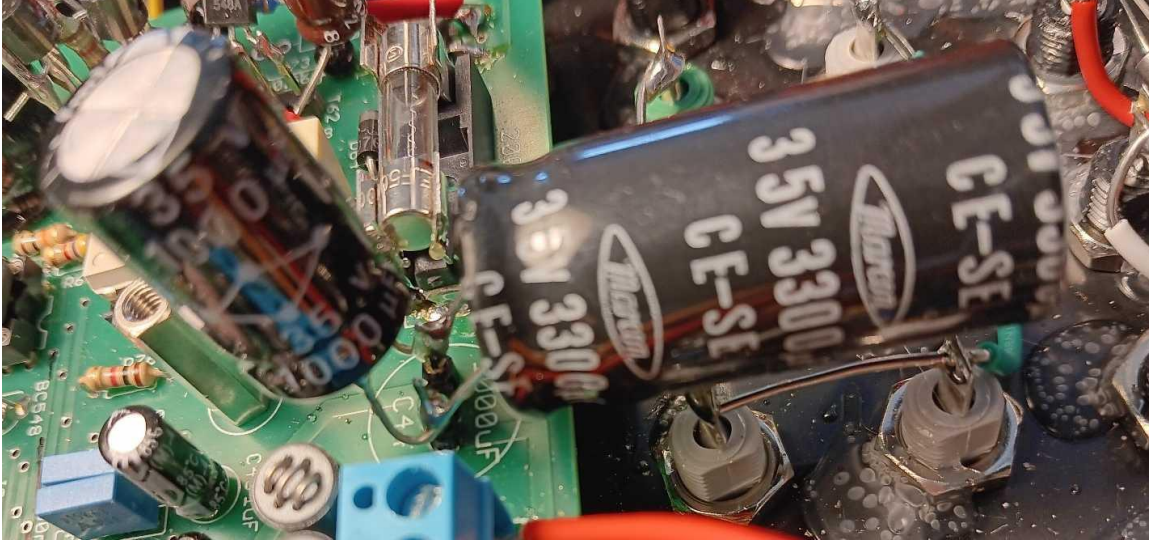
Step 18)

A 3300uF to 4700uF capacitor is used to add to in parallel or replace C44.

I had a 3300uF cap on hand and so I just added it in parallel to the current 1000uF capacitor at C44.

I also added to header pins to the holes for C44 so future changes can be made without harming the PCB.
