EMI Stories Compendium

EMI Stories

A collection of 890 real-life short stories about the dangers of electromagnetic interference (EMI)

Compiled by Keith Armstrong
keith.armstrong@cherryclough.com

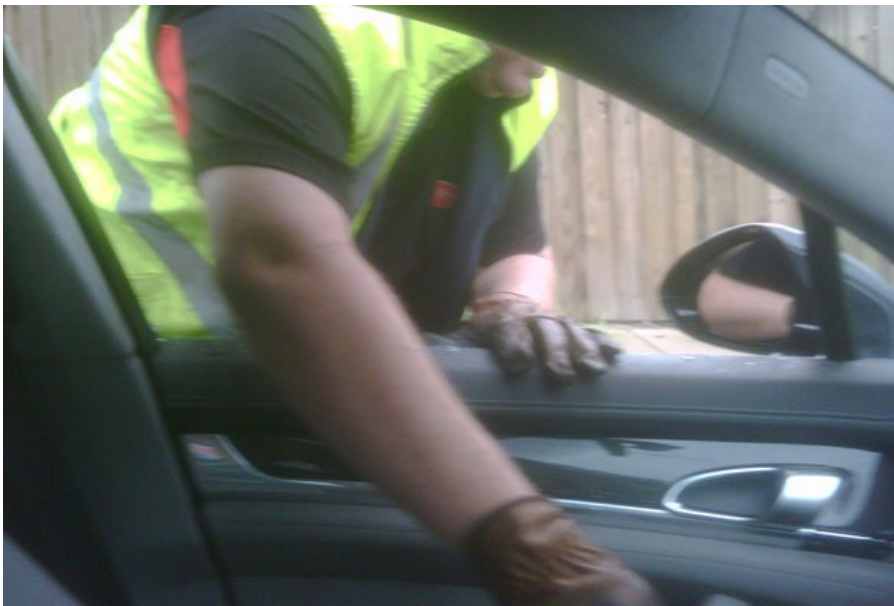
After five minutes of trying to lock and unlock doors (in an effort to reset the system or immobiliser) a phone call was made to Porsche Assistance. It was then that the locks thunked closed — and refused to open. Three people were trapped — wife and child included. Door handles did not work, buttons did not respond and with no ventilation the cabin heated up quickly.

After half an hour — including a phone call to the police — the decision was made to smash a window. *(See photograph below, Editor)*

Porsche has since tracked the problem to radio interference, presumably from TV and radio towers in the area. Similar problems had apparently occurred in four other Panameras around the world, although this was the first time people were trapped in a car.

Porsche subsequently tried a software update but it failed. More recently the company ordered a radio suppressor unit designed by the factory in Germany to further shield the electronics from interference; it was trialled this week and worked.

Porsche now intends to fit the suppressor units to all Panameras as part of a mandatory service campaign.

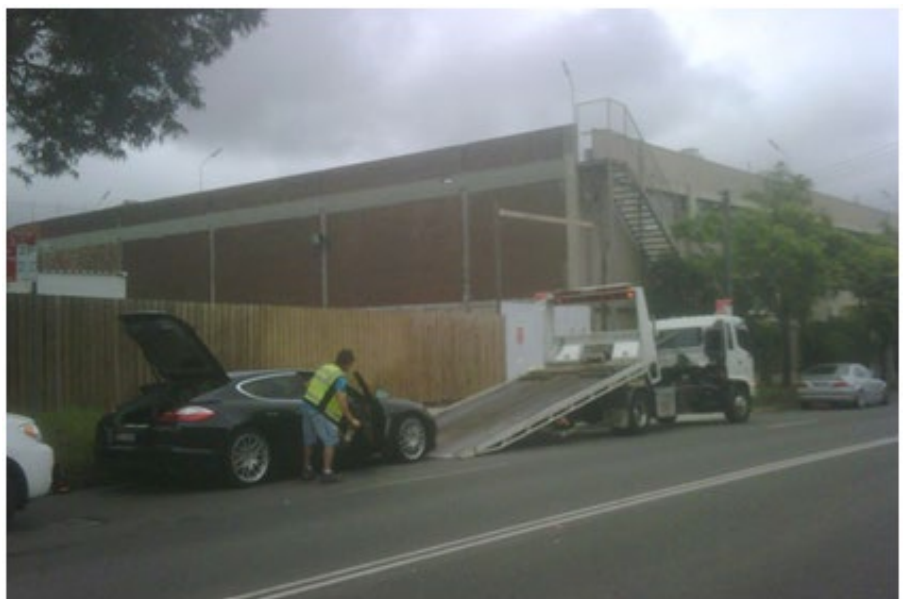
It took another 90 minutes to drag the car on the tow truck, with its electronic handbrake refusing to release. *(See photograph below, Editor)*

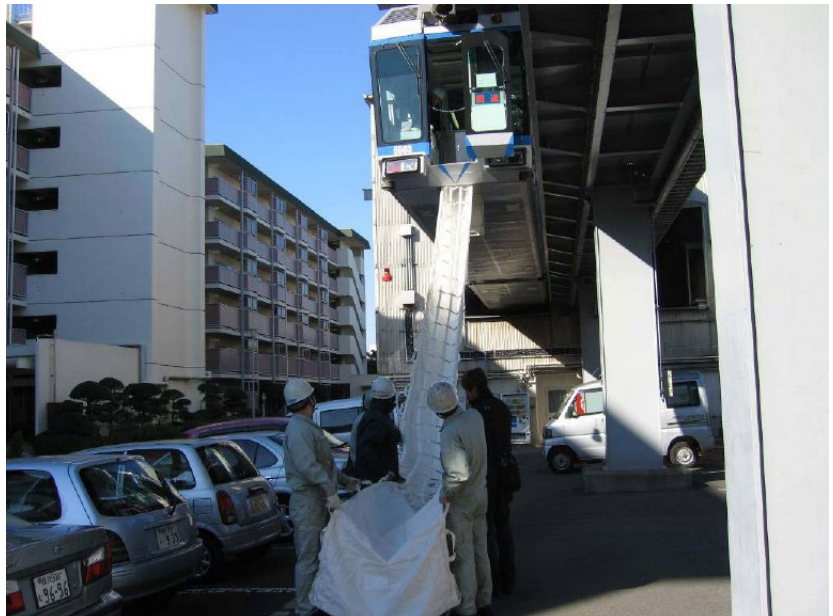
When the train came near to the next station, it could not be decelerated enough even with its emergency brake activated, and caused an overrun. The train finally stopped, fortunately with no casualties, after collision with a rail point.

On 26 June 2009, an accident investigation report, RA2009-6, was issued from the Transportation Safety Board. The Board concluded that the accident was caused by roughly the following reasons:

1. Poorly grounded VVVF inverter (which drives the train) on the train caused excessive noise, which could be coupled to nearby wires;
2. A cable for an unused monitor board was still connected to the CPU, and the cable was not properly protected from possible incoming noise;
3. Noise on the cable could cause interrupt signal to the CPU;
4. The CPU didn't mask (disable) the unexpected interrupt, so the corresponding interrupt handler in the software could be activated due to the noise;
5. Somehow, once activated, the interrupt handler (not expected to be activated in normal situations) disabled all other interrupts after that, which made the acceleration/deceleration process no longer work at all;
6. The integrated watchdog timer couldn't recover the system due to a defect in the control software.

(Kindly sent in by Tom Sato from Japan, on the 17 Jan 2010. The photograph below shows rescuers using an emergency chute to remove passengers from the crashed monorail train. I'd like to remind readers of the IET's very practical 2008 Guide to EMC for Functional Safety,

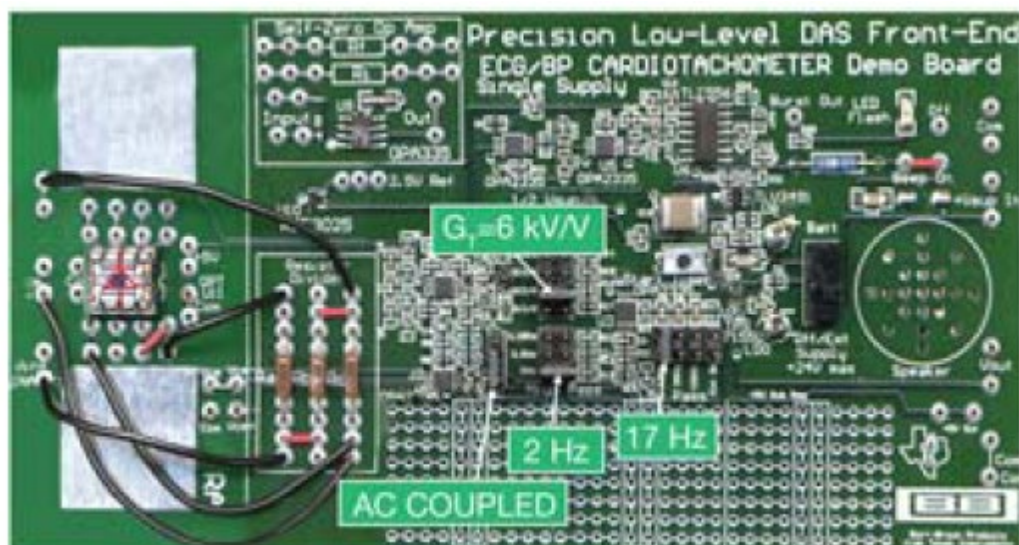
Figure 2 An engineer's precision, low-level ECG cardiometer board took the measurements for Figure 1.

Figure 1 EMI from a cell phone can cause a 1.5V change from normal on an ECG. The ECG diagnostic tool senses a heart while a 0.5W, 470MHz transmitter turns on and off just one and a half feet away.

The heart's input signal to the system is approximately 0.25 mV p-p. This small signal requires an instrumentation amplifier's gain of approximately 6000V/V. The good news is that the results in Figure 1 do not represent the performance of a doctor's office ECG-measurement tool. This measurement was actually taken in an engineer's lab from the board in Figure 2.

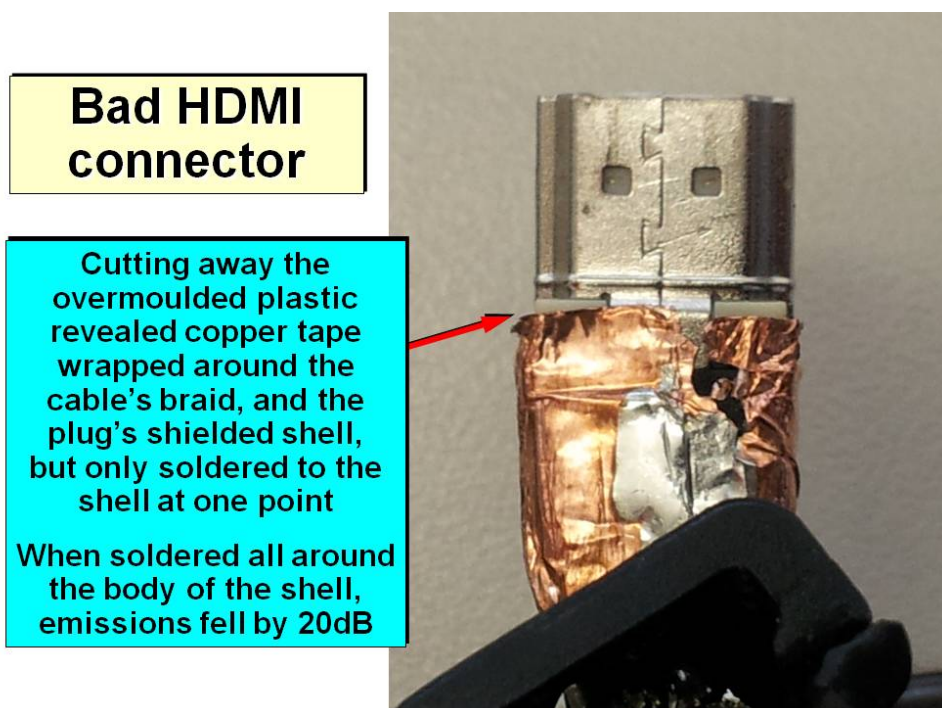
Most EMC test lab managers have long experience with poorly-constructed cables sold as “shielded” types, some of which contain shields that are not even connected to the connector shells at the ends!

A particular problem is that even if a purchased cable has good shielding performance when used with a prototype product, future batches supplied for production can suffer degraded shielding due to incorrect assembly – but of course it is impossible to tell by visual inspection because the cable-connector joints are overmoulded with opaque plastic.

Unless cables can be purchased with transparent overmoulding, the only ways to ensure that a product's EMC performance (and legal compliance) has not been hugely compromised by the poor quality of purchased cables are:

- Assemble your own cables, don't buy them, so that you control the quality of your EMC-critical cables yourself.
- X-ray a random sample of cables from each batch delivered, checking their internal assembly is correct before accepting them into the company stores. Although a costly solution, it may be most cost-effective because the X-ray machine can be used to check the correct assembly of any/all other components/assemblies supplied for manufacture, and also a big help in avoiding assembling with counterfeit parts.
- Using a spectrum analyser with tracking generator, two clamp-on current probes and a cable termination box fitted with two HDMI sockets, check that a random sample of cables from each batch delivered measure the same as the 'known good' example of the same cable that is known to help ensure that products pass their EMC tests.

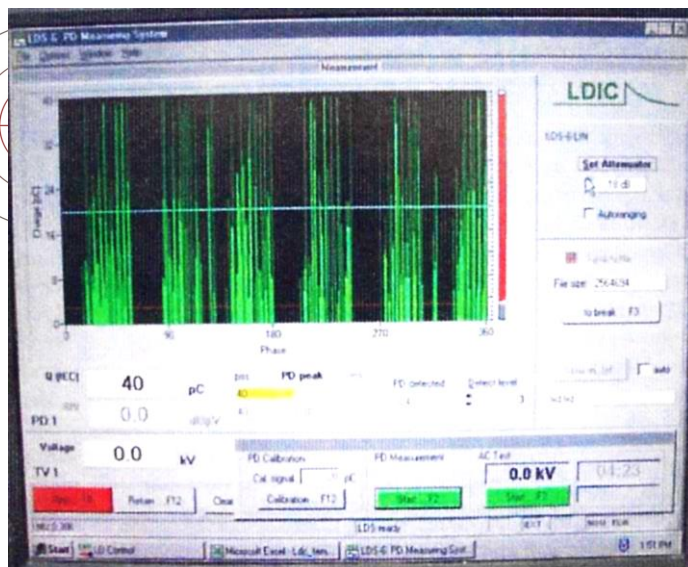
Upon startup of this new production line, use of the partial discharge test setup revealed a problem. As shown in Figure 1, the partial discharge test system revealed a leakage much larger than five picocoulombs. In fact, the test yielded a leakage of almost 40 picocoulombs, eight times the acceptable level. Plant engineers were concerned that the partial discharge test system was not working properly and decided that this system could not be used until someone determined the reason for the unacceptable test results.

In response to the problem, the plant staff began seeking the cause of the erroneous readings on the test monitor. Connections to the equipment were investigated. This partial discharge test system was switched with another one in the plant, and the same problem reoccurred near the new production line. The probe to the partial discharge system was also checked. Cable reels that failed the test at the problem location were taken to the other partial discharge test system and passed the test there. The manufacturer of the partial discharge system was called in, but could not determine the cause of the erroneous readings. A partial discharge test expert was also called in, and still the problem remained unsolved. After several months of investigation, the plant engineer turned to the local utility for some assistance. The local utility called upon EMC engineers to investigate the problem and to determine the cause of the problem.

Measurements were performed at the area of the line input to the ASD nearest the partial discharge test system, and a custom designed filter had to be manufactured and installed. After the EMC investigator left, the filter was installed by the electrical contractor at the step-down transformer; however, interference problems still occurred. Upon a re-examination of the filter installation, the EMC investigators quickly realised that the contractor had not

followed the guidelines provided by the team. To control the radiated and conducted emissions, the filter must be installed directly at the ASD (as close to the input terminals as possible), and the transformer must be located next to the filter to ensure proper emissions attenuation. Once corrective actions were taken, the interference was reduced and found to be at acceptable levels with all systems operating as shown in Figure 7.

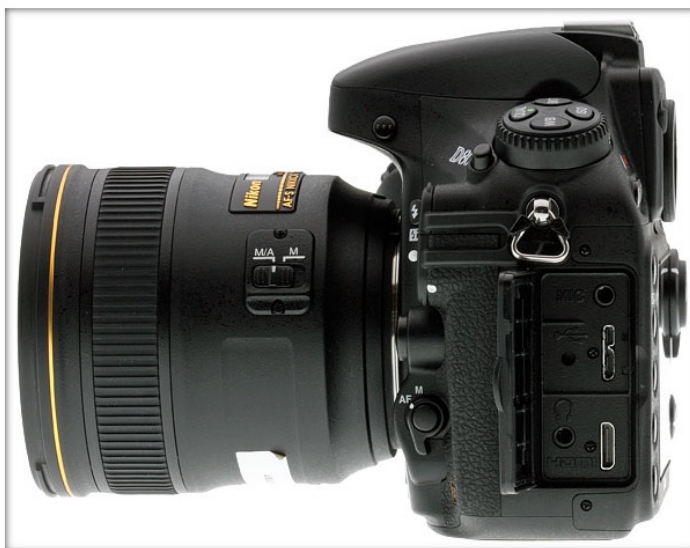
According to an Eye-Fi representative, the company determined the issue was caused by interference emanating from the unique USB 3 connector inside the camera. The update provided by Eye-Fi changes the card's broadcast channel to prevent further interference issues.

"By default, Direct Mode broadcasts on channel six. In the D800, due to noise that's coming from the USB 3 interface, we needed to broadcast on channel 11," Ziv Gillat, Eye-Fi co-founder, said.

Nikon's D800 is the first DSLR with USB 3.0 connectivity, but Eye-Fi has discovered that it can interfere with the default channel used by its Wi-Fi connected flash cards.

Makers of the Eye-Fi wireless memory cards this week released a fix to an issue that kept their cards from working fully with the Nikon D800 and D800E. The problem, according to an Eye-Fi representative, is caused by noise coming from inside the camera, specifically from the D800's unique new USB 3 connector. Posted on Monday, the update works around the issue by changing the card's broadcast channel.

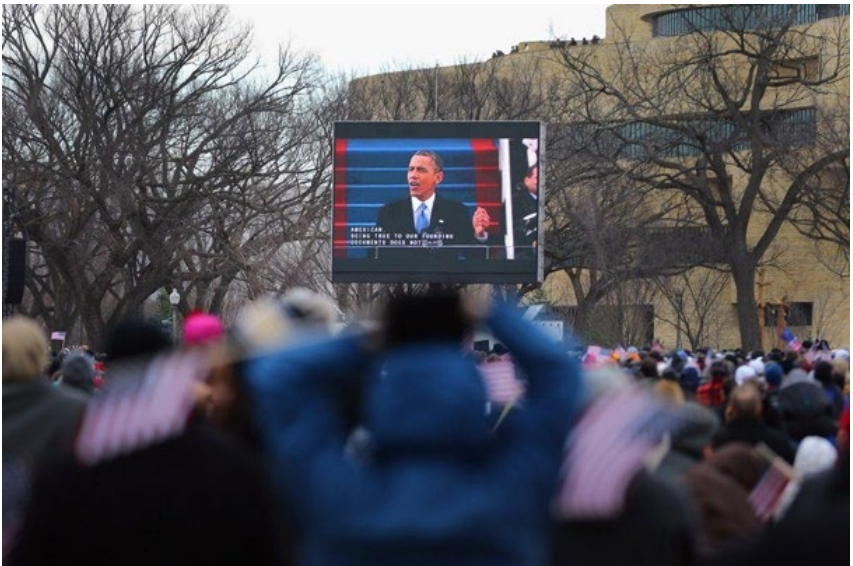
The interference problems affected one of 12 giant video screens erected for the ceremony, and officials have thus far been unable to determine the source of the interference.

Sharkoski added that crews located in the same area as the malfunctioning video screen were unable to communicate on their walkie-talkies while the screen was experiencing problems.

Joe Raedle/Getty Images – President Barack Obama is seen on a jumbotron during his public swearing in ceremony during his Inauguration on Jan. 21, 2013. Interference with a microwave signal may have caused one of the giant screens to fail.

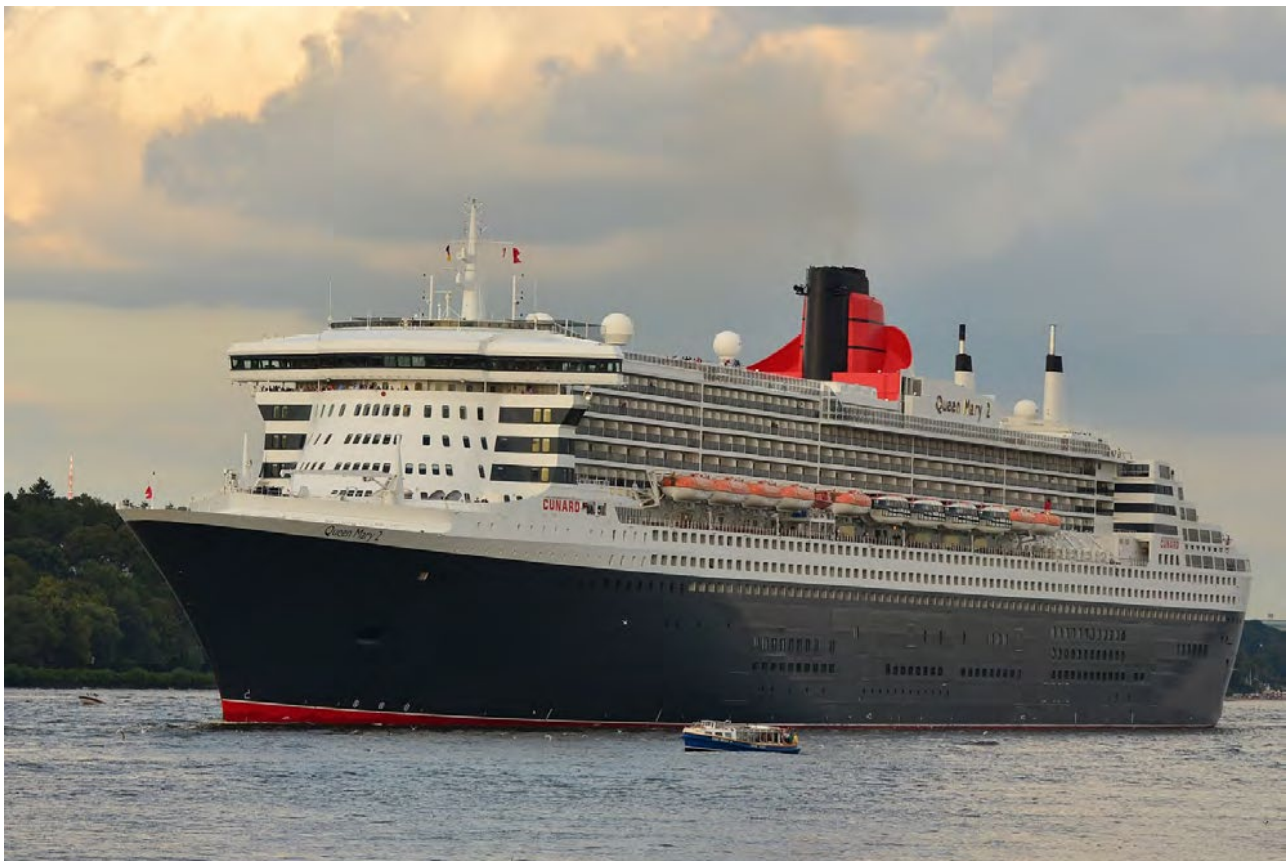
RMS Queen Mary 2. Photo courtesy of Jörn Prestien.

The Maritime and Coastguard Agency has been recommended to produce specific guidance regarding the harmful effects of excessive harmonic distortion in electrical networks and to update the Code of Safe Working Practices for Merchant Seamen to raise awareness about the hazards of arc-flash in high voltage equipment.

QM2's manager, Carnival UK have also been recommended to: improve the standards of protection against the effect of harmonic distortion and component failure; and, to review the machinery alarm systems fitted to QM2 in order to identify and prioritise those alarms which indicate failure conditions that could significantly affect the safety of the vessel.

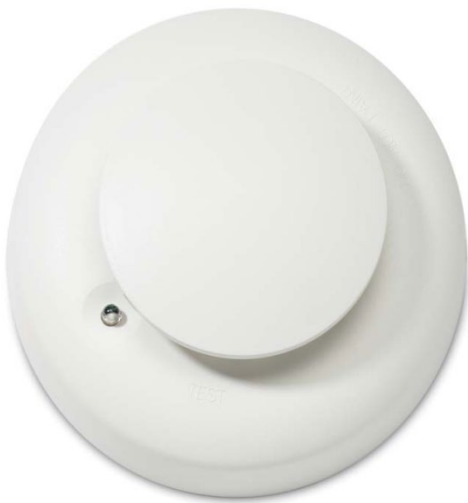
According to a press release issued by the U.S. Consumer Product Safety Commission (CPSC), radio frequency interference (RFI) can cause the smoke detectors to fail to alert consumers of a fire. There have been no reports of incidents or injuries related to the smoke detectors, but the company has issued the product recall to prevent the risk of future incidents.

image 2 of 3 Recalled ESL/Interlogix smoke detector, 500 series

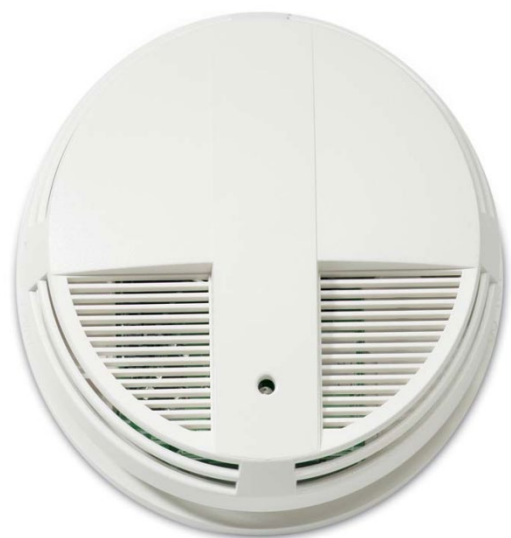
image 1 of 3 Recalled ESL/Interlogix smoke detector, 400 series

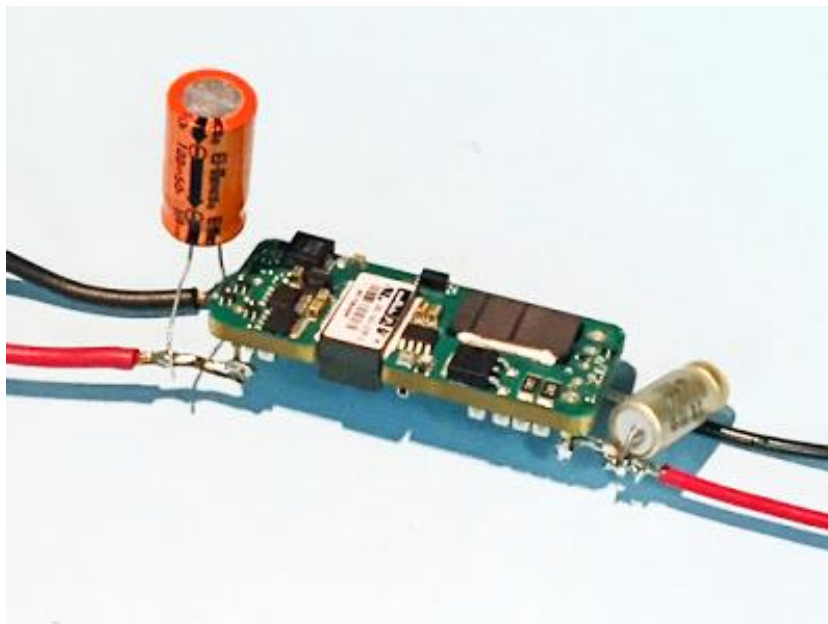
One example of this type of “drop-in” DC-DC converter is manufactured by Murata and we’ll use their model UWE-24/3-Q12, which is an “Eighth Brick” power supply that can take 9 to 36V and convert it to 24V at 3A (Figure 1). My client was using three of these converters on a product and was measuring a high level of radiated emissions, as well as observing broadband noise throughout his system all the way through 150 MHz.

Figure 1 – The Murata UWE-24/3-Q12 DC-DC converter.

After trying some inductors and common-mode chokes I had on hand, I determined that simply placing a 100 μ H inductor in series with the input terminal was enough to quiet the emissions rather drastically (Figure 3).

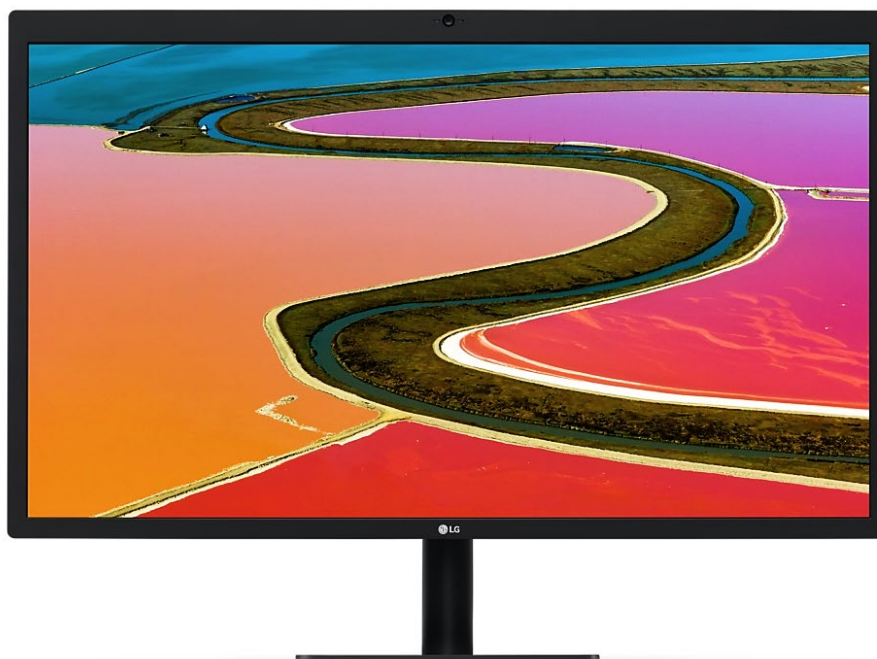
In recent days, I've encountered a similar situation, albeit somewhat in reverse. Apple's been whittling down its product plethora lately, not only turning its back on its longstanding networking equipment presence but also dropping its line of branded displays. Back in June of last year, the company discontinued its last LCD, a Thunderbolt-interface model; a couple of months later, Apple formalized a reference-sell relationship with LG Electronics. Only one problem, though; LG's 27" "UltraFine 5K" display (www.apple.com/shop/product/HKN62LL/A/lg-ultrafine-5k-display) tends to misbehave when in close proximity to a router. According to 9to5Mac's testing, the LCD begins to flicker when a router is approximately 2 meters (6.5 feet) away; any closer than that and the display will eventually go completely dark. The destructive interaction between router and display can in some cases be so severe as to lock up a connected computer, necessitating a restart even if the router is moved away again.

LG's Ultrafine 5K display, from www.apple.com/shop/product/HKN62LL/A/lg-ultrafine-5k-display
(Taken from <http://www.edn.com/electronics-blogs/brians-brain/4458576/Electronics-interference--LG-displays-and-routers>, by Brian Dipert on June 26, 2017 in the "EDN Network" www.edn.com. Kindly sent in by Ronny Deseine of Barco NV, Belgium, on 10 July 2017. Also see: <https://tech.slashdot.org/story/17/01/30/2241256/lgs-ultrafine-5k-display-becomes-useless-when-its-within-two-meters-of-a-router>, and <https://9to5mac.com/2017/01/30/lg-ultrafine-5k-display-router-disconnecting/>)

An LG spokesperson confirmed with Ars that the 5K UltraFine monitor isn't adequately shielded from EM radiation, and that displays manufactured after February 2017 "will be fitted with enhanced shielding." Furthermore, existing displays can be retrofitted with extra shielding—if you own the 5K UltraFine, and you're having issues, you should "contact your nearest customer service centre for prompt service." Curiously, the spokesperson said that the Wi-Fi router interference problem only

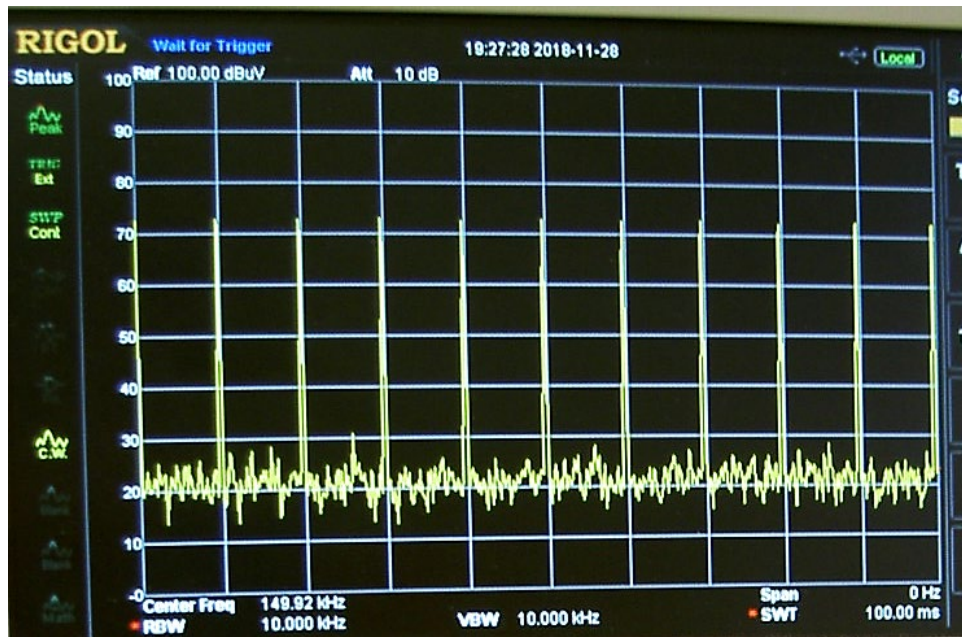
Figure 2

We set up the spectrum analyser in zero span in conjunction with an oscilloscope (with a shared trigger) and confirmed that the emission occurred at zero crossing, see Figure 3.

All this from a bridge rectifier?
