SCHEMATIC DIAGRAMS (1/12)

1U-3373-1 (1/3)
AUDIO/DSP UNIT

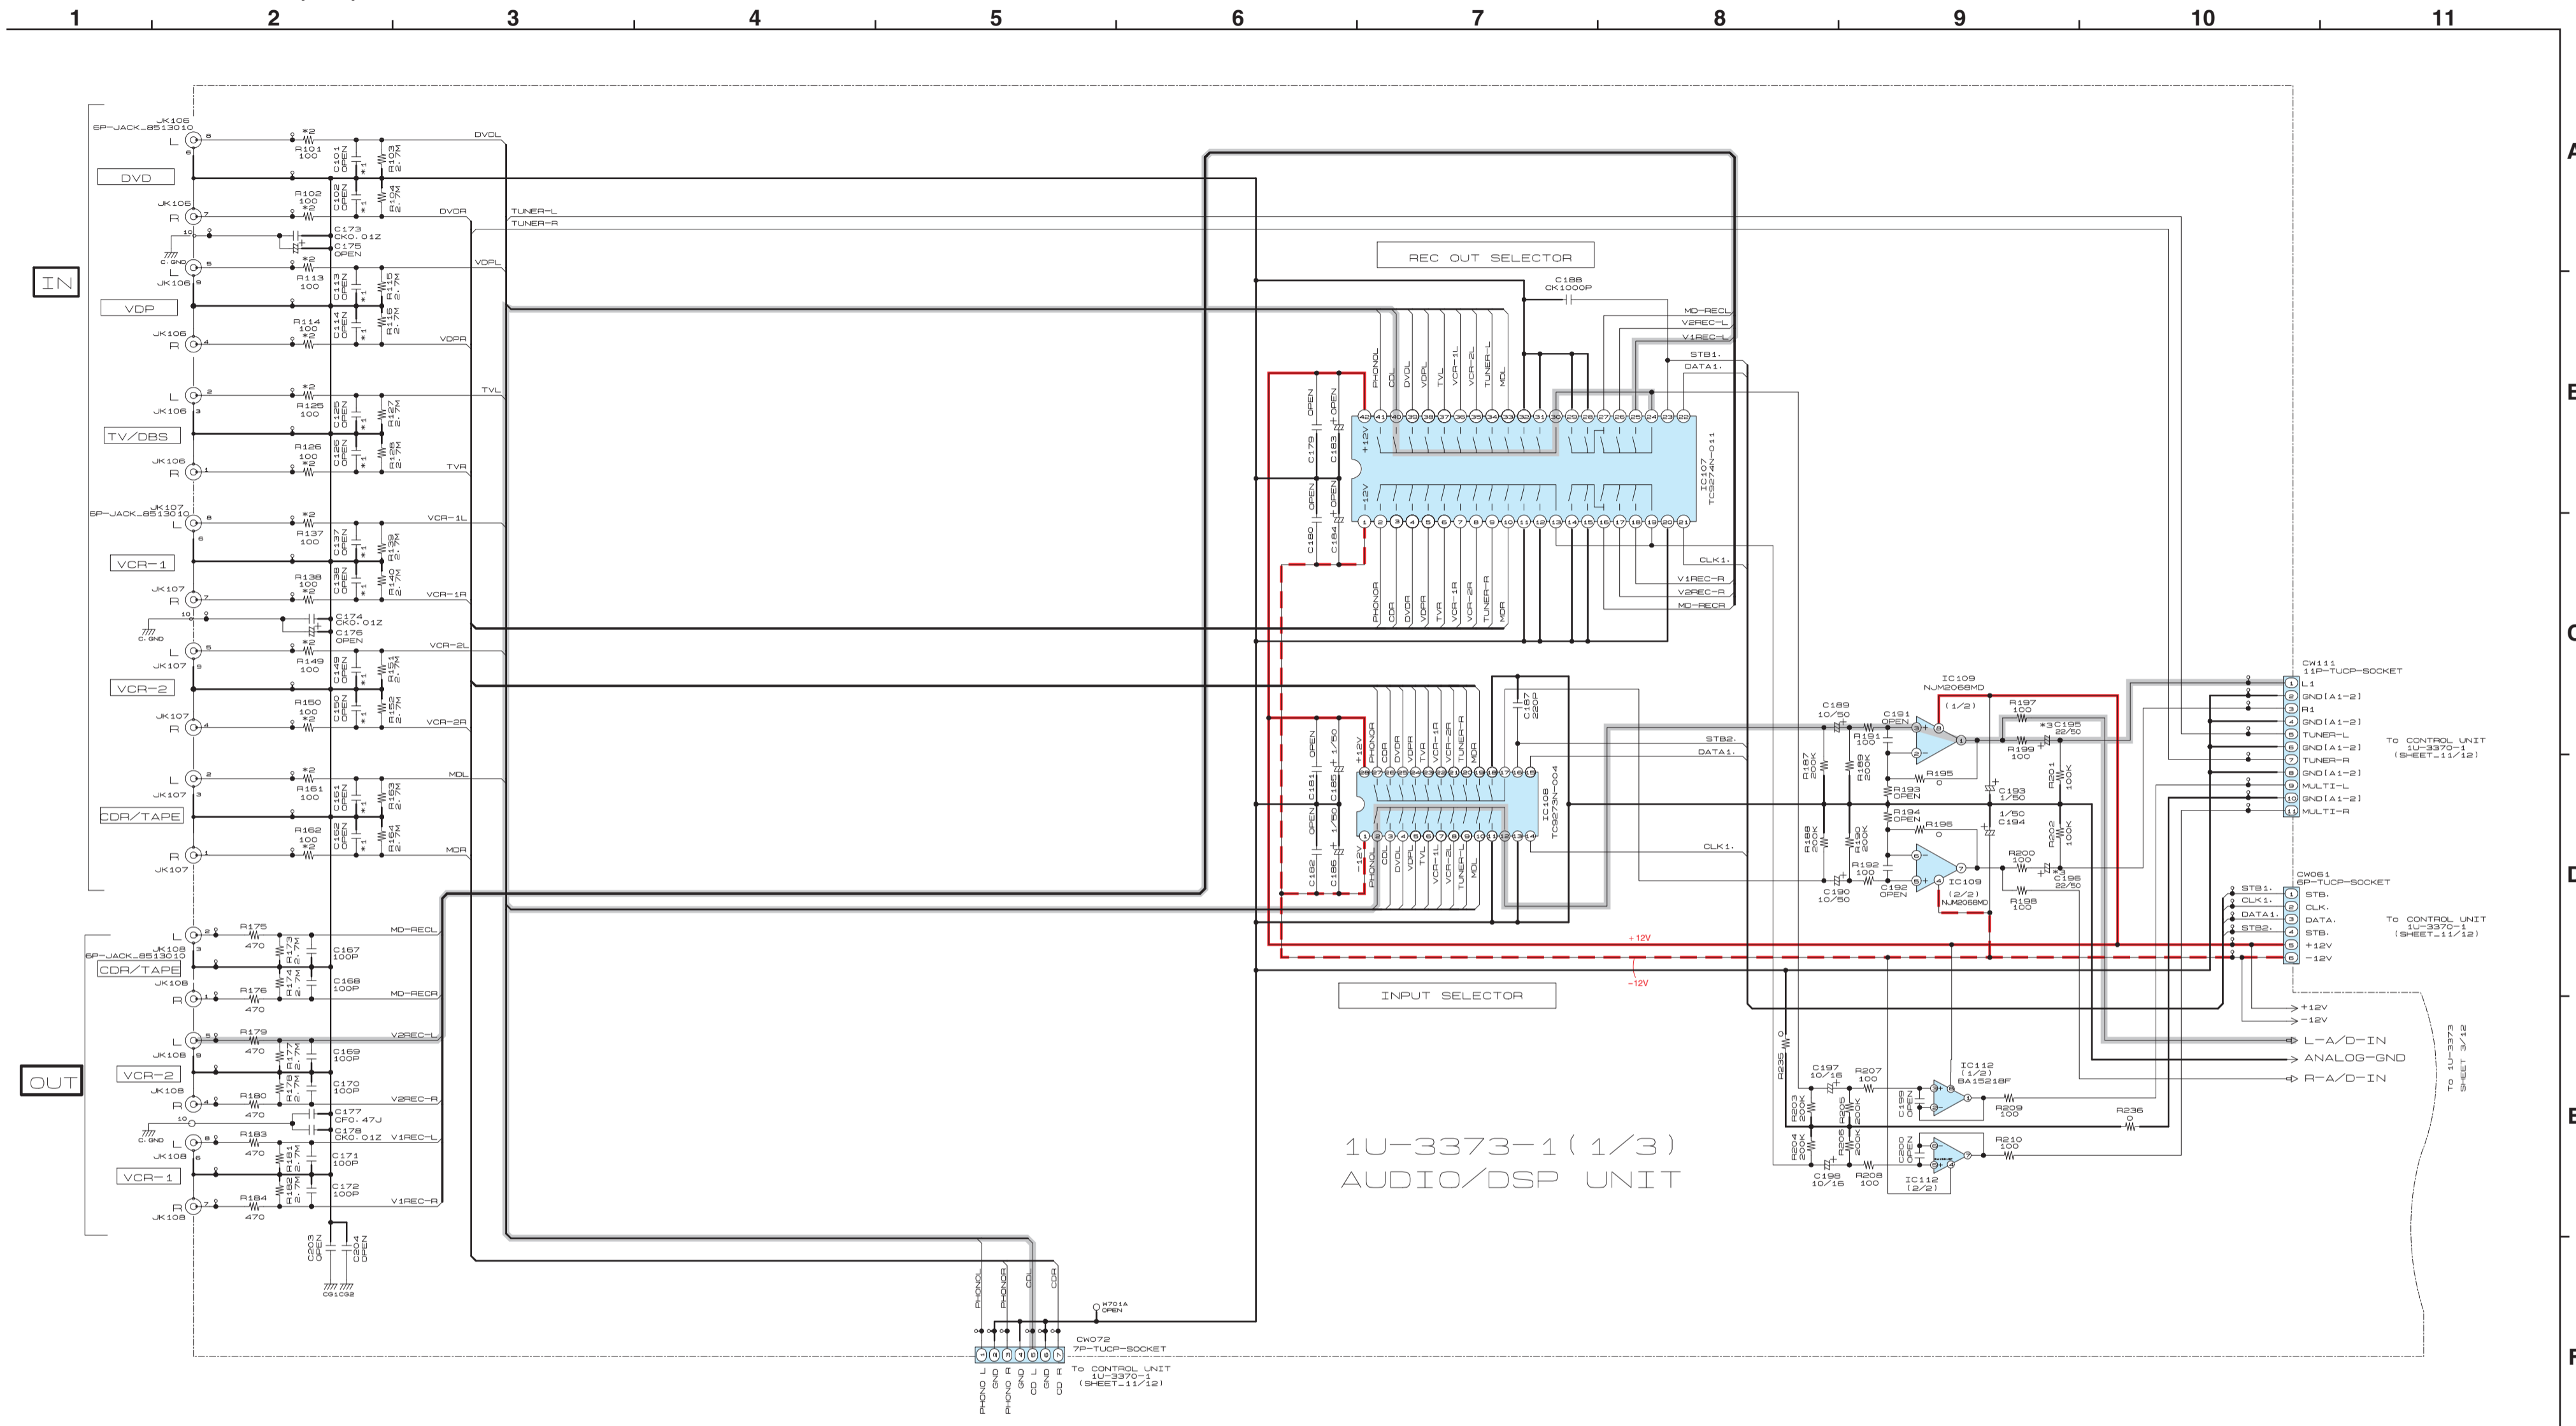
*1	*2	*3
	C101, 102, 113, 114 C125, 126, 137, 138 C149, 150, 161, 162	OPEN	OPEN
USA CANADA	330P	470	100/16
EUROPE	330P	470	22/50
ASIA HONG KONG CHINA TAIWAN P. R. C.	330P	470	22/50
