MB150-III POWER AMP
 BOARD NO: 406-0211-B1
 PART NO: 206-0211-B1
 COMPANY: GALLIEN-KRUEGER
 FILENAME: 6211B1.sch

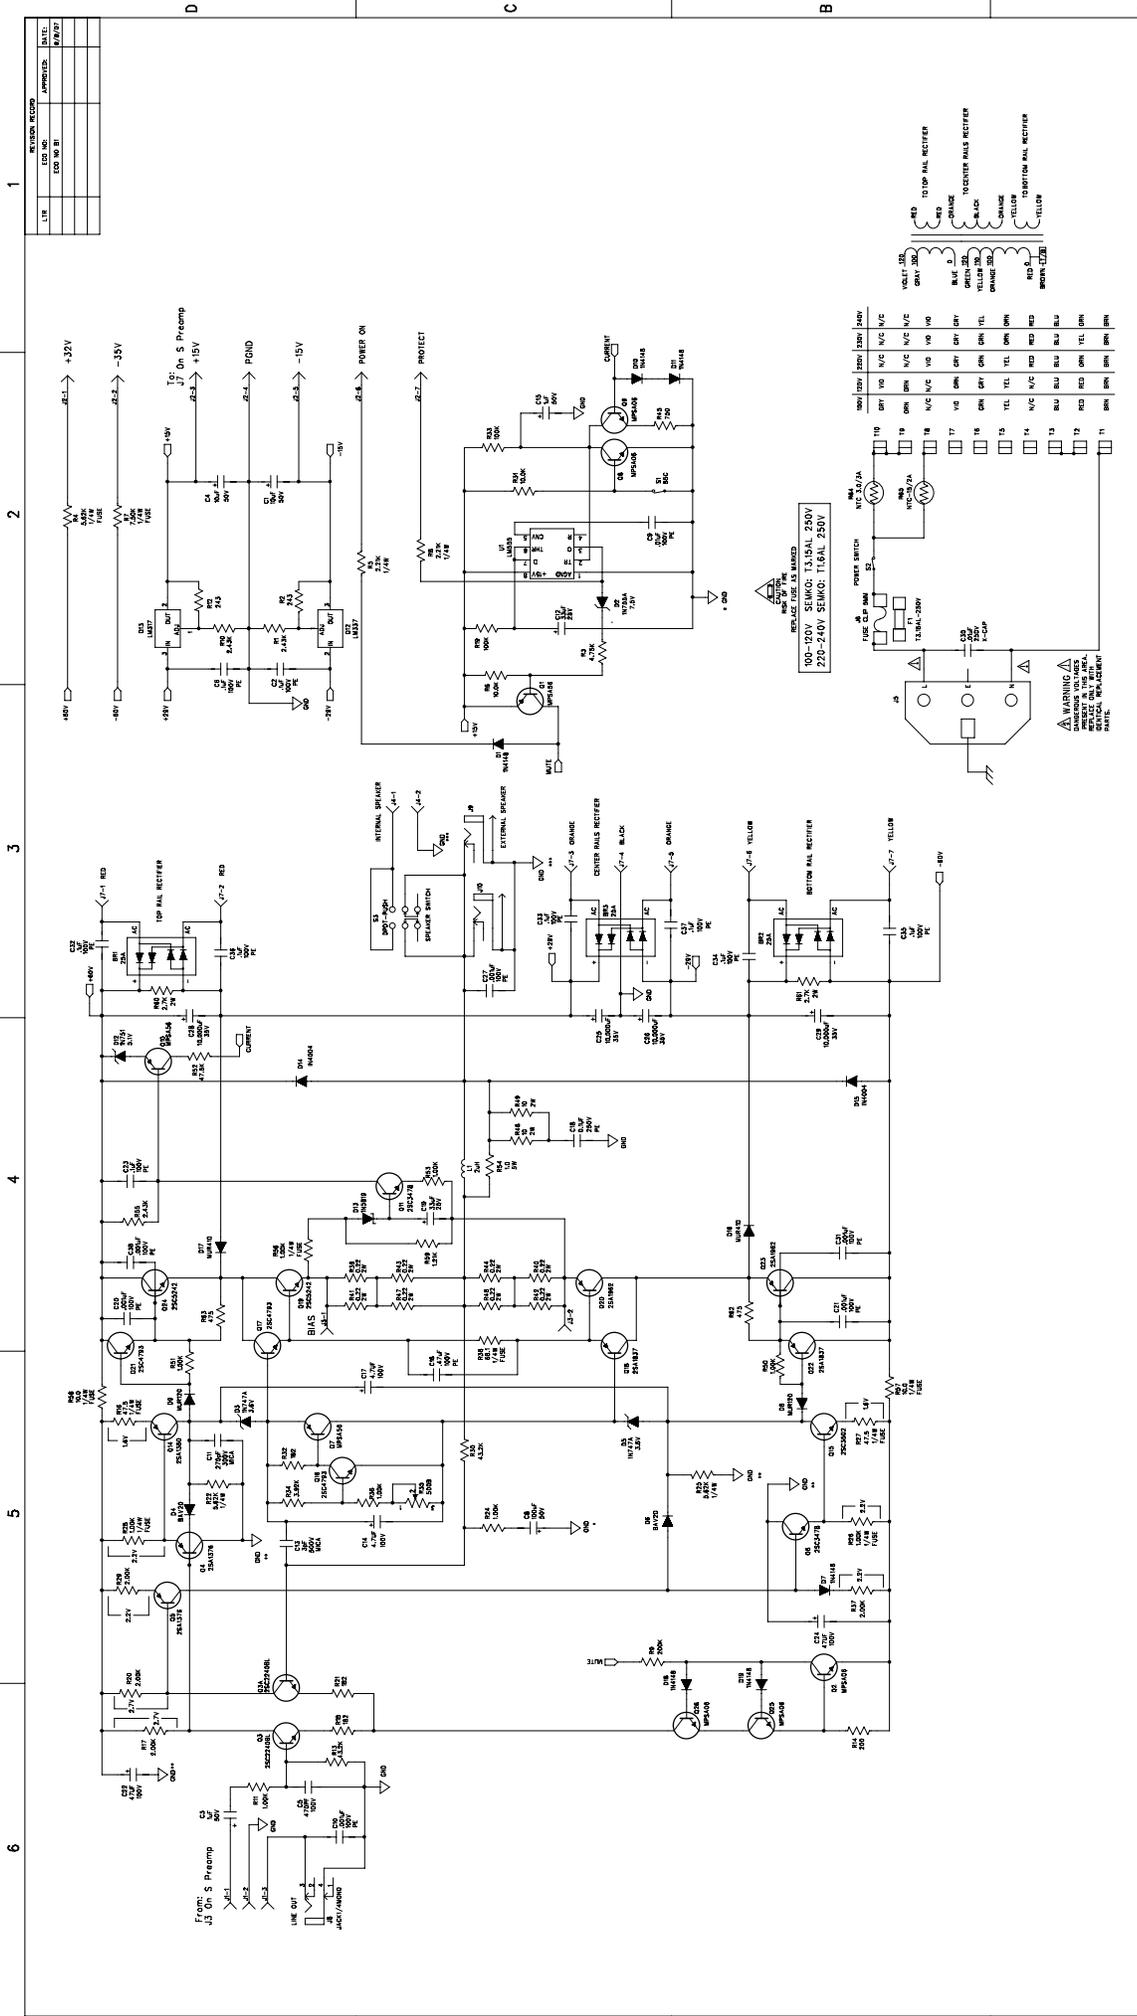
BIAS ADJUSTMENT PROCEDURE
 WITH POWER OFF, ADJUST POT R35 TO FULL COUNTER-CLOCKWISE POSITION.
 TURN ON POWER AND WAIT 5 SECONDS FOR TURN ON DELAY.
 TURN R35 CLOCKWISE UNTIL VOLTAGE ACROSS J3 READS 10 mVDC.
