Factory modification on some early Philips CD 100 CD players. (Drawn by inspection)

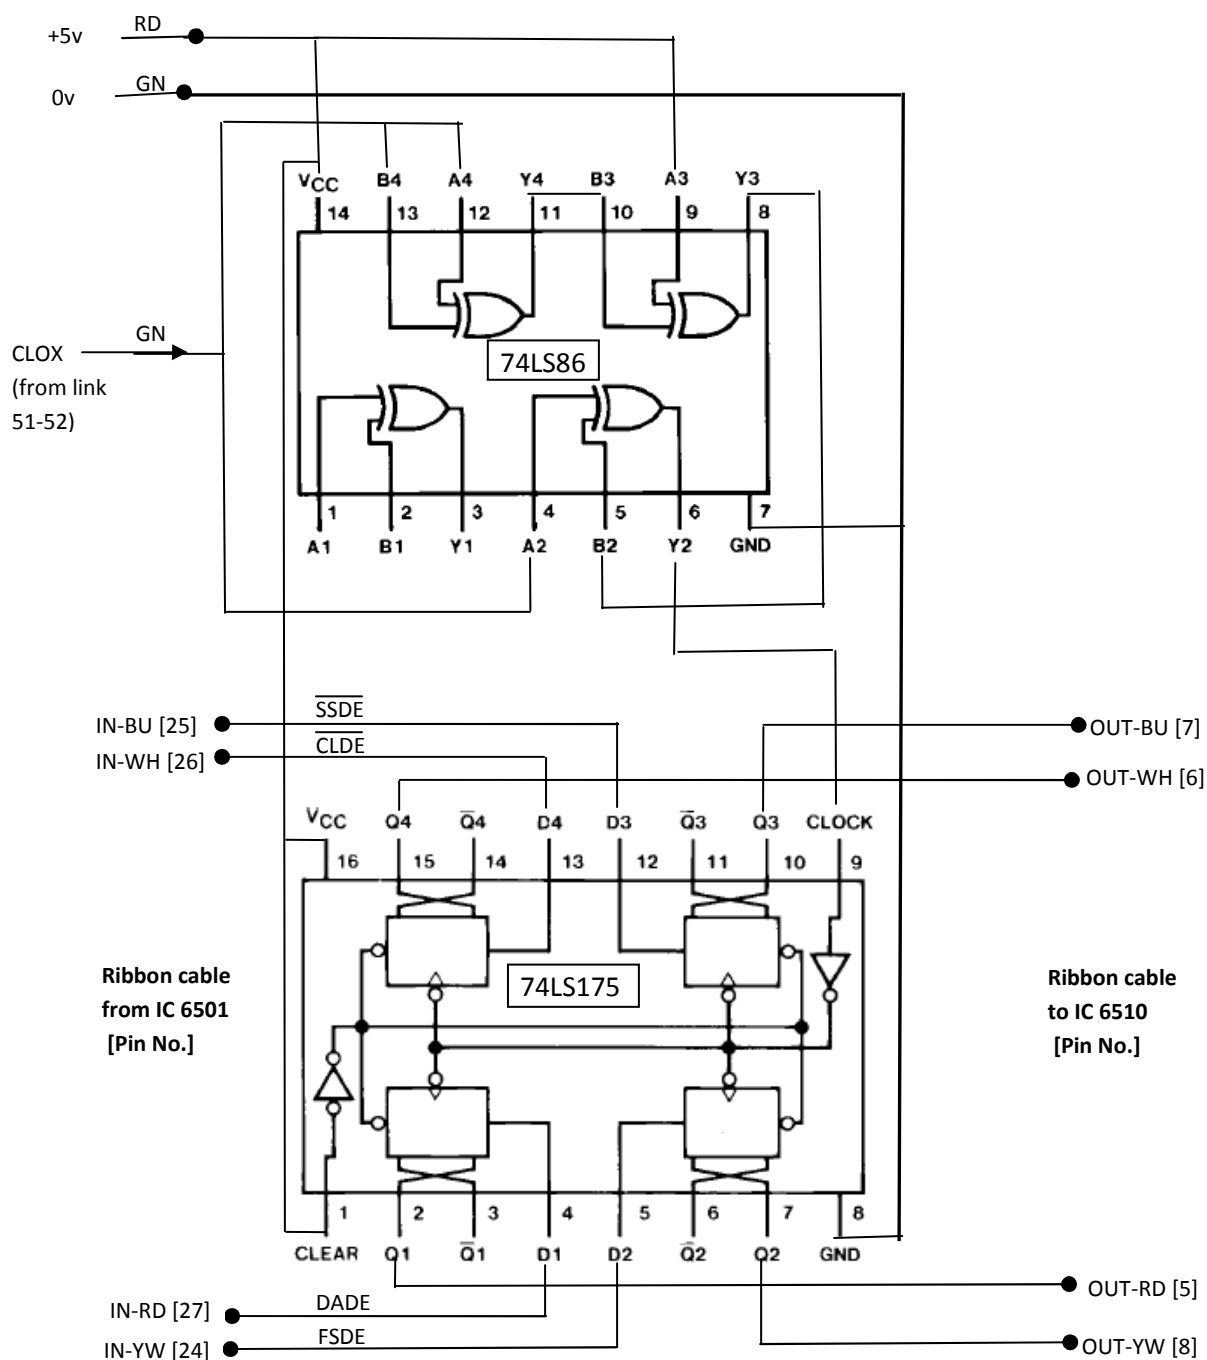
This board is not shown in the service manual. It is probably the 'Demod-Erco Interface Board' referred to in the version notes table (A02 to A05 of the Demod Board) in section 11-4 of the Dutch service manual. Its function appears to be to alter the timing and/or active edge of the 4 data lines concerned.

The 4 tracks on the Decoder PCB between ICs 6501 and 6510 are cut and diverted via ribbon cables to/from the above circuit.
