Title		
Current Feedback Amplifier		
Size	Number	Revision
B		
Date:	15-Apr-1997	Sheet of
File:	E:\COLBY\SCHEMA-1\CARAMP-1\CFBAMP.SCH

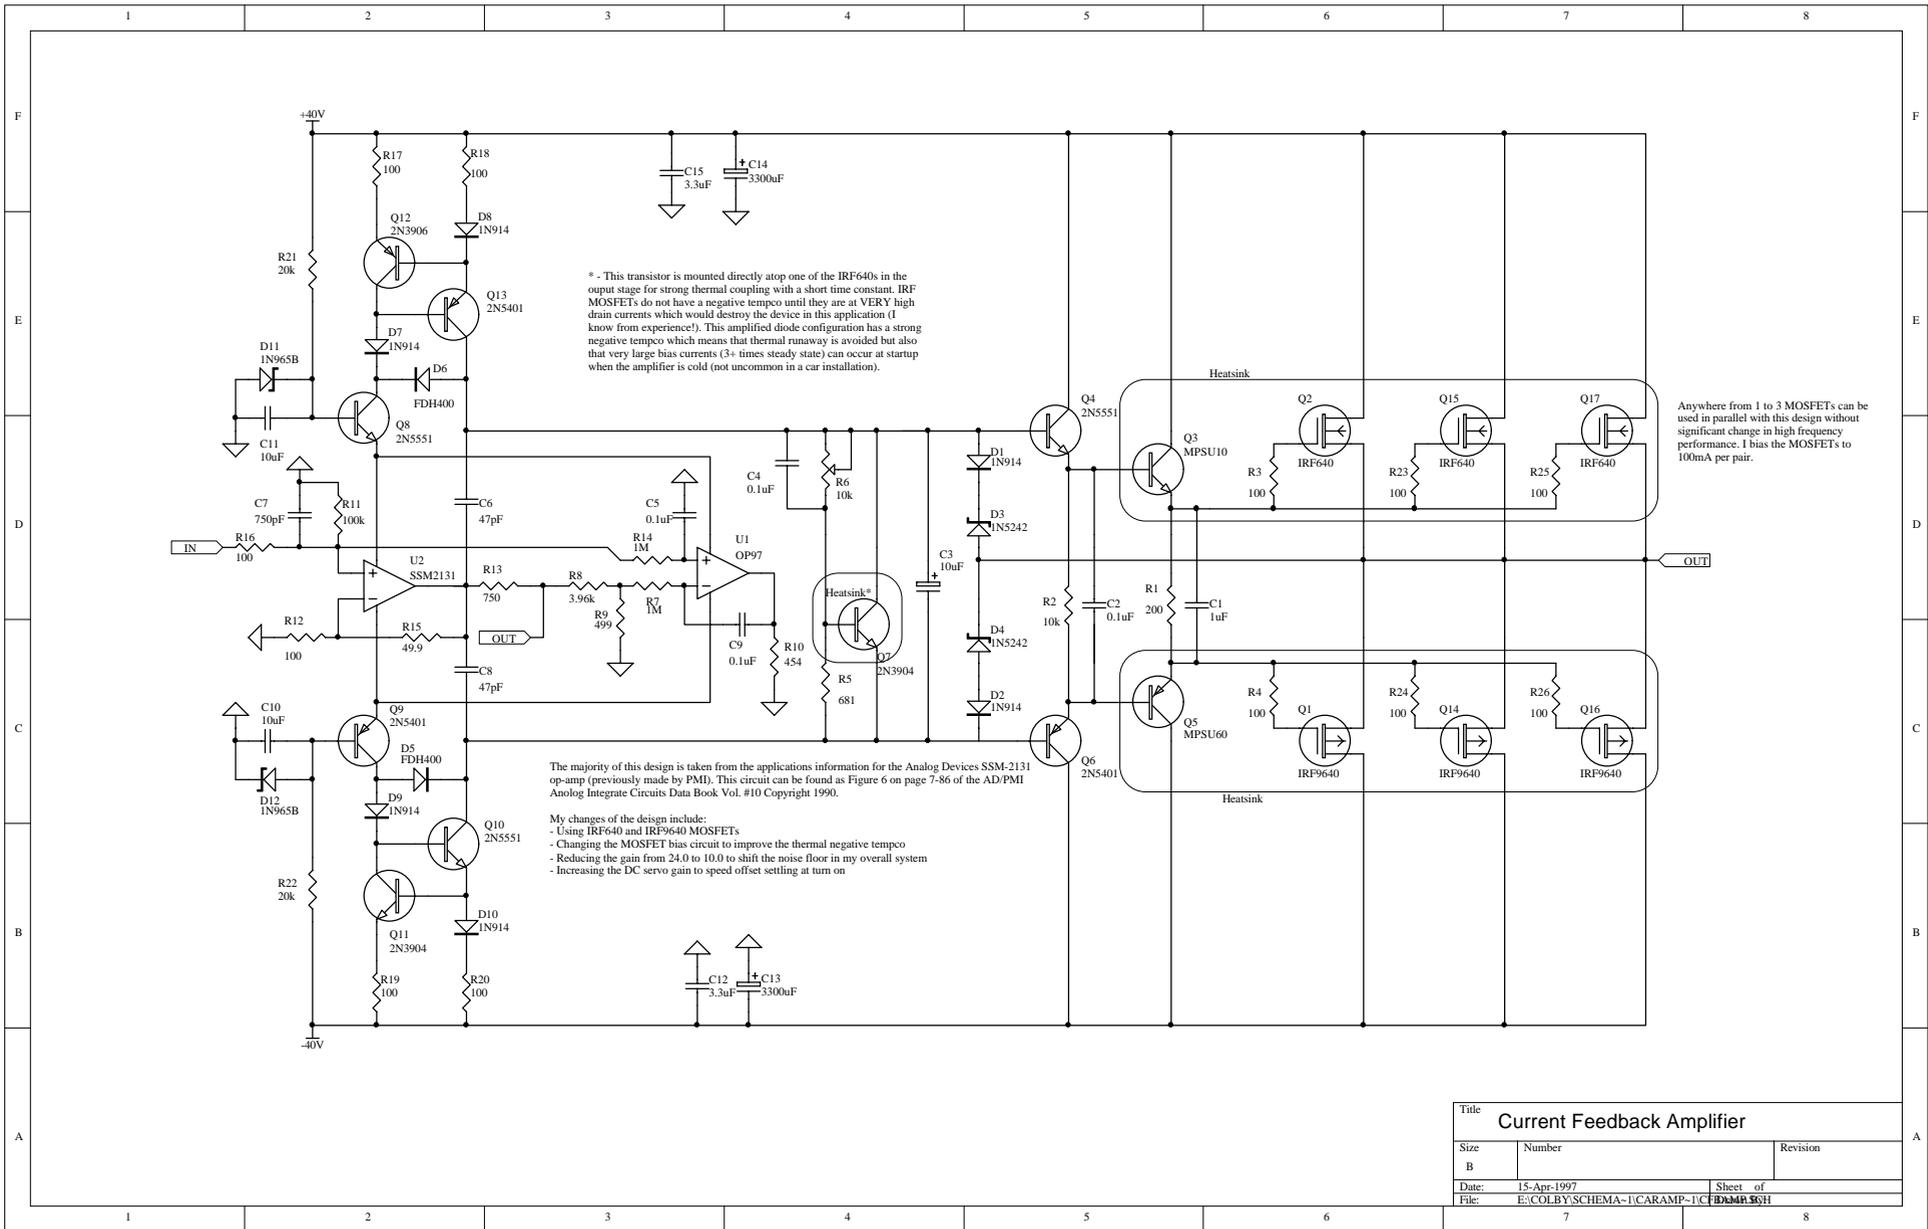
* - This transistor is mounted directly atop one of the IRF640s in the output stage for strong thermal coupling with a short time constant. IRF MOSFETs do not have a negative tempo until they are at VERY high drain currents which would destroy the device in this application (I know from experience!). This amplified diode configuration has a strong negative tempo which means that thermal runaway is avoided but also that very large bias currents (3+ times steady state) can occur at startup when the amplifier is cold (not uncommon in a car installation).

The majority of this design is taken from the applications information for the Analog Devices SSM-2131 op-amp (previously made by PMI). This circuit can be found as Figure 6 on page 7-86 of the AD/PMI Analog Integrate Circuits Data Book Vol. #10 Copyright 1990.

- My changes of the design include:
- Using IRF640 and IRF9640 MOSFETs
 - Changing the MOSFET bias circuit to improve the thermal negative tempo
 - Reducing the gain from 24.0 to 10.0 to shift the noise floor in my overall system
 - Increasing the DC servo gain to speed offset settling at turn on

Anywhere from 1 to 3 MOSFETs can be used in parallel with this design without significant change in high frequency performance. I bias the MOSFETs to 100mA per pair.
