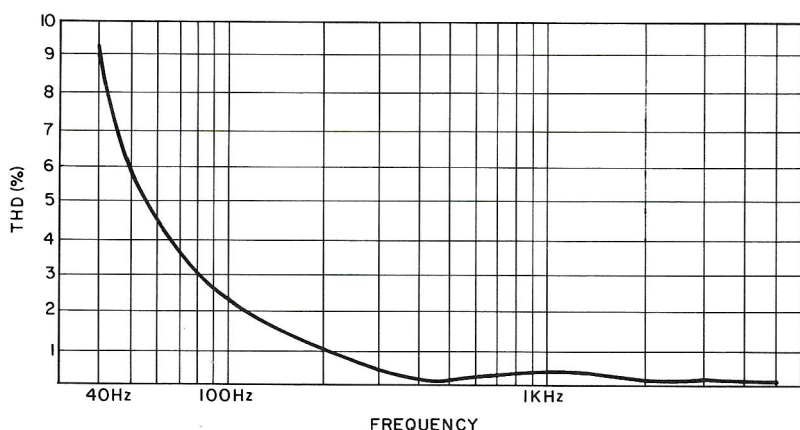
FIGURE 2: Distortion measurements of the JBL D130 15-inch speaker in a C40 short, rear-loaded horn enclosure. Insufficient loading caused distortion to rise rapidly at low frequencies. THD at 40Hz, 90dB SPL at 3 feet, was 8.5 percent.
