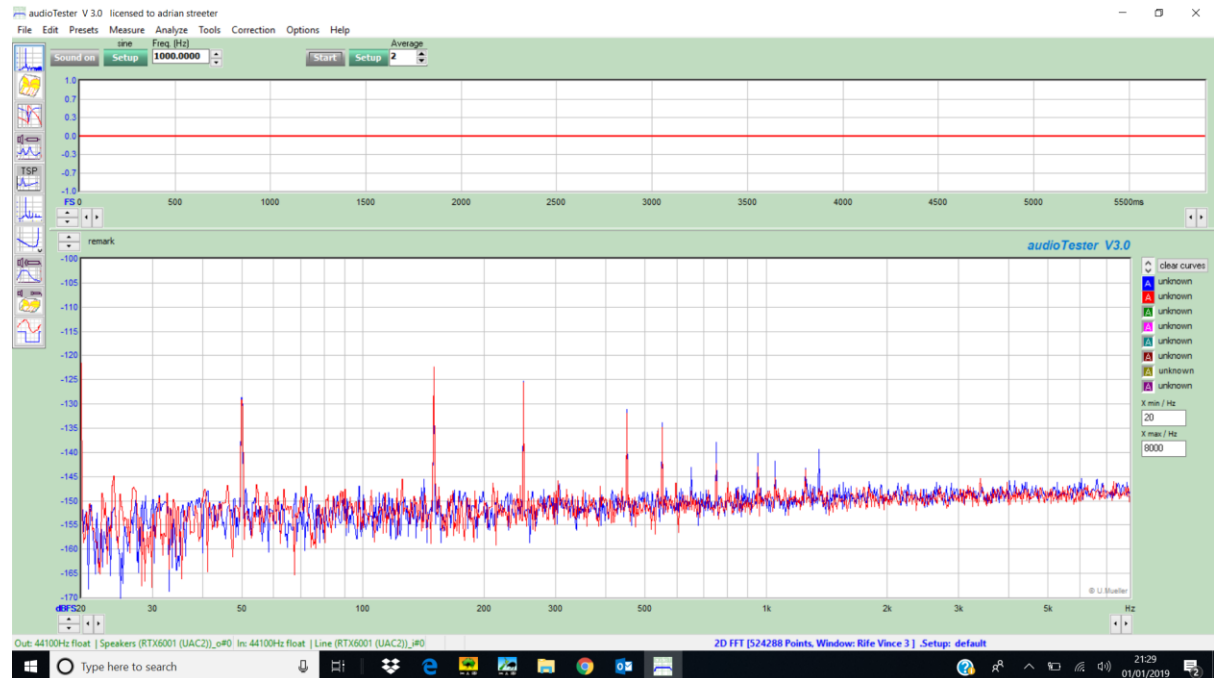
Inputs shorted together and grounded at the input connection on both input channels. Input attenuator setting -20dB.

XFR in 'as built' configuration

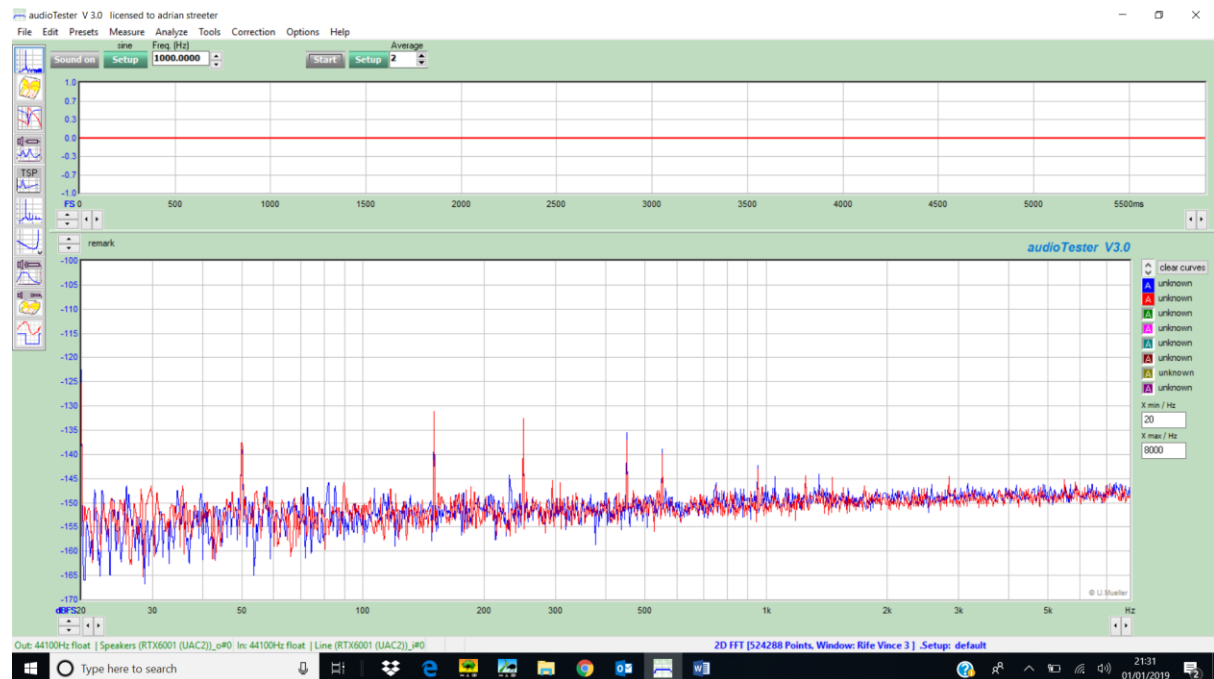
XFR located against real wall

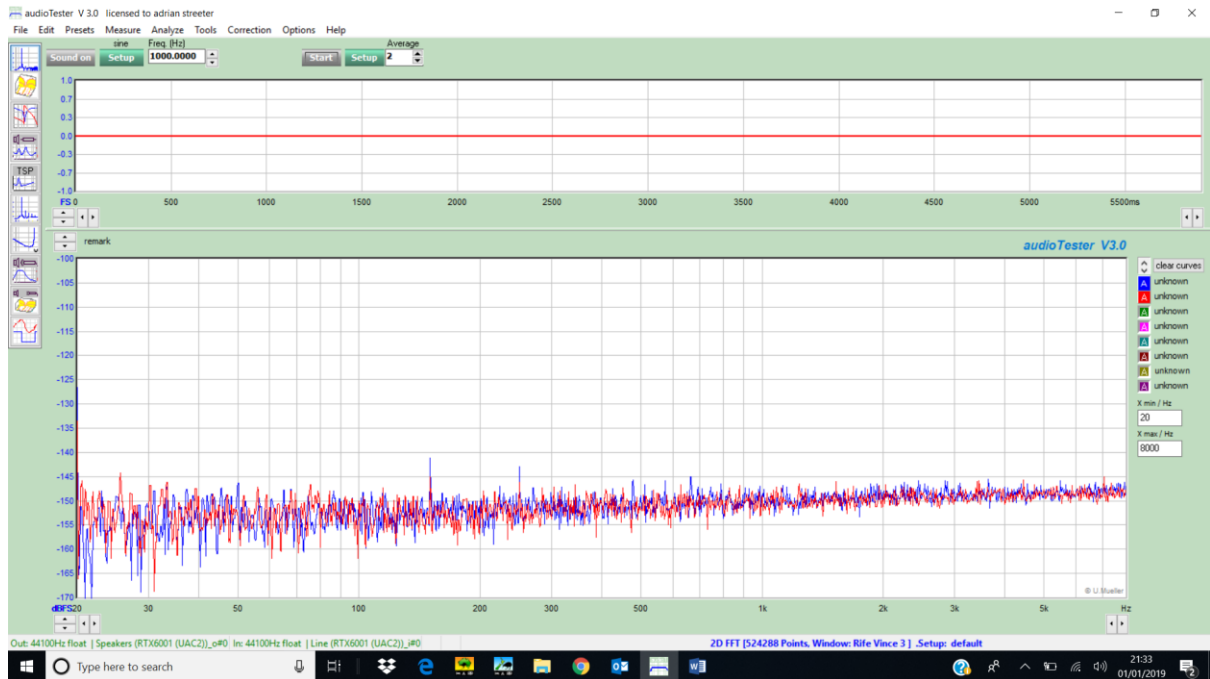
XFR hanging outside side of case
