Sinus wave testing in to 80Ohm dummy load → Distorted wave form  
Circuit used, only 1 pair 2SC2922/2SA1216 OPS

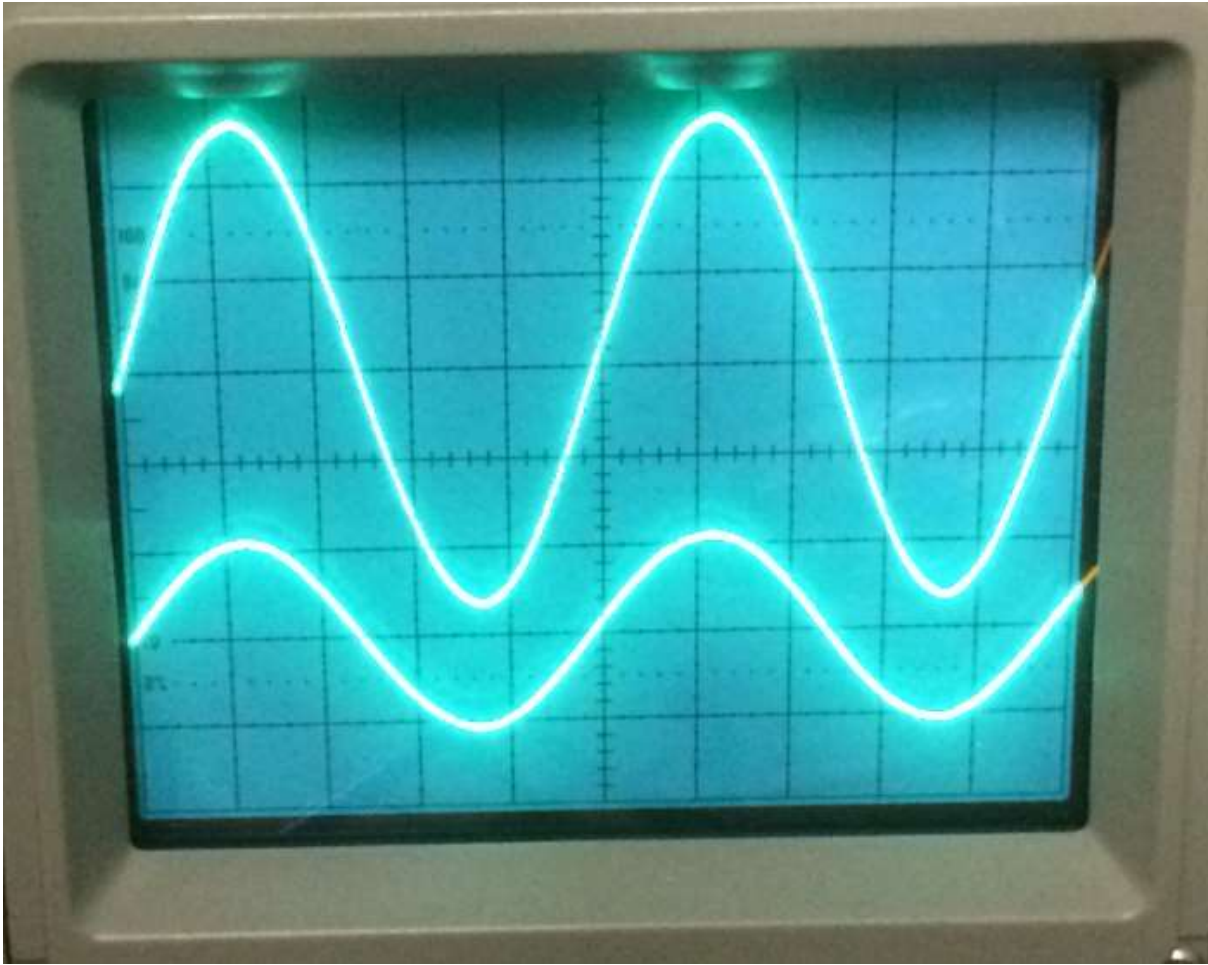
Sinus wave testing in to 80hm dummy load → Distorted wave form  
10kHz: wave looks fine

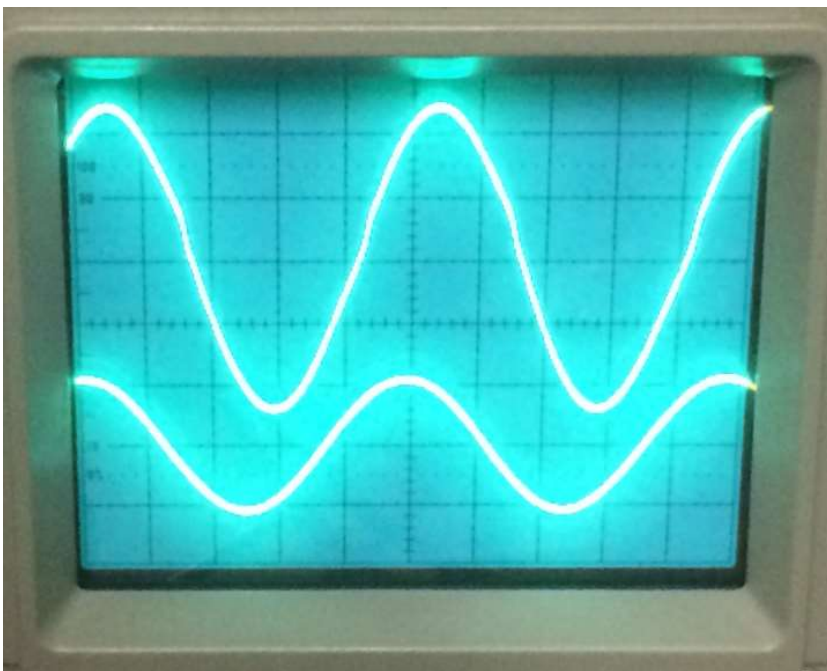
100Khz: “vertical” area around crossover point

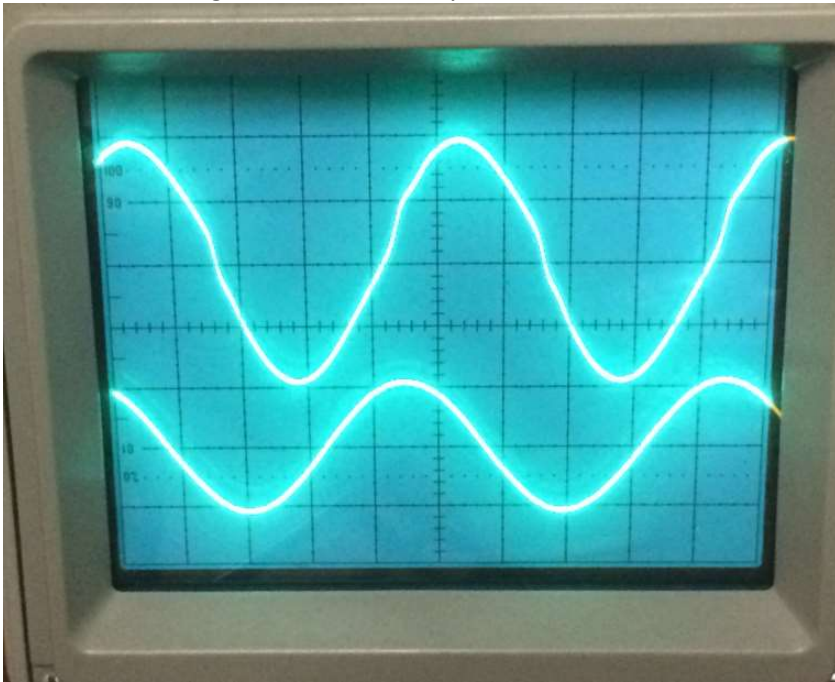
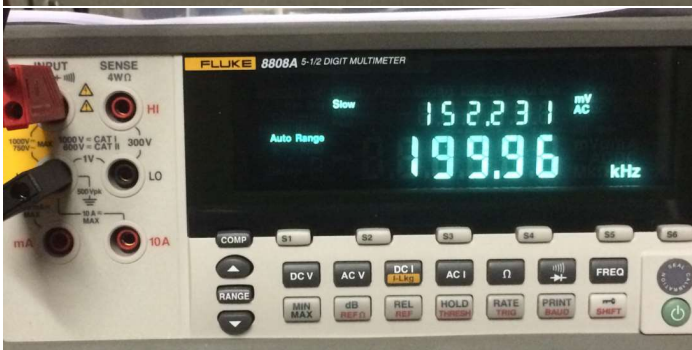
200Khz: more “vertical” area around crossover point

Sinus wave testing in to 80hm dummy load → Distorted wave form
