Modification L1210 servo board – "No disc" playability issue.

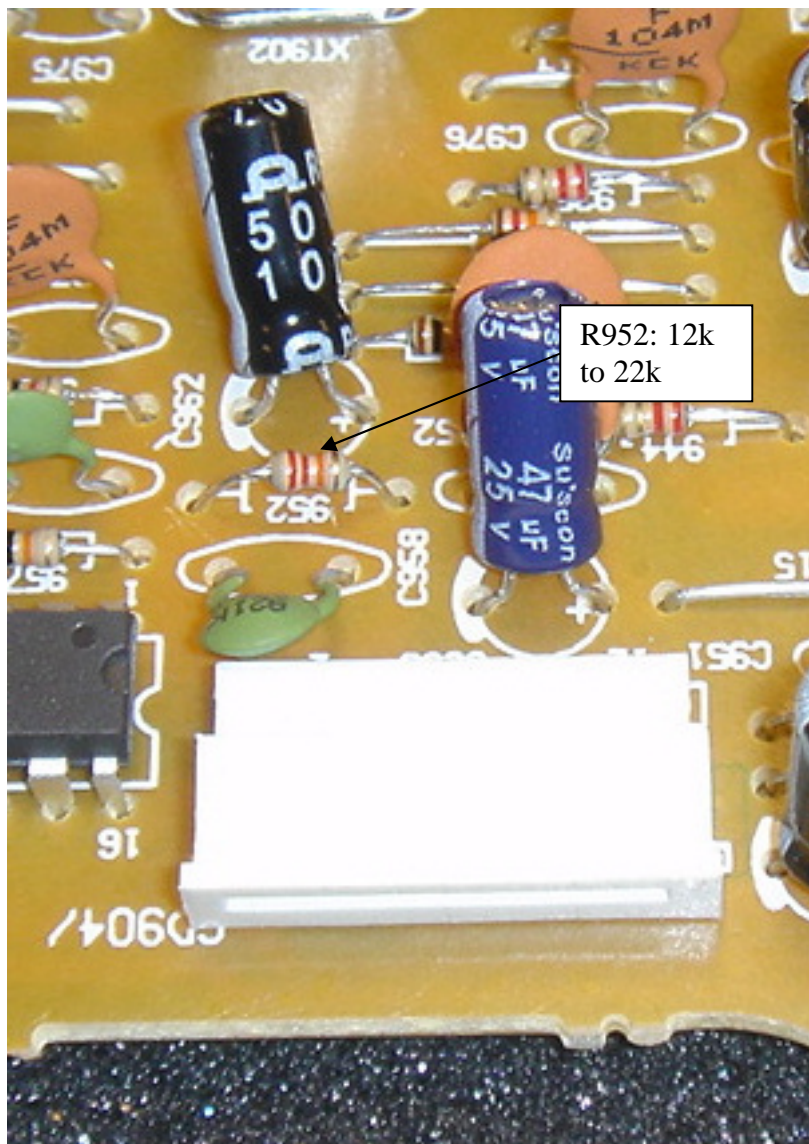
Components side of the L1210 servo board.
Location near the mechanism flex connector.

R952 old value: 12k ohms
R952 new value: 22k ohms
